NO. 93-119
TRAIN 301
COLLISION WITH MOTOR VEHICLE
HUNTLY
7 NOVEMBER 1993

TRANSPORT ACCIDENT INVESTIGATION COMMISSION

RAIL ACCIDENT REPORT NO. 93-119

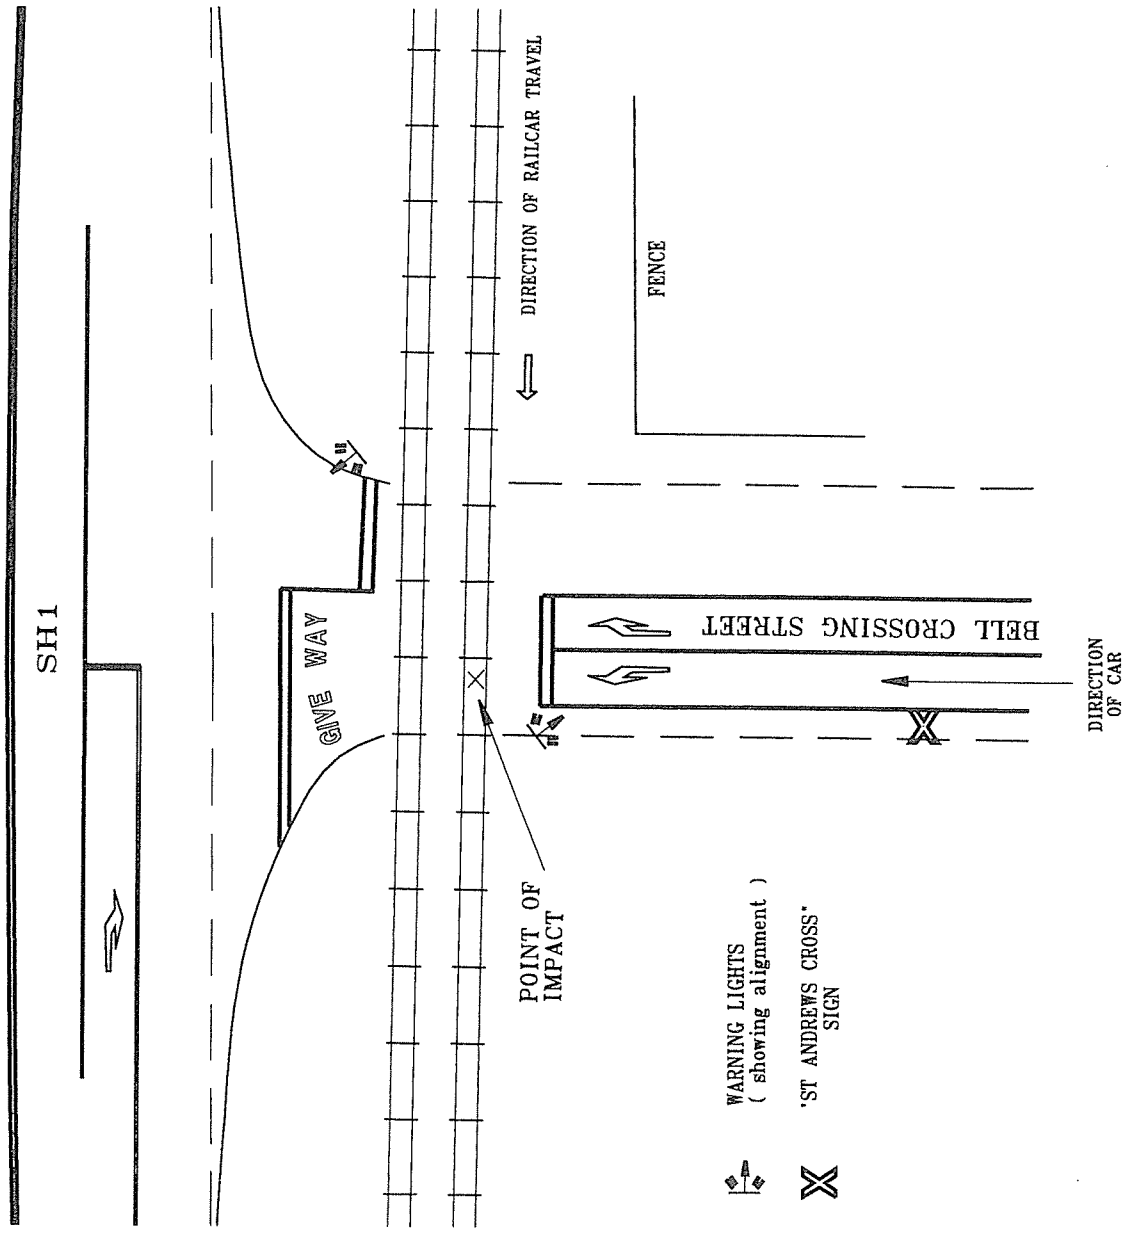
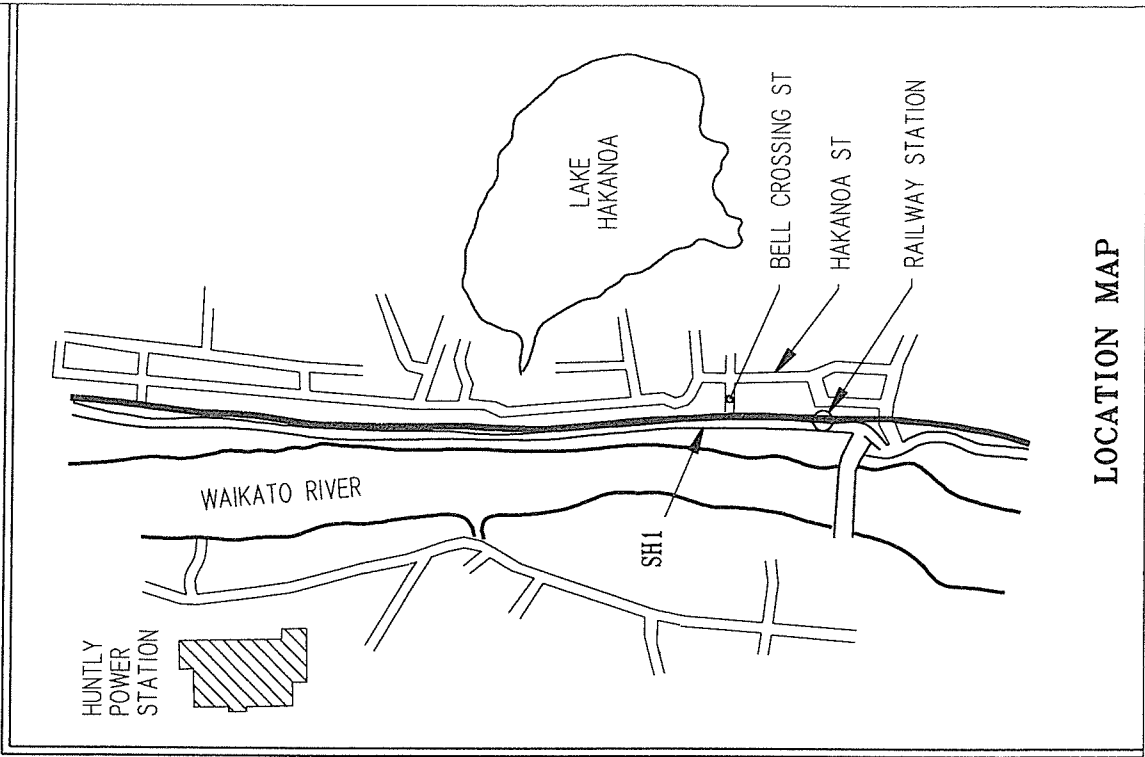
BELL CROSSING STREET , HUNTLY

1.14 The sun was low. Although there was a considerable amount of cloud in the sky, the sun was shining just prior to the accident. The sun's azimuth would have been adjacent to the single crossing alarm for most of the car driver's approach to the crossing and would certainly have made observation of the flashing lights difficult.

1.15 The railway track from the north would not have been visible to the driver until he was close to the crossing, the view being obstructed by a tall fence of the adjacent house property.

1.17 There was only one pair of flashing lights on the eastern side of the crossing. The road had been marked for two lanes approaching the crossing, and it was the policy of NZRL to have a pair of flashing lights for each approach lane. However, the roading authority had marked the road without reference to NZRL, which was unaware until this accident that the change had occurred.

1.18 If NZRL's policy had been implemented, a second pair of flashing lights would probably have been installed on a traffic island in the middle of Bell Crossing Street just before the crossing. The angle of vision for the

oncoming driver would have been different from that for the first pair, and would have been clear of the setting sun.

2.4 The azimuth of the setting sun was very close to the flashing lights of the crossing alarms in the field of vision of the car driver.

2.9 The view of the railway track to the north from the east side of the crossing was restricted by a tall fence until the car was within 20 metres of the crossing. The driver had very little time in which to observe the train.

2.14 The crossing had only one pair of flashing lights facing the double lanes on the eastern approach, contrary to NZRL's usual policy of providing a pair of flashing lights for each lane.

3.2.1 They place a large dark board behind the flashing lights of the crossing alarms on the eastern side of the crossing in order to improve the visibility of the lights when the sun is setting (025/94), and

3.2.1 *The background board has been provided behind the flashing lights at Bell Street Road Crossing to improve the visibility of the lights when the sun is setting.*
