NO. 93-124
TRAIN 248
TE KAUWHATA
6 DECEMBER 1993

TRANSPORT ACCIDENT INVESTIGATION COMMISSION

RAIL INCIDENT REPORT NO. 93-124

Train Type and Number:	Express Freight 248
Locomotive:	DF6300
Date and Time:	6 December 1993, 1740 hours
Location:	Te Kauwhata 591.52 km North Island Main Trunk
Type of Occurrence:	Derailment
Persons on Board:	Crew: 1
Injuries:	Crew: Nil Others: Nil
Nature of Damage:	Substantial damage to locomotive, wagons, and track.
Information Sources:	Transport Accident Investigation Commission field investigation
Investigator in Charge:	Mr W J D Guest

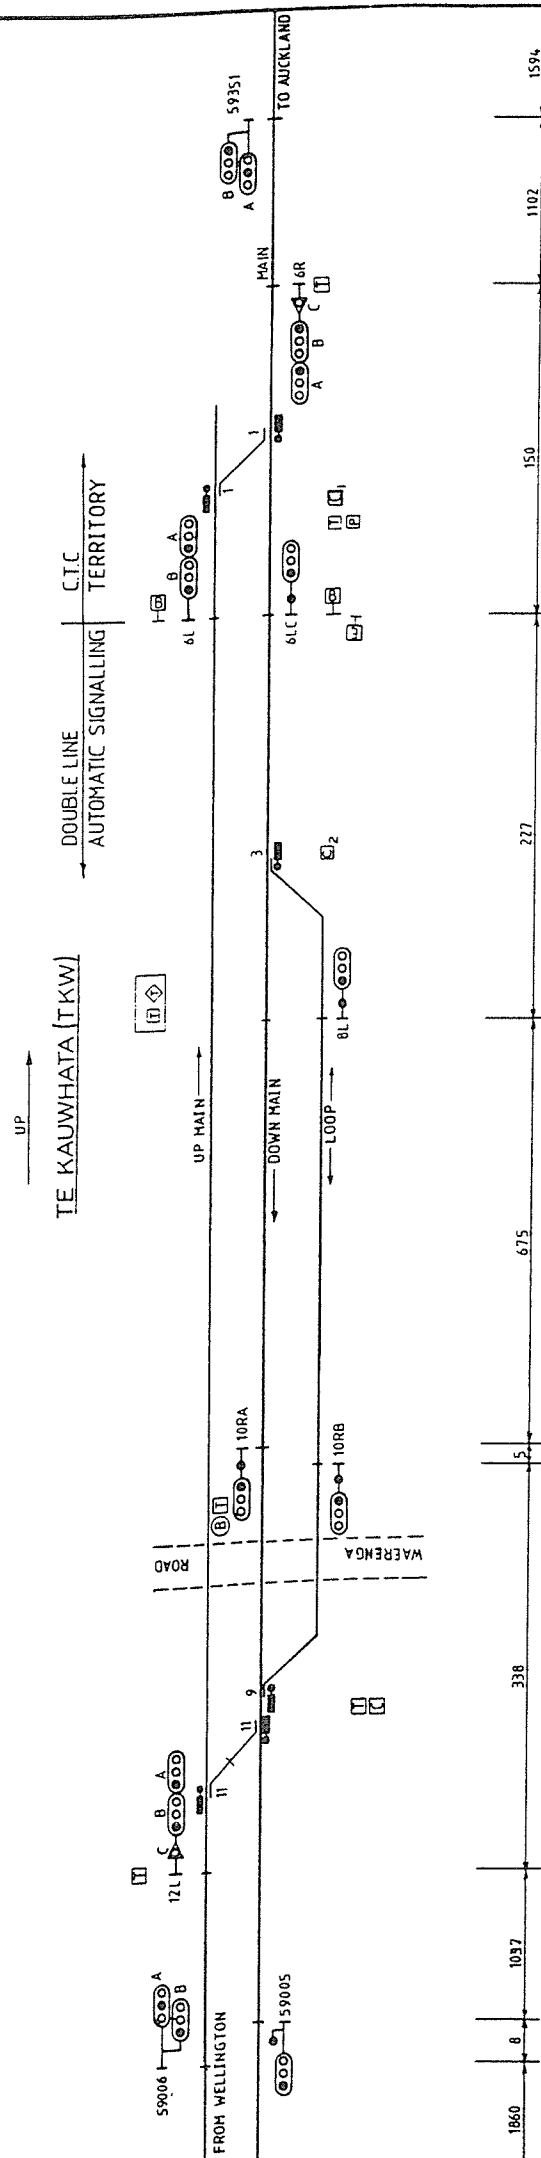
SIGNALLING & INTERLOCKING ARRANGEMENTS

1.12 The signal after signal 59006 was signal 12L. It was located 1.045 km further along the track, close to the points leading to the crossing loop at Te Kauwhata. The medium speed aspect on signal 12L was only for movement off the main line and towards the loop. This aspect was not displayed for any other purpose at this signal.

1.13 The aspects of the signals and the layout and location of them at Te Kauwhata were shown in Signalling

and Interlocking Circular (widely called an “S and I” Circular) No. 2063 available to all Locomotive Engineers and operating staff working over this part of the North Island Main Trunk. A copy of this “S and I” circular is attached as Appendix A.

1.14 The yellow over green aspect at signal 59006 therefore advised the Locomotive Engineer explicitly that the points at the south end of Te Kauwhata were set for the crossing loop.

- Investigate the practicability of introducing an intermediate speed aspect for the signals 12L and 6L at Te Kauwhata and other similar locations (038/94)
