NO. 93-127

TRAIN 573

COLLISION WITH PEDESTRIAN

RAIL ACCIDENT REPORT NO. 93-127

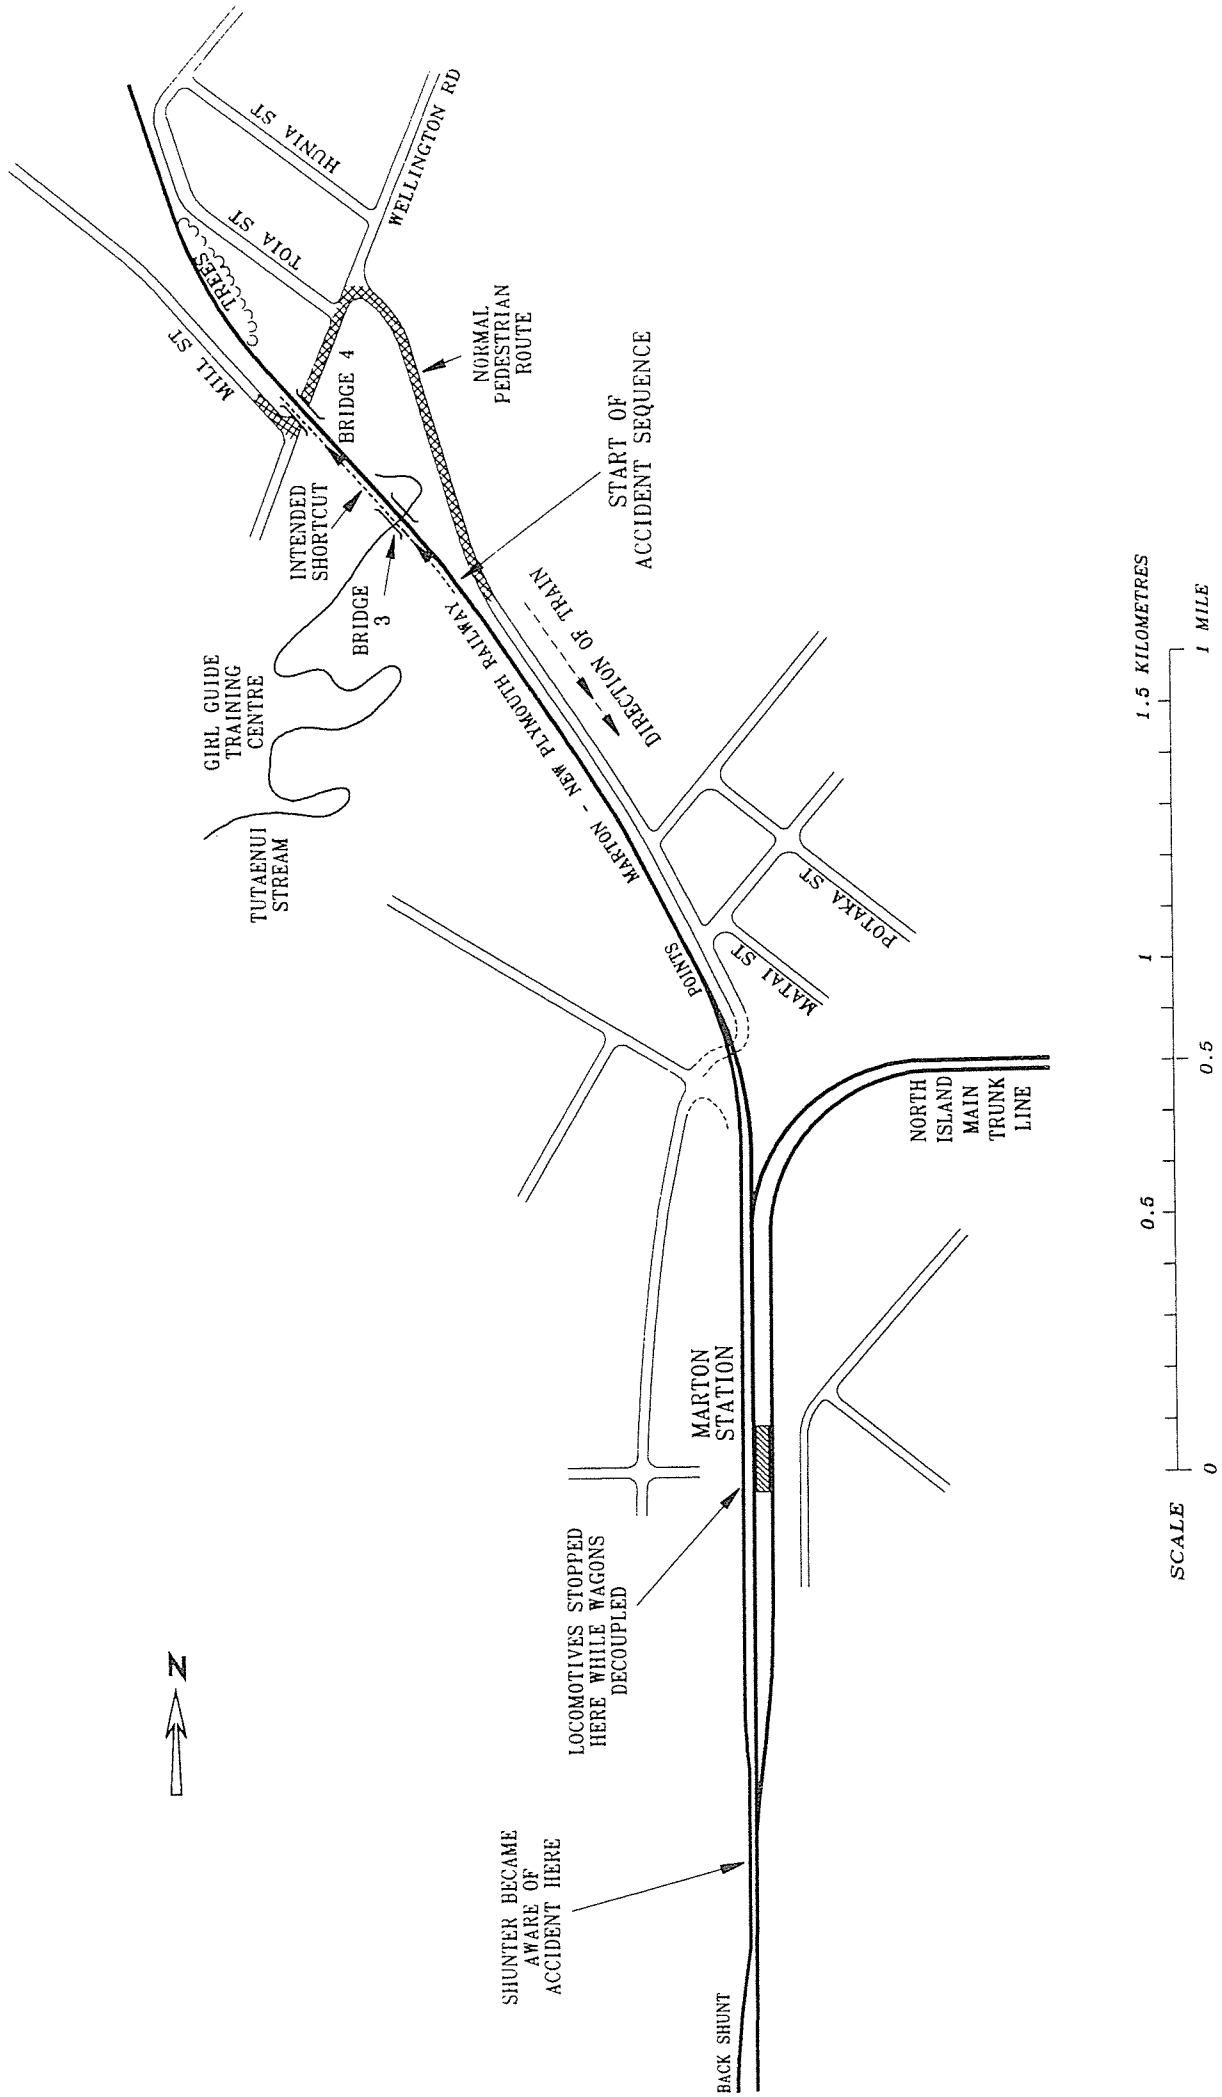
MARTON RAILWAY LINES
ACCIDENT ENVIRONMENT

1.10 The incident occurred in the vicinity of two bridges, which carried the track across a large stream and then a main road, which stood between the residence at which the pedestrian had been attending a party and his home. The rail track provided a more direct access and a significant saving in time for his walk.

1.11 There was no refuge for the pedestrian on either of the bridges should he have been confronted by an approaching locomotive. The train approached the road bridge first and the approach to bridge and the bridge itself were screened from the driver's view by a tree lined left hand curve. Thus had the pedestrian been crossing the bridge over the road as the train approached the locomotive driver would have had no opportunity to stop the train before it collided with the pedestrian.

1.12 The point of the collision with the pedestrian was adjacent to a back gateway to Arahina a New Zealand Girl Guide Association training centre. The rail track was unfenced and was a frequently used short cut for local pedestrians.

1.14 There were no warning signs in the area to advise persons using the rail bridges of the hazard of using them as a short cut.
