**NO. 93-128**

**TRAIN 573**

**ELTHAM**

## RAIL INCIDENT REPORT NO. 93-128

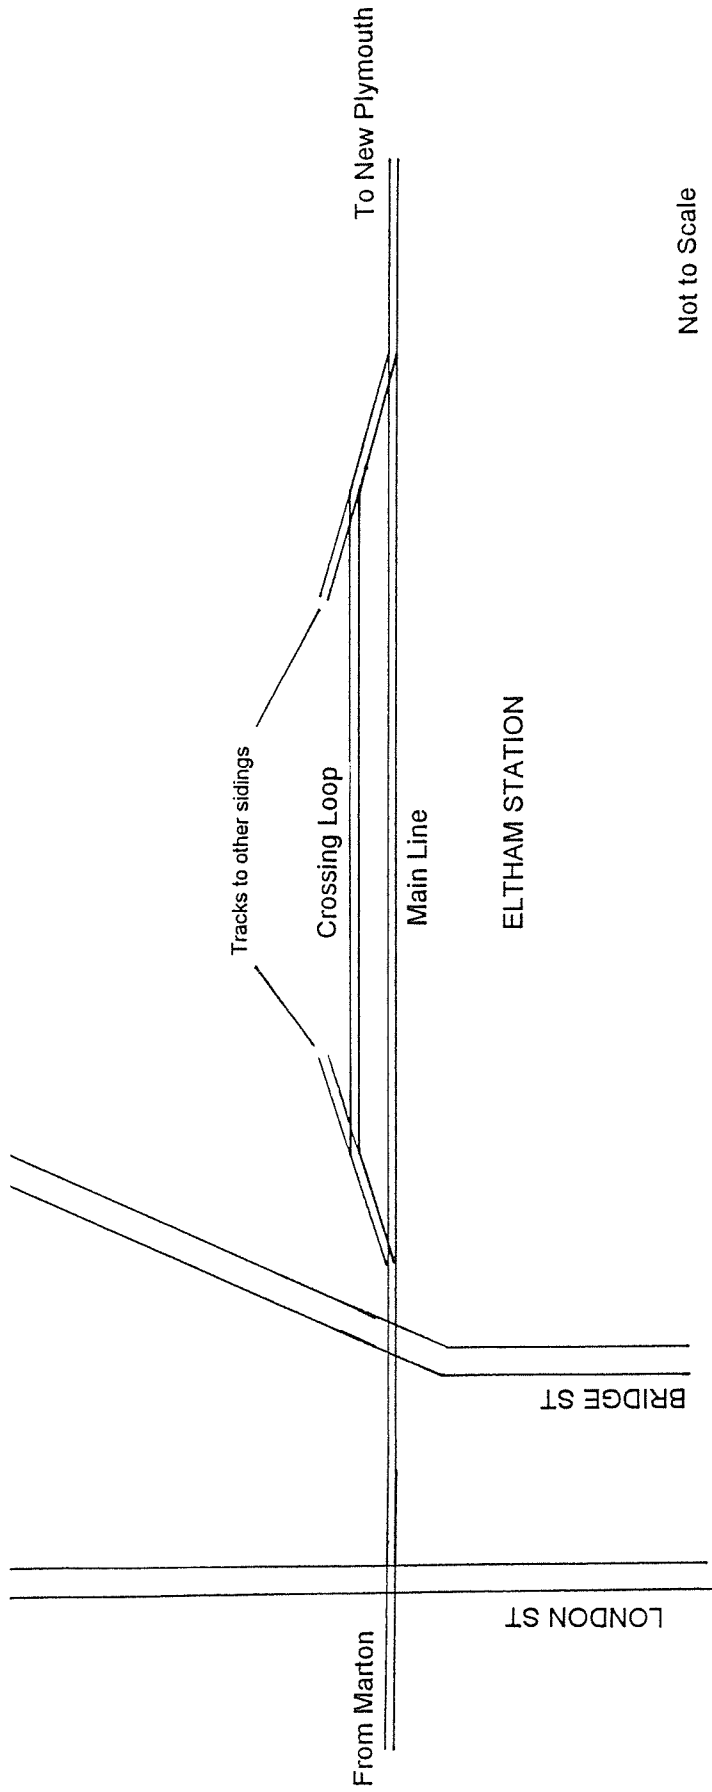
DIAGRAM SHOWING LAYOUT OF ELTHAM CROSSING LOOP AND ADJACENT LEVEL CROSSINGS

- 1.6 Two local streets cross the railway just to the south of Eltham. Bridge Street is 25 m from the end of the loop, and London Street is 175 m distant (see diagram).

1.15 The sequential berthing of trains 57 and 573 at Eltham caused an anomaly on the operation of the crossing alarms at both Bridge and London Streets. The first train on to the circuits for both crossings was 57, and as it passed the insulated joints after each street, the alarms cancelled correctly.

1.16 There were two options for the complete clearing of the track circuits for the crossing alarms. The first was an insulated joint placed on the main line, while the second was a joint in the loop. If 573 were not present, the passage of 57 over either of these joints would have cleared the circuit completely and the control equipment would have returned to the waiting state.

1.17 However, the distant insulated joint on the main line at the other (northern) end of the circuit was occupied by the southbound 573 before 57 had cleared the joint in the loop. The circuitry was not designed to discriminate between these joints, and the control circuitry did not resume the waiting state. Consequently when 573 moved southwards from Eltham, the crossing alarm control mechanism did not recognise the southward movement and the alarms did not activate correctly.
