NO. 93-129

TRAIN 404

COLLISION WITH MOTOR VEHICLE

RAIL ACCIDENT REPORT NO. 93-129

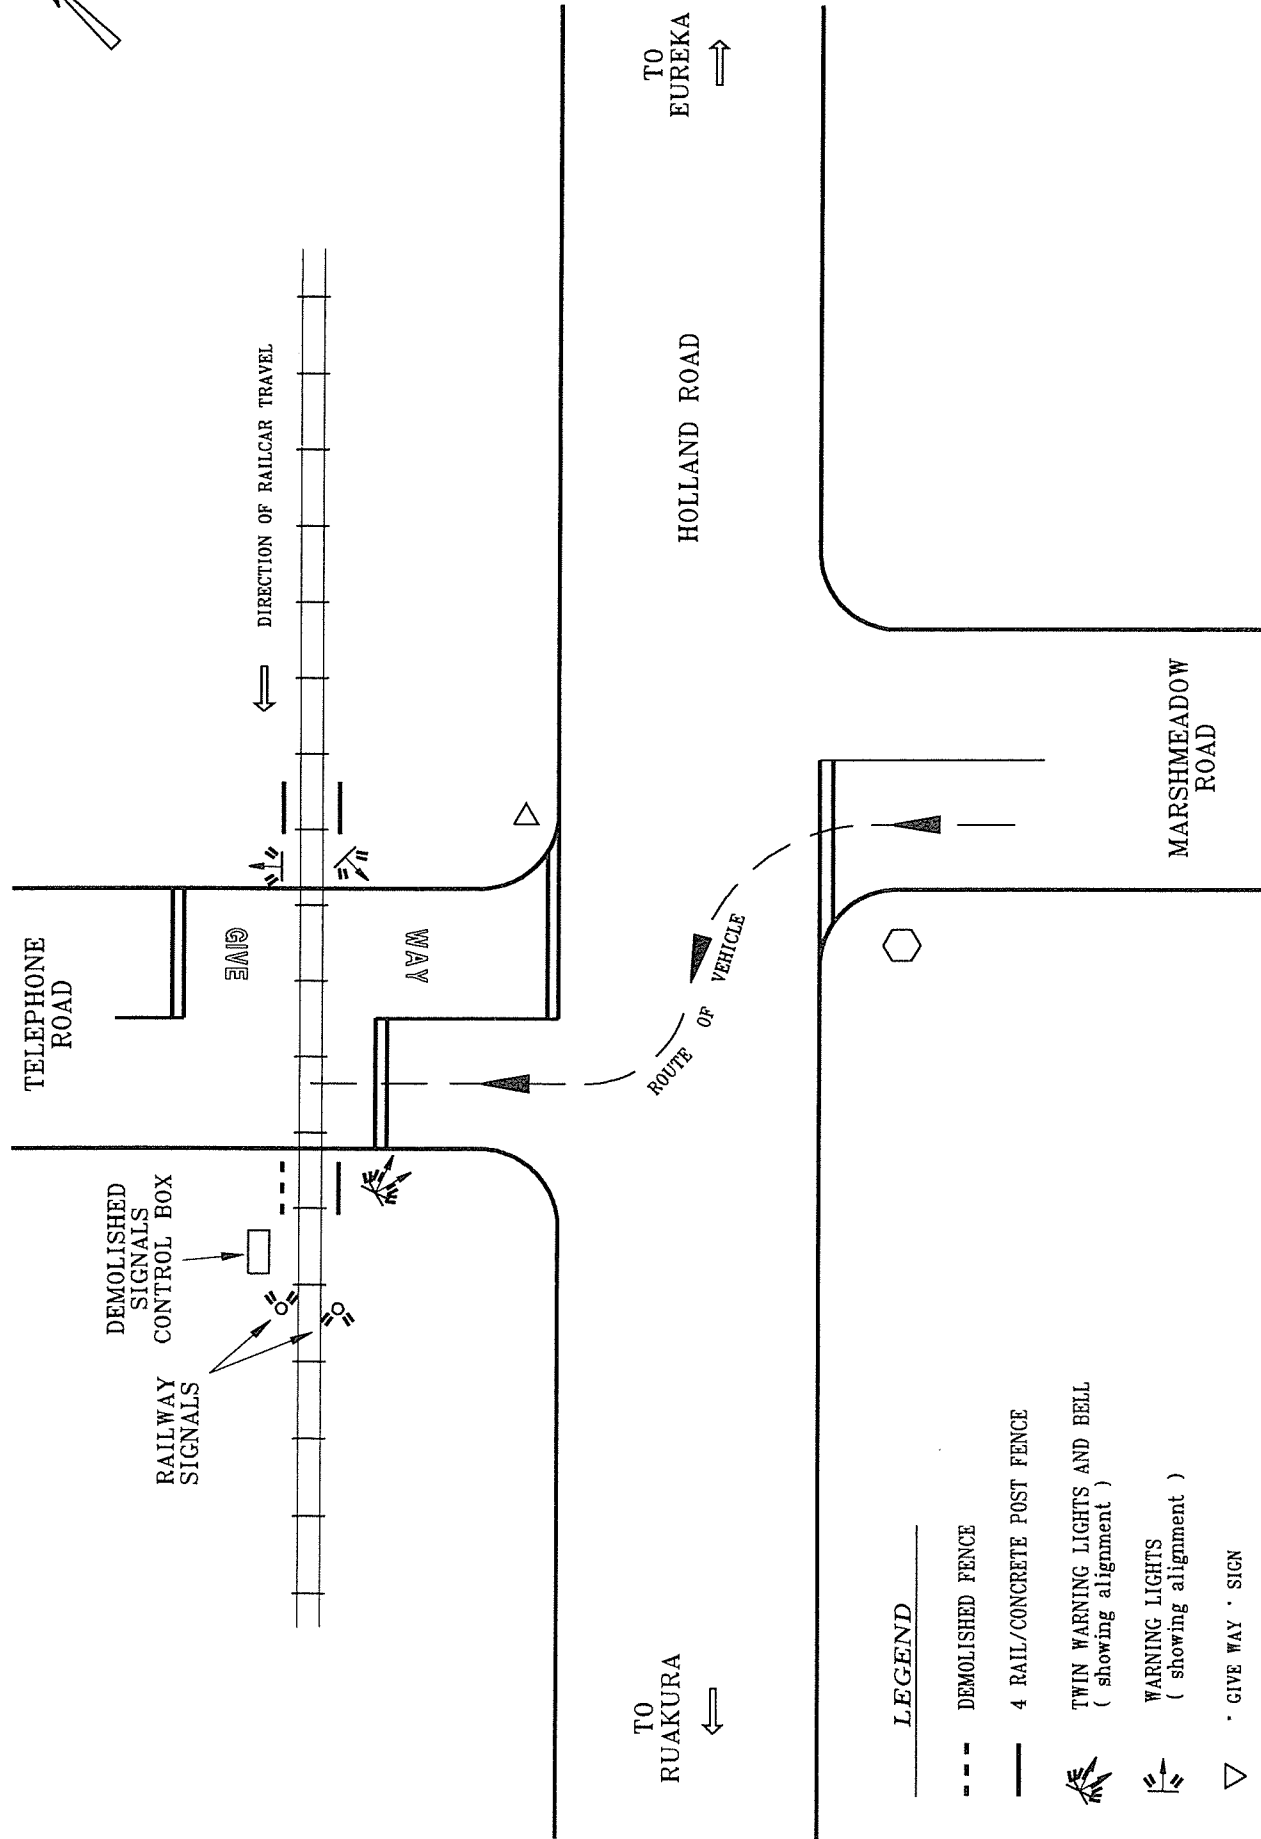
1.4 From the time that the Locomotive Engineer first saw the car driver he expected him, in sequence, to stop at the Stop sign at the intersection between Holland and Marshmeadow Roads, turn left and drive a short distance then turn right across Holland Road into Telephone Road. The distance from the intersection of Holland and Telephone Roads to the tracks on the level crossing over Telephone Road was 18 m and between Marshmeadow Road and Telephone Road 17 m.

1.10 The motorist's view of the railcar was however partially blocked by roadside vegetation due to the approach road being initially some 10 feet below the track level. The trackside telephone poles also obstructed the driver's view of the rail car as he passed through their plane of alignment ie the position at which all the poles were in line from the driver's point of view.

1.28 After the motor vehicle was struck by the railcar it demolished two concrete posts and a section of obsolete cattle stop fencing and damaged a crossing signal control box and a railway track signal stanchion.

2.11 An adjacent railway signal mast, the crossing alarm control box, the standards on which the warning lights were mounted, concrete posts for short fences formerly sides to cattle stops and miscellaneous out of use concrete blocks each had the potential to aggravate the consequences of any collision in which a road vehicle was struck by a rail vehicle.

3.1.1 Investigate the practicability of "delethalsing" the level crossing environment progressively by removing obsolete substantial obstructions, and relocating signal stanchions, equipment housings and other essential structures, sited within 500 m of track distance from any level crossing, so that they were at least 5 m from the trackside and investigate the practicality of improving the frangibility of warning light/barrier masts so that they minimised the damage inflicted on vehicles which collided with rail vehicles (045/94) and,
