NO. 93-130

TRAIN 630

**COLLISION WITH PEDESTRIAN
HERETAUNGA STREET HASTINGS**

24 DECEMBER 1993

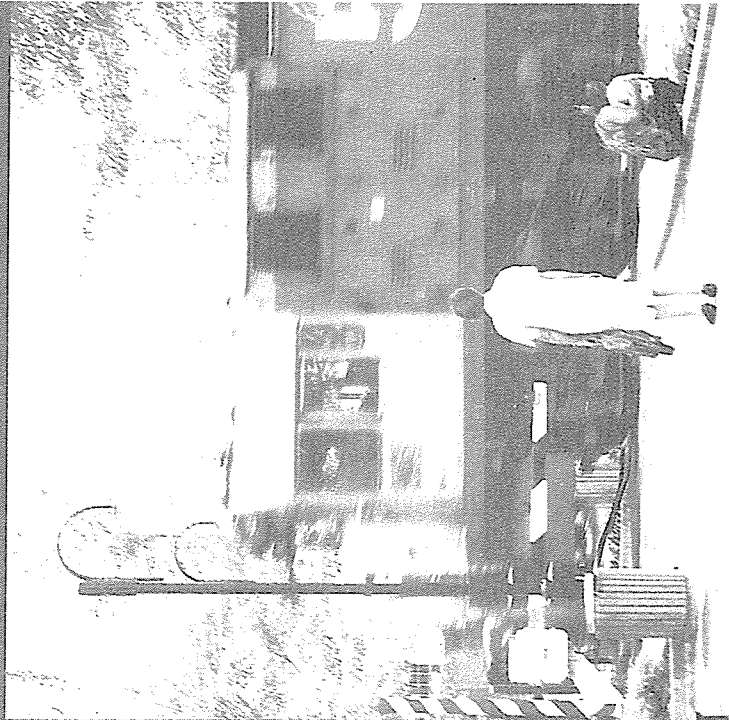
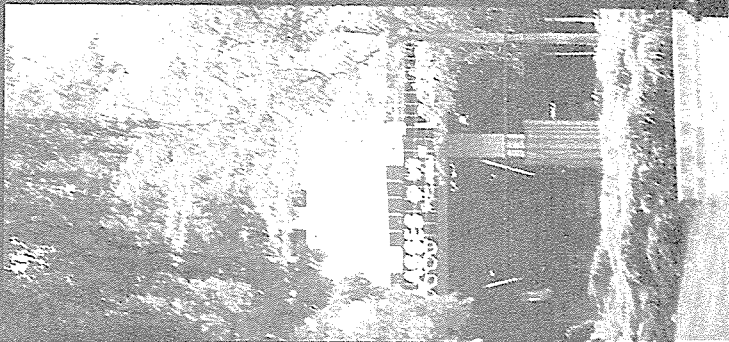
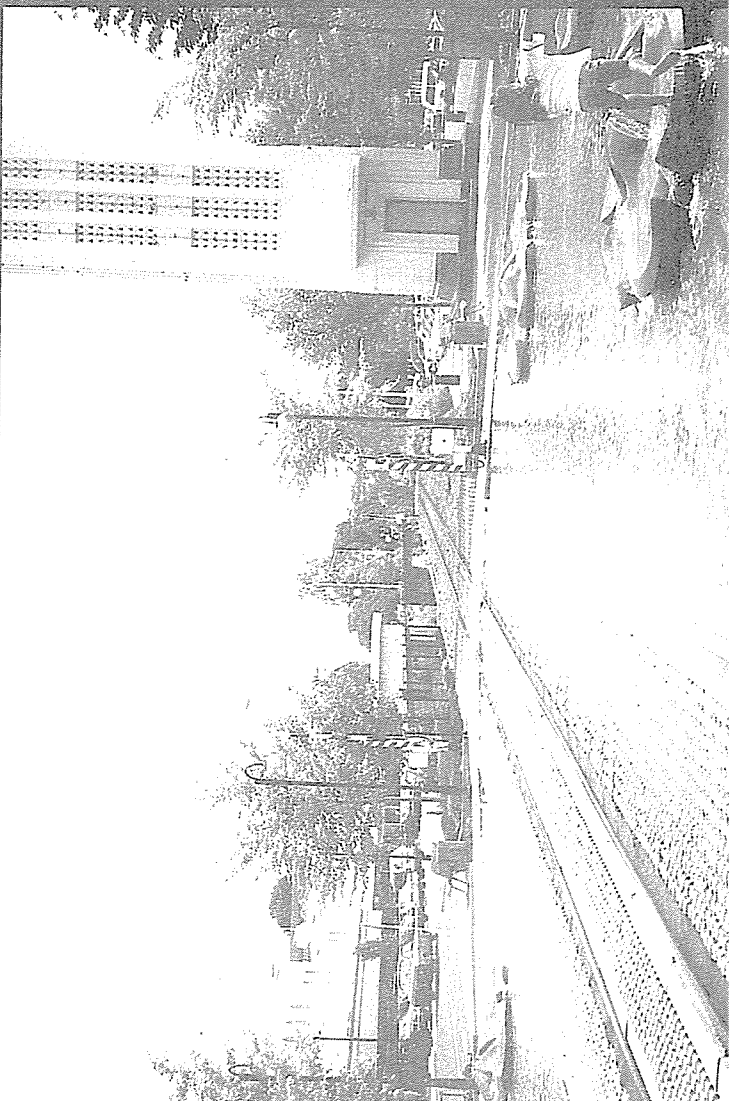
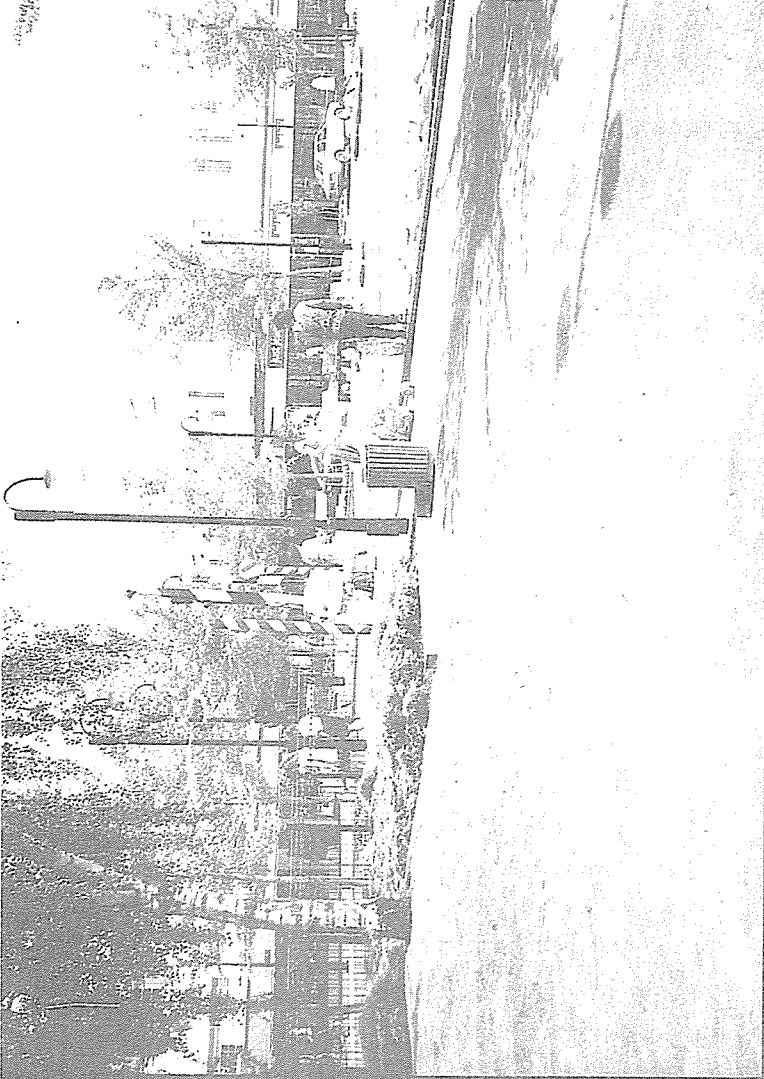
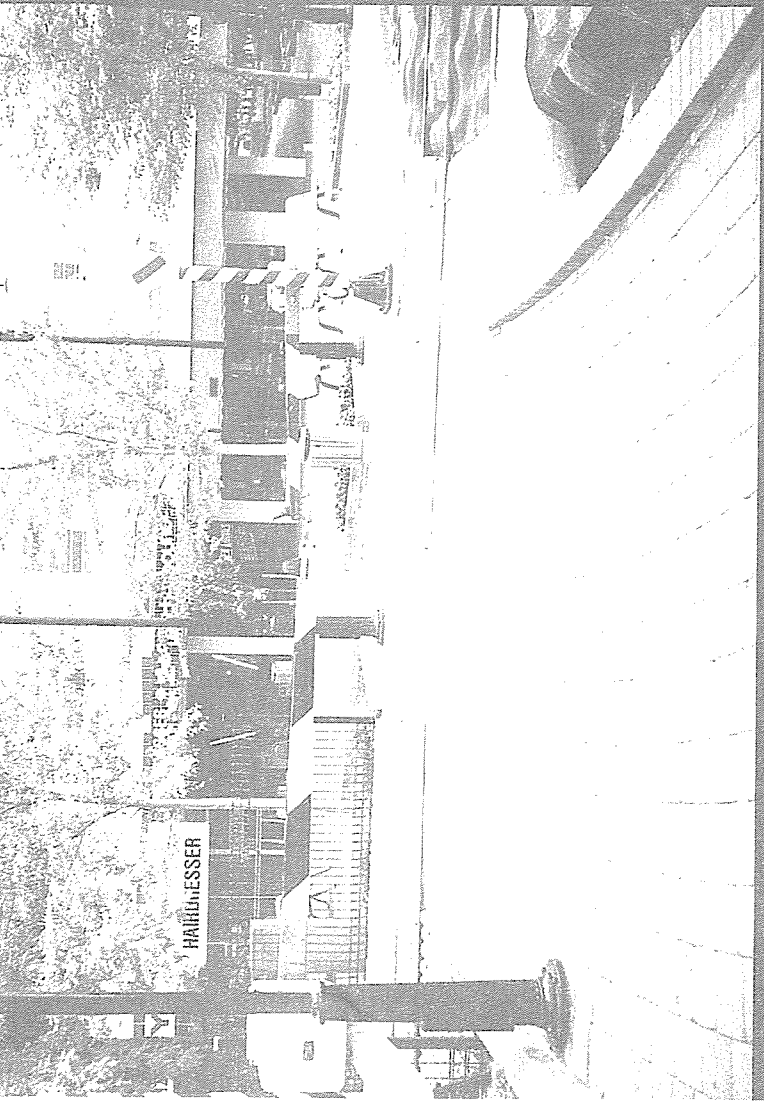
around the fountain for a cooling paddle, sometimes playing within two metres of the active rail track (see illustrations).

1.14 The barrier arms were cut short deliberately to allow an escape route for any pedestrian caught on the track as the arms came down. This truncation paradoxically provided access to the track for anyone not noticing the arms or wishing to by-pass them.

Street fountain pedestrian level crossings, children played at a distance from their parents in close proximity to the rail track. In this area no effective barrier to trespass on the rail track existed. Further the public was encouraged to cross the line by the provision of two wide pathways which facilitated passage between two sections of a shopping mall on either side of the rail track.

1.19 The sounding of a bell and lowering two short barriers, each carrying two small 12 volt red lights, across the footpaths did not form an effective barrier to children in this area, particularly as their area of play extended into the fountain which gave unimpeded access to the rail track.

They design and construct an underpass in an adjacent but discreet location so that the use of the Heretaunga Street pedestrian level crossings can be discontinued and an effective barrier erected to prevent access to the rail track by young children (008/94) and, until such time as improved safety measures can be introduced they erect conspicuous warning signs to encourage the closer supervision of children playing in the railway/fountain environment (009/94).

Until more effective protection for the public is provided at the Heretaunga Street pedestrian level crossing area in Hastings they restrict the speed of trains in that area to 40 km/h (010/94).
