**NO. 94-013**

**FAIRCHILD SA-227-AC METROLINER III**

**ZK-NSW**

## AIRCRAFT ACCIDENT REPORT NO 94-013

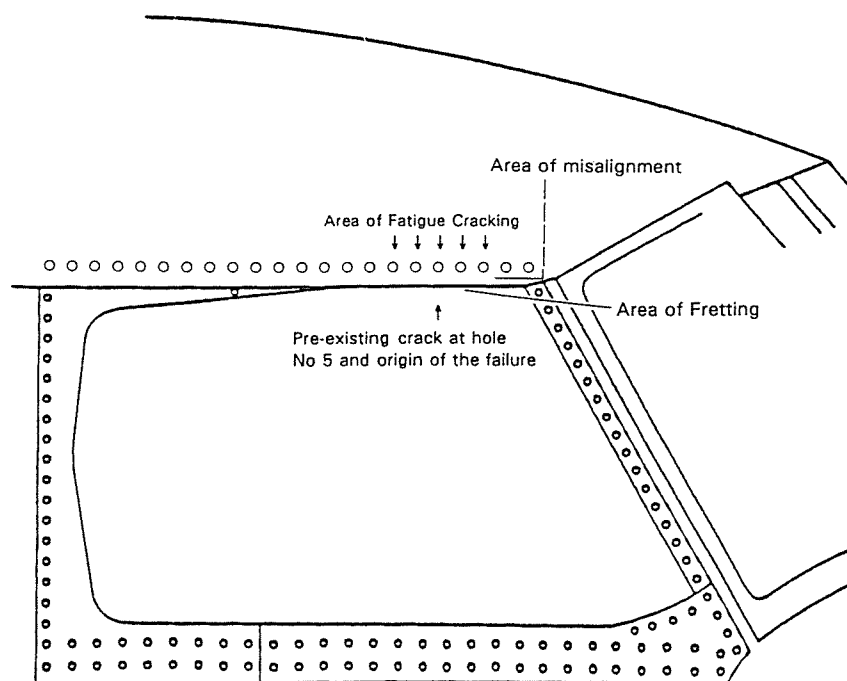
1.15 The outer edge of the acrylic side panel which remained in the aircraft was removed and sent to Industrial Research Ltd for analysis. Examination showed that a pre-existing crack at the fifth fastener hole on the top edge of the panel, numbered rearwards from the front edge, had existed from the time of the installation of the panel. The crack was 6 mm in length, and extended from the outside face in to a depth of 3 mm. The panel was 6.35 mm thick. The original window sealant which was green in colour could be seen adhering to the remaining face of the crack. Further examination revealed that the last failure originated at that crack, and the crack had propagated outwards from the fastener hole to a critical length of about 15 cm, from hole number three to midway between hole number eight and hole number nine, before failure occurred. (See diagram).

1.16 Examination also showed that a series of small fatigue cracks, up to 6 mm in length, had developed at holes 3, 4, 5, 6 and 7. These cracks had propagated slowly during the life of the panel to about 6 mm, and then rapidly within about 100 cycles to the combined critical length of 15 cm. It is most likely that the cracks originating at hole number five propagated and ran over the top of fatigue arcs found at holes 3, 4, 6 and 7. Additionally, there was evidence of heavy fretting between the fuselage and the acrylic panel adjacent to fastener holes 3, 4 and 5. (See diagram).

1.24 Investigation showed that this misalignment had existed when ZK-NSW was first manufactured and when its acrylic panel was installed. The window panel was therefore pre-stressed in the area of the subsequent failure, from installation. It is probable that this pre-stressing, in conjunction with the normal pressurisation cycles, eventually caused the pre-existing crack to propagate and the fatigue cracks to form at holes 3, 4, 6 and 7.

- 2.8 The failure of the side window panel resulted from stress fatigue caused by the combination of an airframe design fault causing stress to be set up in the top forward corner of the window panel, plus the normal pressurisation cycles of the aircraft. A pre-existing crack, the rapid propagation of the cracks within the inspection cycles, and the inadequacy of the inspection procedures were contributing factors.

2. Remove cockpit side windows.
  - (a) Inspect windows for burrs, cracks, fretting or any other damage using a 10 times magnifying glass. If any damage is found, replace window before further flight.
  - (b) Inspect fastener hole plastic bushes for any evidence of damage and replace bushes as necessary. Smooth window exterior edges.
  - (c) Install window without pre-stress per Fairchild MM, and allow sealant to set before tightening screws.
