**NO. 94-019**  
**BOEING 737-219 ZK-NAS**  
**AND**  
**CESSNA 152 ZK-EOJ**  
**5NM NORTH-EAST OF DUNEDIN AIRPORT**  
**25 AUGUST 1994**

## AIRCRAFT INCIDENT REPORT NO. 94-019

<b>Aircraft Types, and Registrations:</b>	Boeing 737-219, ZK-NAS and Cessna 152 ZK-EOJ
<b>Date and Time:</b>	25 August 1994, 1115 hours*
<b>Location:</b>	5NM north-east of Dunedin Airport
<b>Types of Flights:</b>	Boeing: Scheduled Air Transport Cessna: Aerial Work (Flight Training)
<b>Persons on Board:</b>	Boeing: 117 Cessna: 2
<b>Injuries:</b>	Boeing: Nil Cessna: Nil
<b>Pilots in Command's Licences:</b>	Boeing: Airline Transport Pilot Licence (Aeroplane) Cessna: Commercial Pilot Licence (Aeroplane)
<b>Pilots in Command's Total Flying Experience:</b>	Boeing: 10 000 hours Cessna: 440 hours
<b>Information Sources:</b>	Transport Accident Investigation Commission field investigation
<b>Investigator in Charge:</b>	Mr J J Goddard

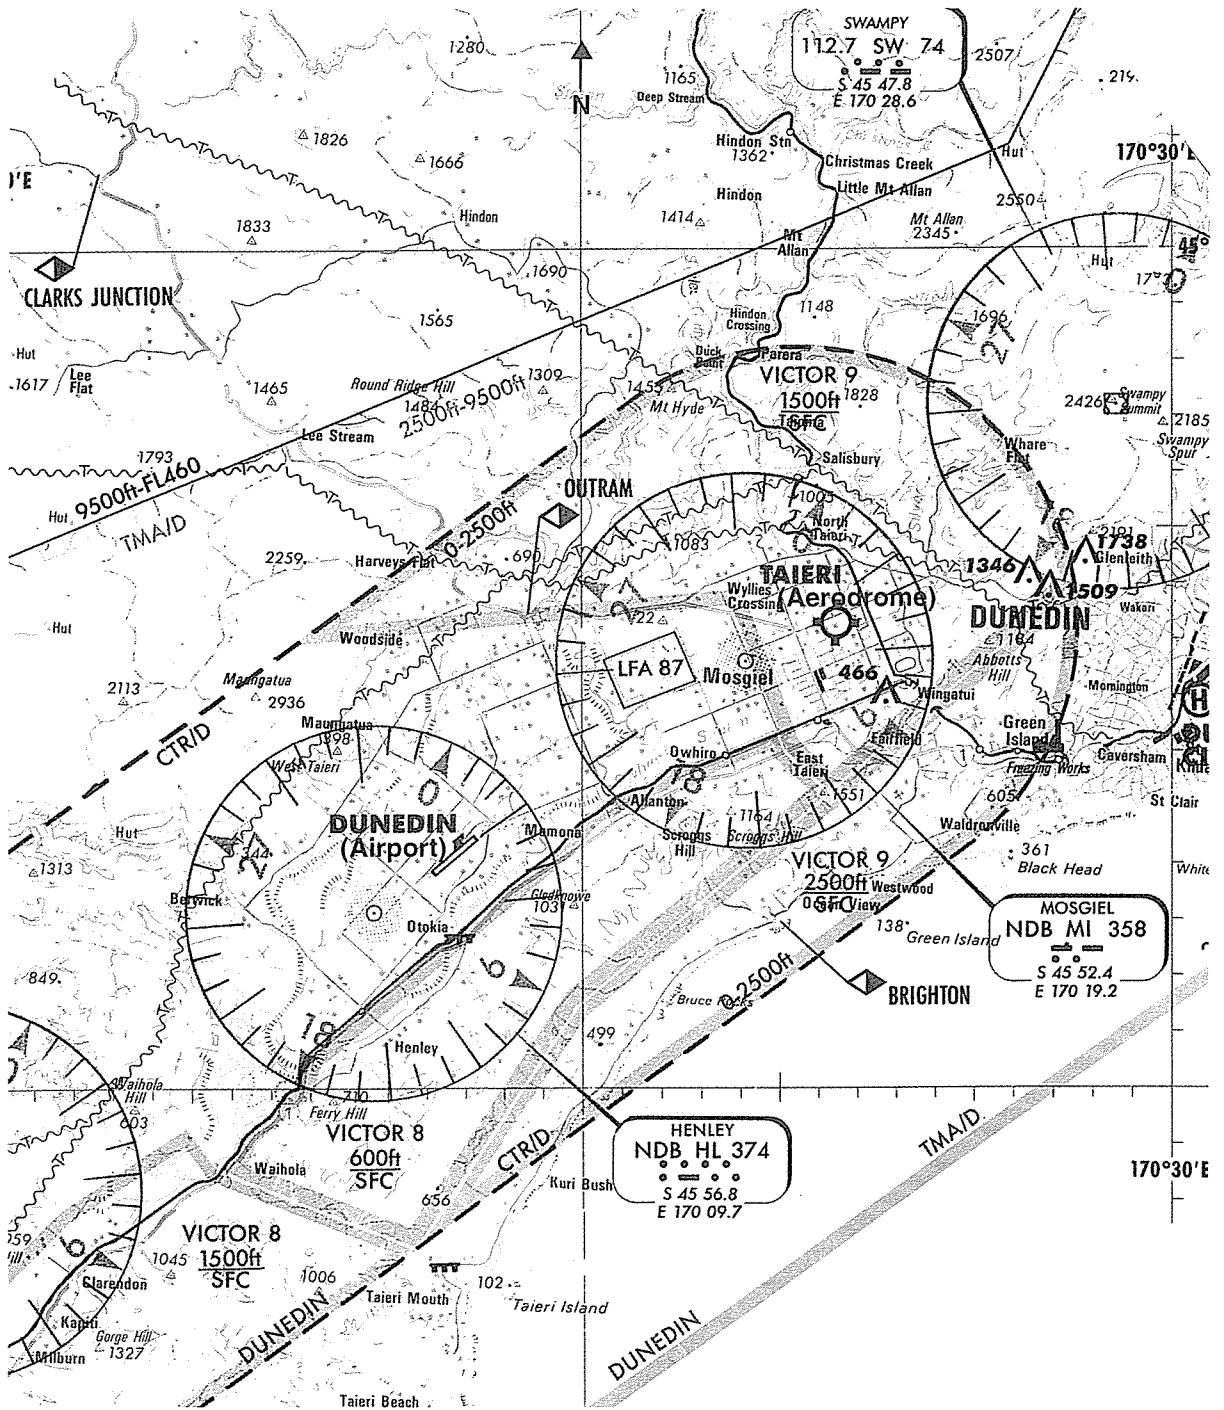
Figure 1

1.12. Taieri Aerodrome is an uncontrolled aerodrome situated towards the north-east end of the Taieri valley (Figure 1). It is some 8 NM north-east of Dunedin Airport and within the Dunedin CTR/D, which extends from the surface to 2500 feet amsl. A VFR lane within the CTR, Victor 9, allows VFR traffic to operate without an ATC clearance up to 1500 feet amsl. As the Dunedin ILS 21 approach passes almost overhead Taieri, the south-west boundary of Victor 9 is located 2 NM from Taieri along Riccarton Road, which is also the location of Mosgiel NDB.

1.13. Uncontrolled VFR aircraft are thus permitted to fly at an altitude of 1500 feet up to this boundary, while the charted minimum crossing altitude at Mosgiel NDB for aircraft on the Dunedin ILS 21 approach is 1800 feet, producing a separation of 300 feet.

1.14. In this incident the Cessna strayed to the south-west beyond the Victor 9 boundary by up to 1 NM. In that position the on-glidepath altitude for the Dunedin ILS 21 is 1580 feet, while normal variations in ILS approaches could be expected to cause some aircraft to be at about 1500 feet.

1.16. Numerous factors in practice can compromise this 300 foot separation. They include altimeter tolerances, turbulence, pilot accuracy in visual navigation, ILS glidepath tolerance and pilot accuracy in flying the ILS. As a result it is considered that the height and position of Victor 9 are not sufficiently error tolerant in relation to instrument approach procedures to Dunedin Runway 21 to ensure a safe separation between IFR aircraft operating on a clearance in controlled airspace, and uncontrolled VFR aircraft.

1.17. Investigation of the flight paths of aircraft departing from Taieri Aerodrome grass vector 23 indicated that some aircraft with a shallow climb gradient, but in compliance with CASO 4, may have difficulty remaining within Victor 9 during their crosswind turn after climbing to 500 feet. Similarly a “practice engine failure after take-off” exercise might cause an aircraft to transgress the boundary.

1.20. The conflicting requirements for the airspace require a modification to be devised to optimise the mutual separation and safety of all traffic. Such a compromise could be achieved by lowering the ceiling to 1000 feet in the sector south-west of Taieri Aerodrome but extending the boundary further from Taieri Aerodrome. The north-east boundary for this 1000 foot sector might be located sufficiently far from Taieri Aerodrome to allow space for overhead circuit joining procedures. This would increase the separation from the descent profile of traffic on approach to Dunedin Airport while facilitating safe compliance by Taieri Aerodrome traffic.

He modify the sector of Victor 9 to the south-west of Taieri Aerodrome in terms of its boundaries and altitude to improve separation between uncontrolled VFR traffic and controlled IFR traffic on approach to Dunedin Aerodrome, while facilitating safe operations within the Taieri circuit. (072/94)
- 3.2 The Director of Civil Aviation responded on 9 September 1994 that:
