Transport Accident Investigation Commission

Train 700

Hundalee

Rail Accident Report No. 94-117

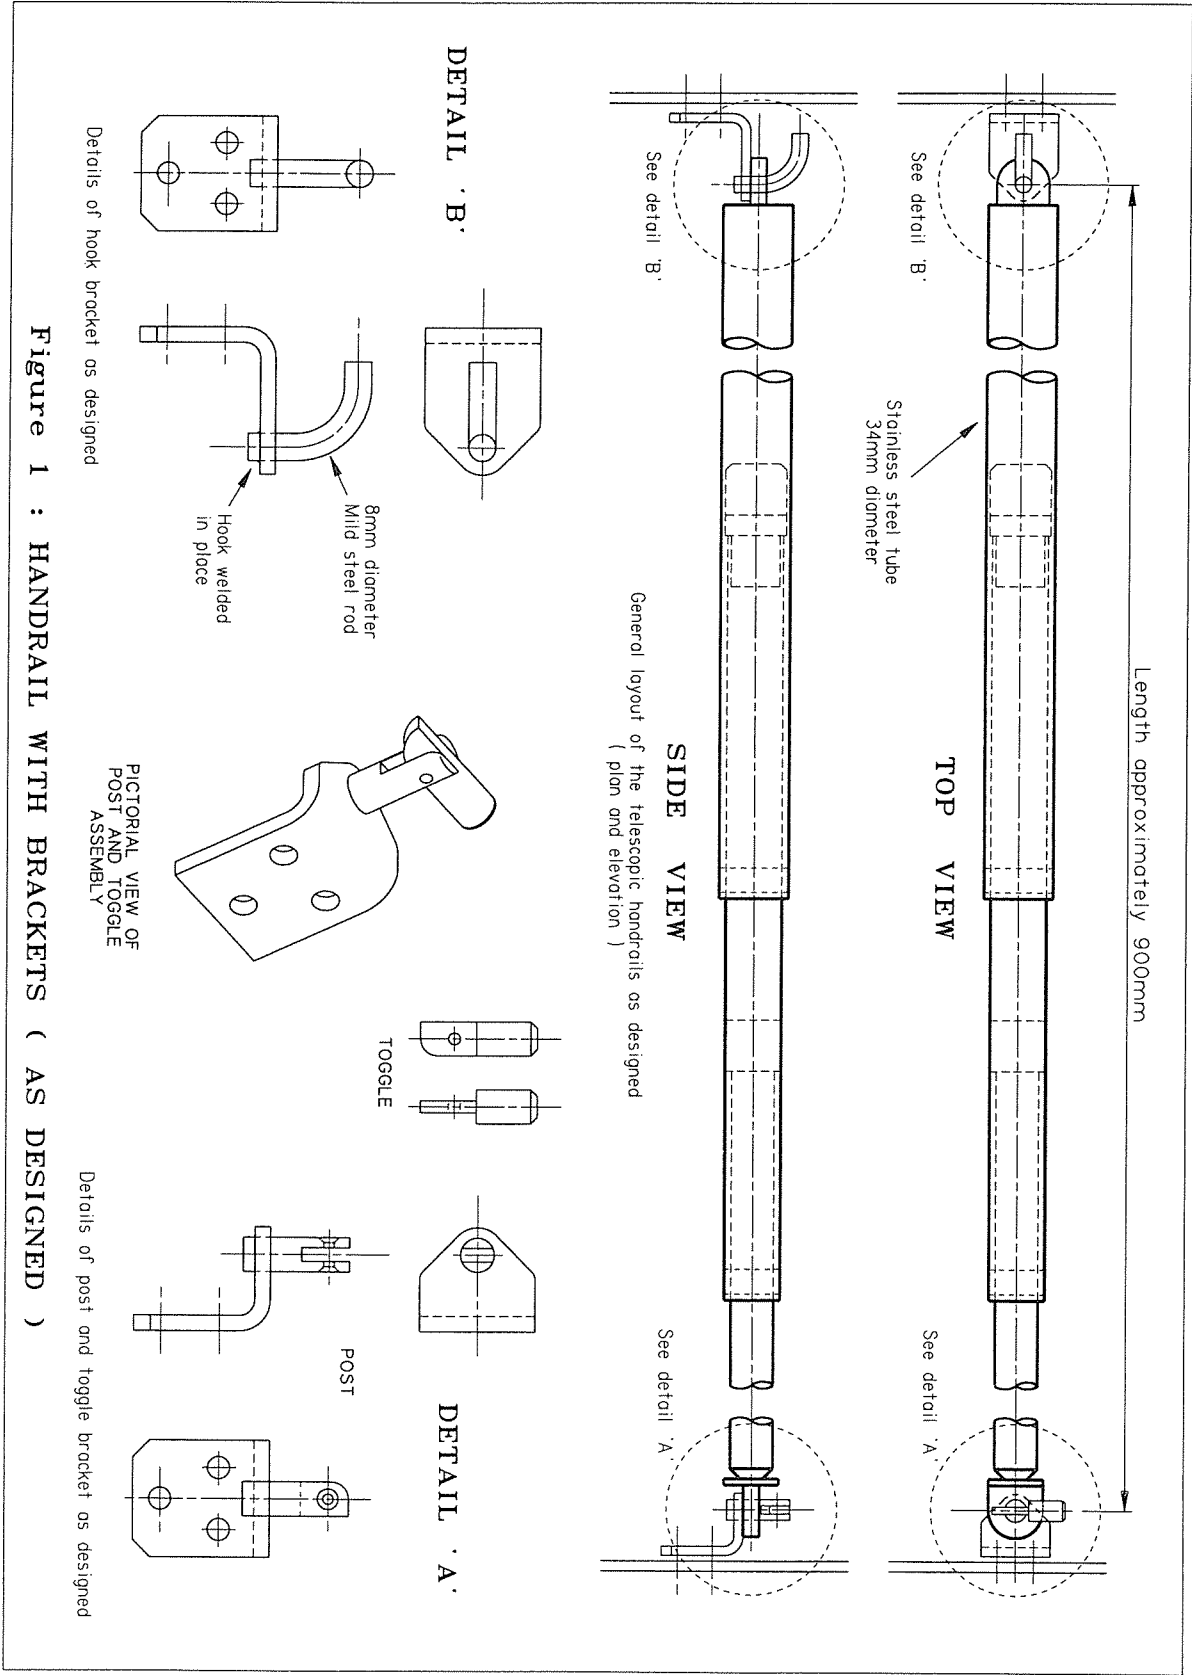
Figure 1 : HANDRAIL WITH BRACKETS (AS DESIGNED)

- 1.32 The handrails and the brackets which held them to the carriages were not as originally designed. The concept of using light stainless steel tubes was first used on the "Silver Star" passenger train in the North Island in the early 1970s, and a similar arrangement was used on the "Silver Fern" railcars. A copy of a plan showing the arrangement for the "Silver Star" is shown in Figure 1.

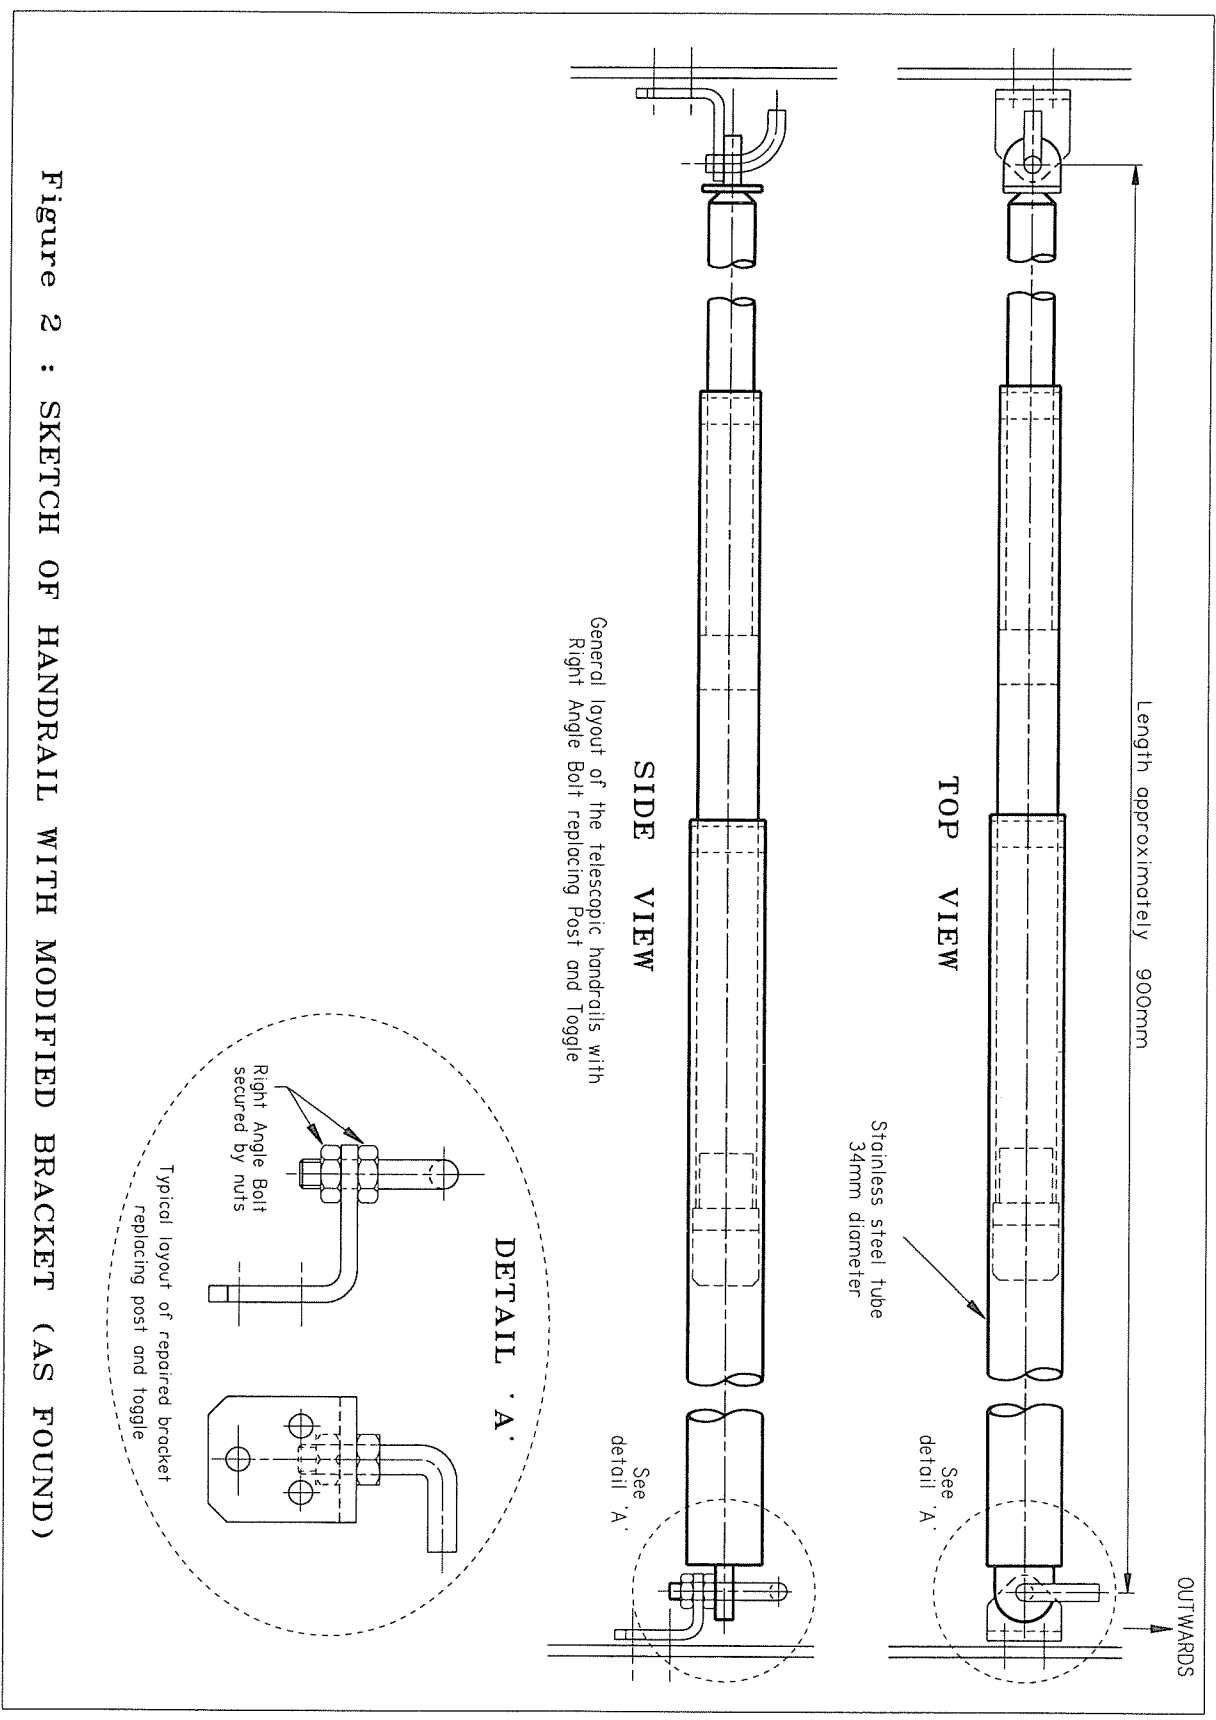
Figure 2 : SKETCH OF HANDRAIL WITH MODIFIED BRACKET (AS FOUND)

- 1.37 From interviews with NZRL repair and examination staff at the NZRL Waltham Yard Depot, it was learned that at some time in the past when the post and toggle arrangements had become damaged they were replaced with an improvised replacement that could best be called a right angle bolt. The right angle bolt had the appearance, but not the function, of the welded hook at the opposite end of the handrail. A sketch of this arrangement is attached as Figure 2. Photographs of the gangway, the post and toggle and the right angle bolts that replaced the post and toggle are shown in Figures No. 3 to 6. These right angle bolts were constructed by maintenance staff at locations such as the Waltham Yard Depot and consisted of an 8 mm bolt attached to the horizontal plate by two nuts, one above and the other below the plate. The bolt was then bent at a right angle and the bolt head was removed by flame cutting. The handrail would then be connected to the right angle bolt, aligned along the axis of the handrail pointing away from the handrail, and the nuts securing the right angle bolt tightened. The exact origin of the type of connection could not be determined; however, from interviews with NZRL staff it is

clear that it has been in use for some time. Some estimates date this back at least 10 years. Also, this connection had not been approved by NZRL design staff.

- 1.38 Repair and examination staff at Waltham Yard Depot revealed that they frequently used this right angle bolt to replace damaged and broken post and toggle arrangements. This replacement was preferred by them because the right angle bolt was easy to construct from material readily available and the carriage involved would not be delayed. It was their opinion that, provided the right angle bolt was aligned along the axis of the handrail and that the two nuts were secure so that it could not rotate, this arrangement would provide the same measure of safety as the post and toggle. As this arrangement was in use for quite some time, they believed that it had been approved by the design staff.

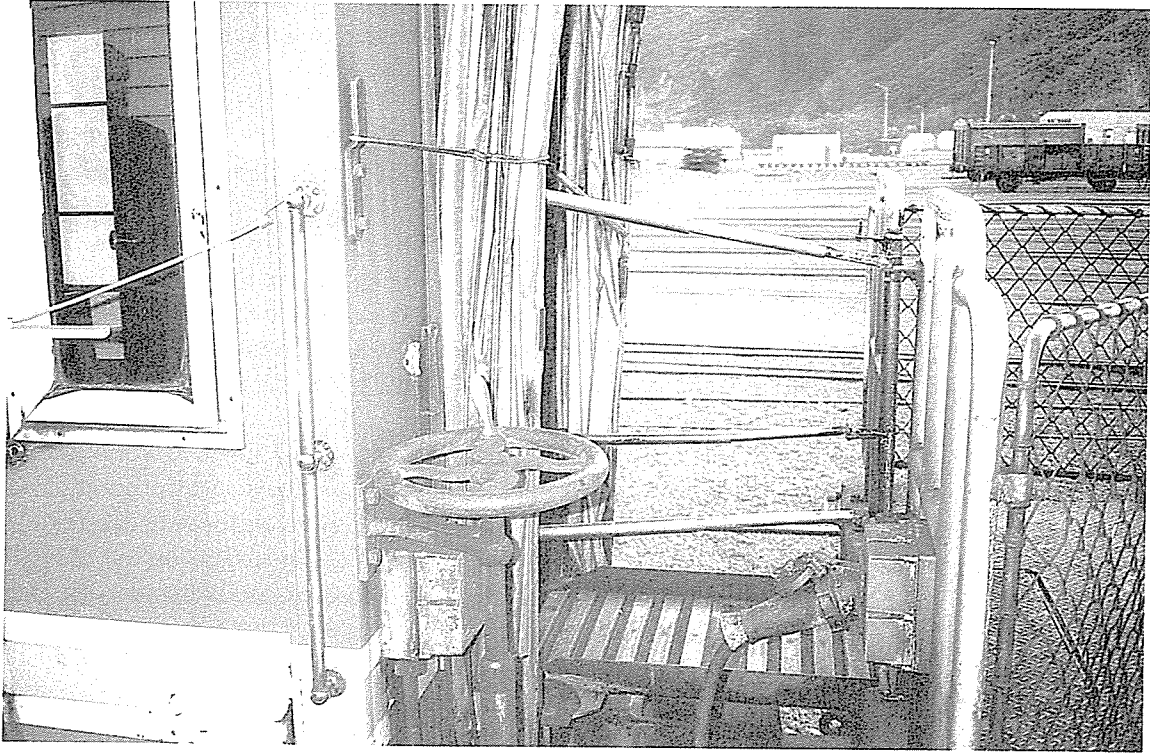
Figure 3
A view of the gangway (taken at Picton on the day of the accident).
The top handrail on the far side is missing

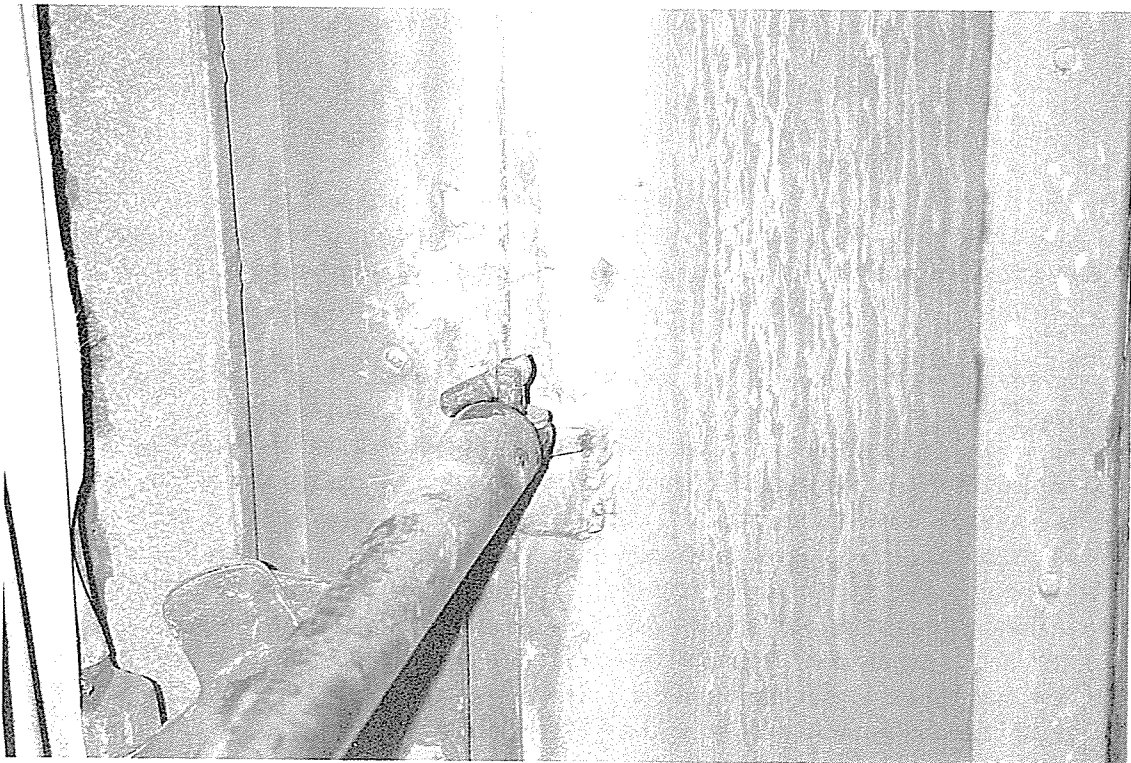
Figure 4
An original post and toggle bracket

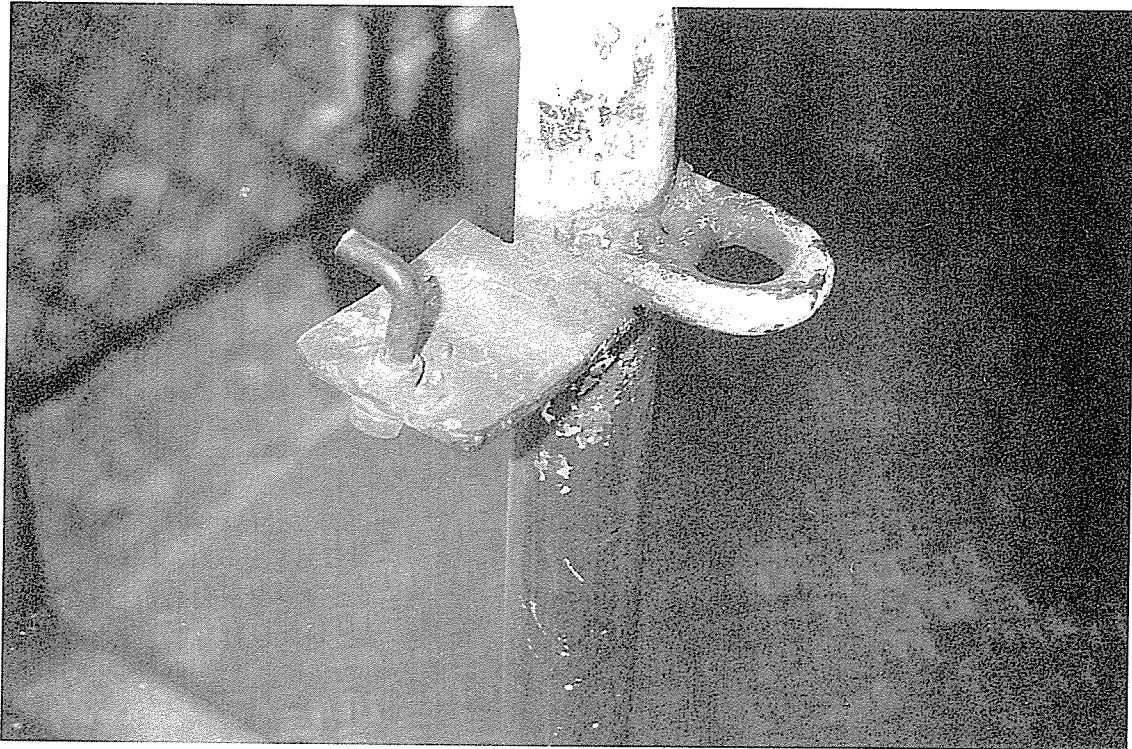
Figure 5
The bracket from which the handrail detached

- 1.40 An examination of the power van and carriage gangway immediately after the occurrence revealed that the right angle bolt from the upper handrail was not oriented along the axis of the handrail. It was pointed outwards. This would be the position that would allow the handrail to become easily dislodged. Also, there was corrosion and dirt built up around the nuts and the threads of the right angle bolt indicating that the nuts had not been either loosened or tightened for sometime. The Police officer who attended the site of this occurrence has indicated that the upper right angle bolt on the power van was loose and could be rotated by hand. There was no upper handrail section attached to the right angle bolt bracket on the power van; however, a single handrail section was found attached to the bracket on the first carriage. In order for the handrail sections to separate, the handrail would have been subjected to a force of sufficient magnitude that the retainers manufactured into the handrail to prevent their separation were damaged. Due to the sturdy construction of the handrail the damage could not have been caused by the boy falling and holding onto the handrail once it became disconnected. Therefore, the retainers were damaged at some time prior to this occurrence. The fact that the retainers were damaged allowing the handrail sections to be separated on the handrail once it was disconnected from the brackets is not considered to have contributed to this occurrence.

- 2.6 The handrail detached at one end because it could be removed by the combination of an upwards and outwards force of between 1 and 2 kg.
- 2.7 The bracket to which the handrail was attached was not in accordance with the original design of the NZRL or its predecessors. However, this arrangement had become an acceptable repair at the NZRL Waltham Yard Depot and had been in use for over a decade.

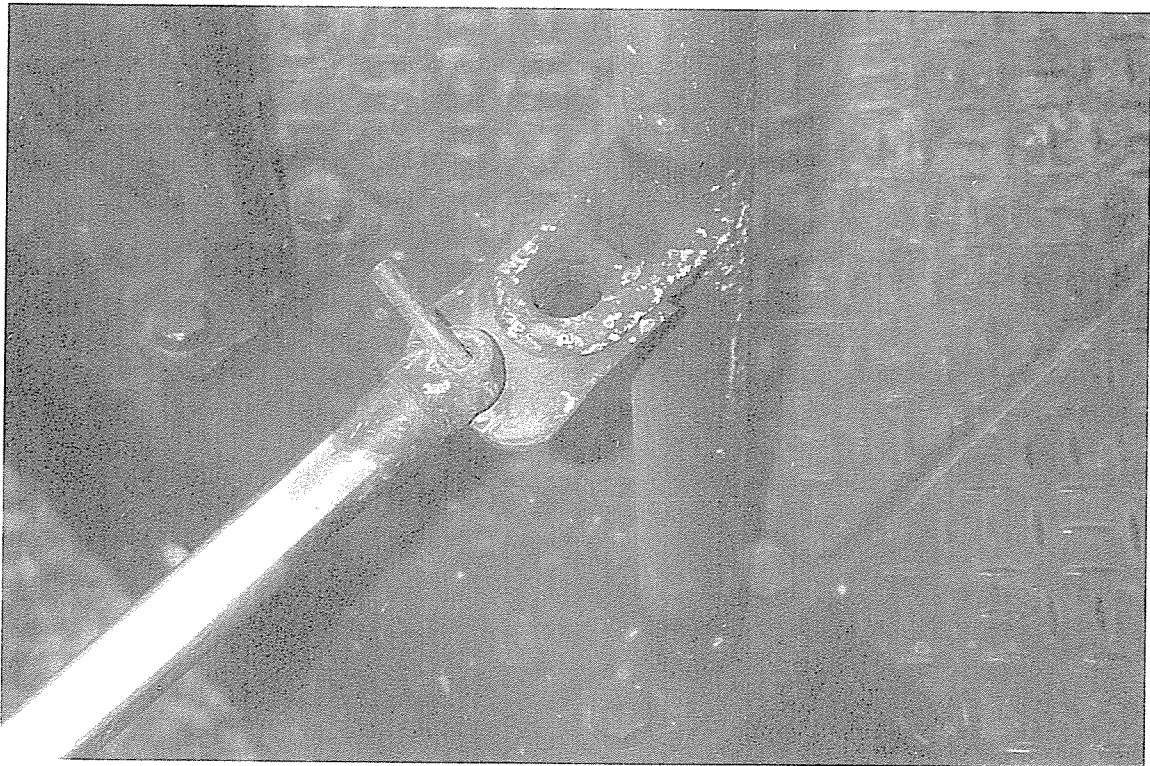
Figure 6
The bracket immediately below, with lower guardrail still in place
