NO 94-123

TRAIN 402

COLLISION WITH TRUCK

RAIL ACCIDENT REPORT NO 94-123

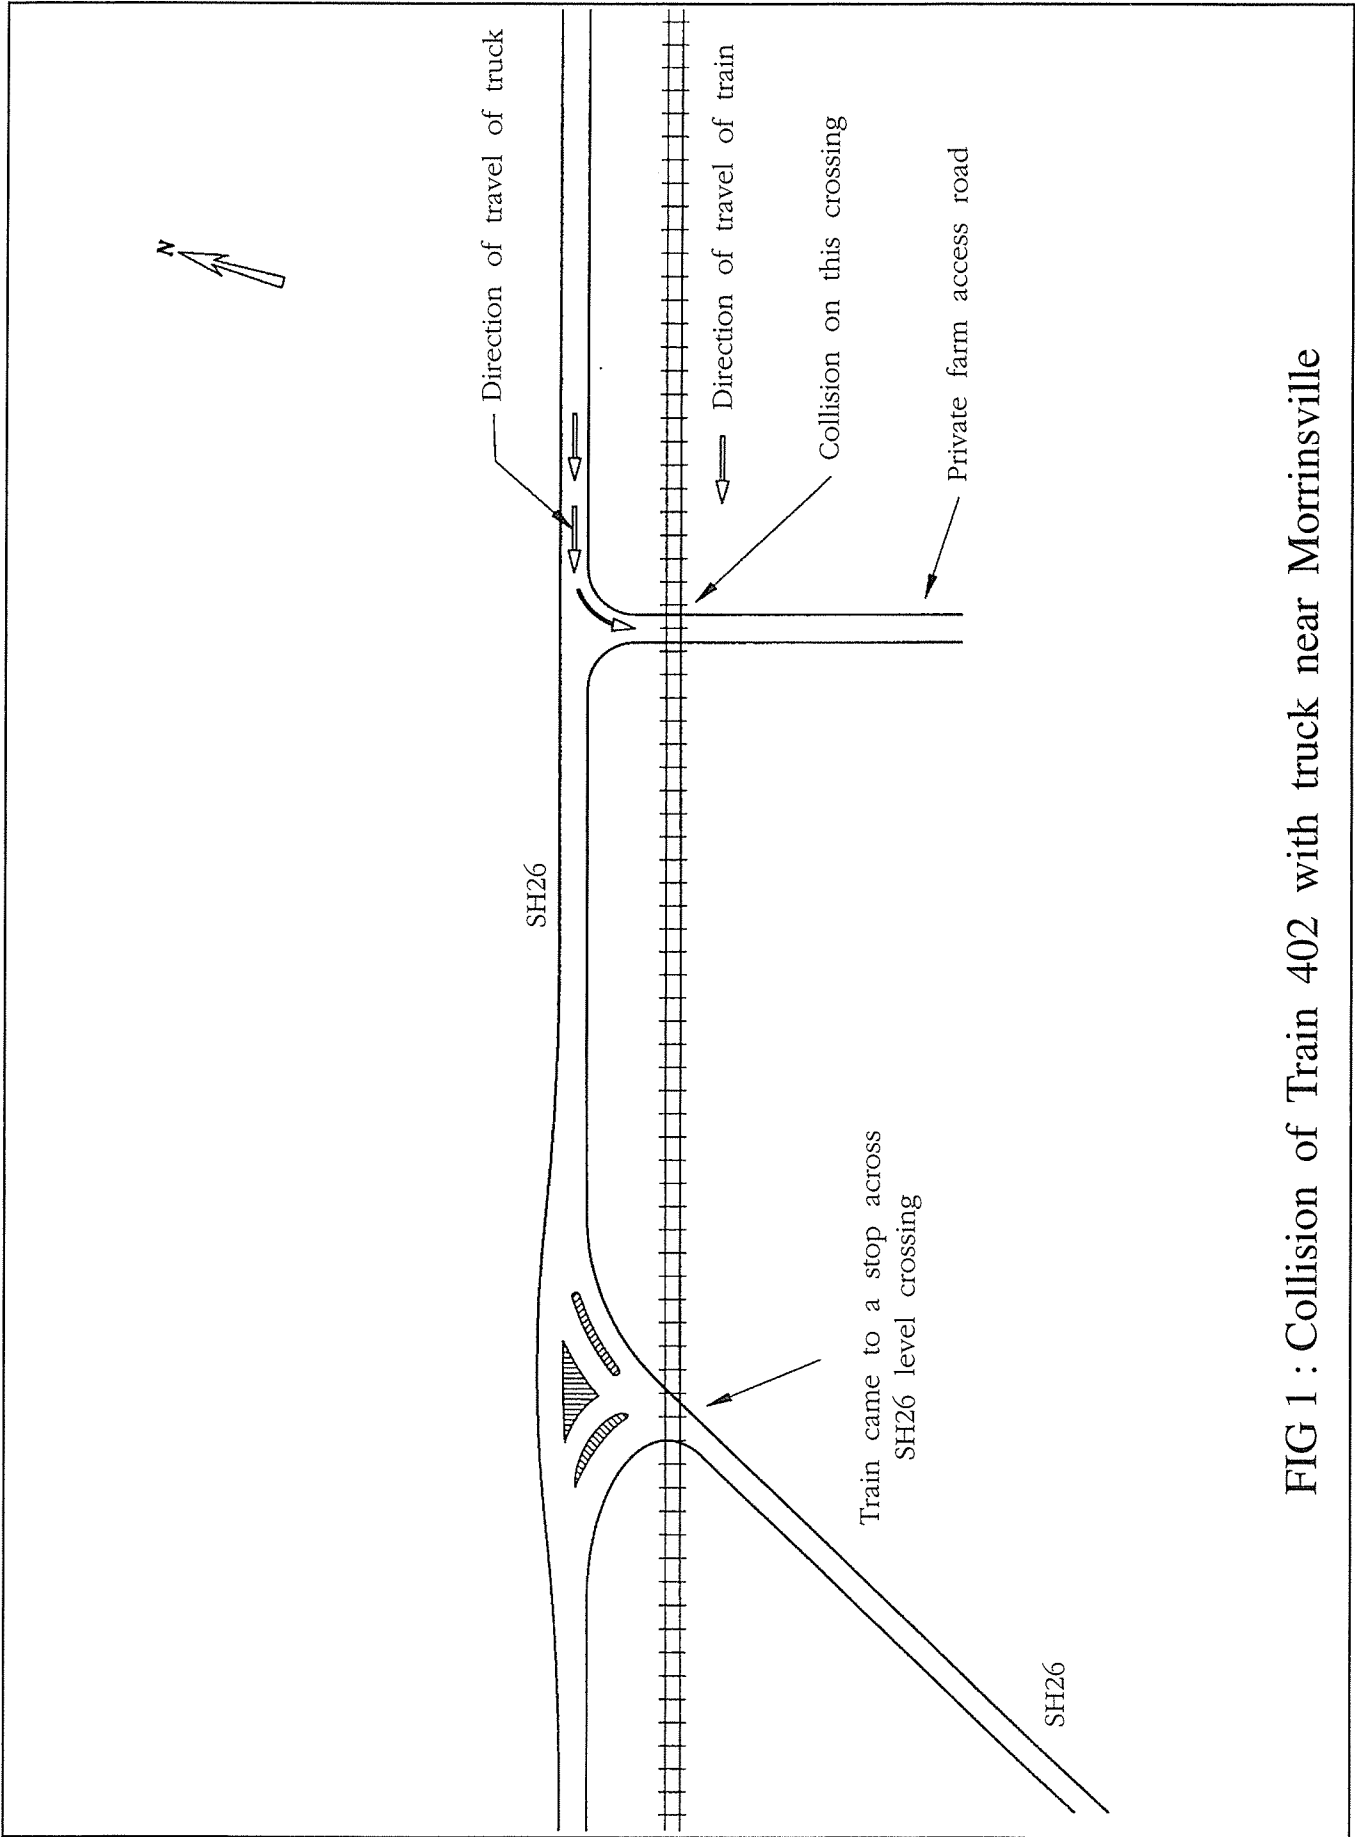
FIG 1 : Collision of Train 402 with truck near Morrinsville

1.9 The edge of the highway was only 14 m from the safe crossing point prior to the railway crossing, and the railcar would have been in a “blind spot” to the truck driver’s left rear, making sighting of the railcar difficult. This may have been exacerbated by rain on the side windows and rear view mirrors of the truck, with possible fogging up of the inside surfaces of the windows.

1.11 There were no signs on State Highway 26 warning of the presence of the railway crossing on the farm access road, but the standard signs were in place for the level crossing 220 m to the west, where State Highway 26 veered left and crossed the railway line. At the farm access road, there was an unobstructed view of the railway line in both directions, and for the entire distance that the road and railway line ran side by side, the railway line was clearly visible from the road. The nature of the crossing did not require the provision of signage by either New Zealand Rail Ltd or Transit New Zealand. Nonetheless, it was the responsibility of the truck driver to ensure that there was no approaching rail traffic before crossing the railway line.
