**NO 94-125**

**TRAIN 776**

**TRACK WARRANT CONTROL IRREGULARITY**

## RAIL OCCURRENCE REPORT NO. 94-125

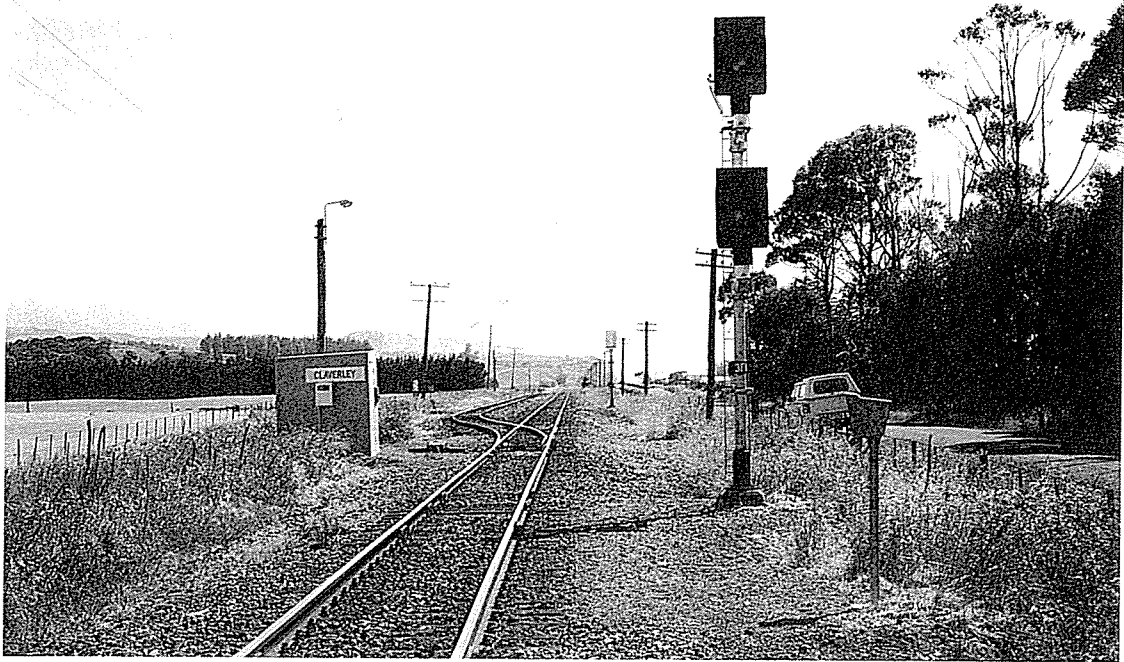
**Fig 1: Claverley Station**

- 1.7 The LE (No 1) of 776 advised that he was at Claverley (approximately 12 kilometres south of Oaro), and said that he had tried to tell the TCO earlier that he would be stopping at Claverley. The TCO asked for and received confirmation that 776 was in the loop at Claverley.

1.29 The origin of the irregularities was the erroneous advice from the LE (No 1) of 776 that he was at Oaro, when in fact he was at Claverley. When interviewed, LE (No 1) could not explain the aberration. The stations are quite different in appearance, and he was very familiar with the route. (See Figs 1 and 2 for photographs of the two locations). The station name is on the Warning Board and the Relay Panel.
