NO 94-126

COLLISION WITH HI-RAIL VEHICLE

POUKAWA, HAWKES BAY

12 DECEMBER 1994

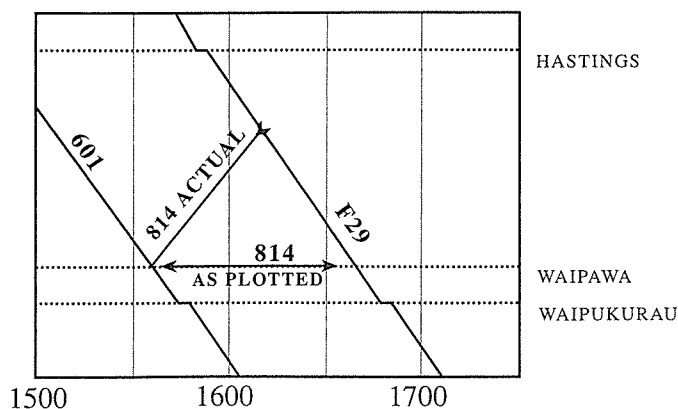
FIGURE 1: SIMULATION OF TRAIN CONTROL DIAGRAM

track as being occupied at the 115.6 mark on his train control diagram⁴, with 1625 hours as the “track clear” time. (See Figure 1). In this location, this would have given an ample time margin before the passage of train F29. Retrospective plotting of the HRV’s travel, beginning at 115.6 km about 1535 hours and terminating at the 158 km point (on the southern outskirts of Hastings) at 1625 hours, showed the HRV progress line crossing that of train F29 almost exactly at the point where the collision occurred.
