**NO 94-127**

**TRAIN 901**

**DERAILMENT**

## RAIL OCCURRENCE REPORT NO. 94-127

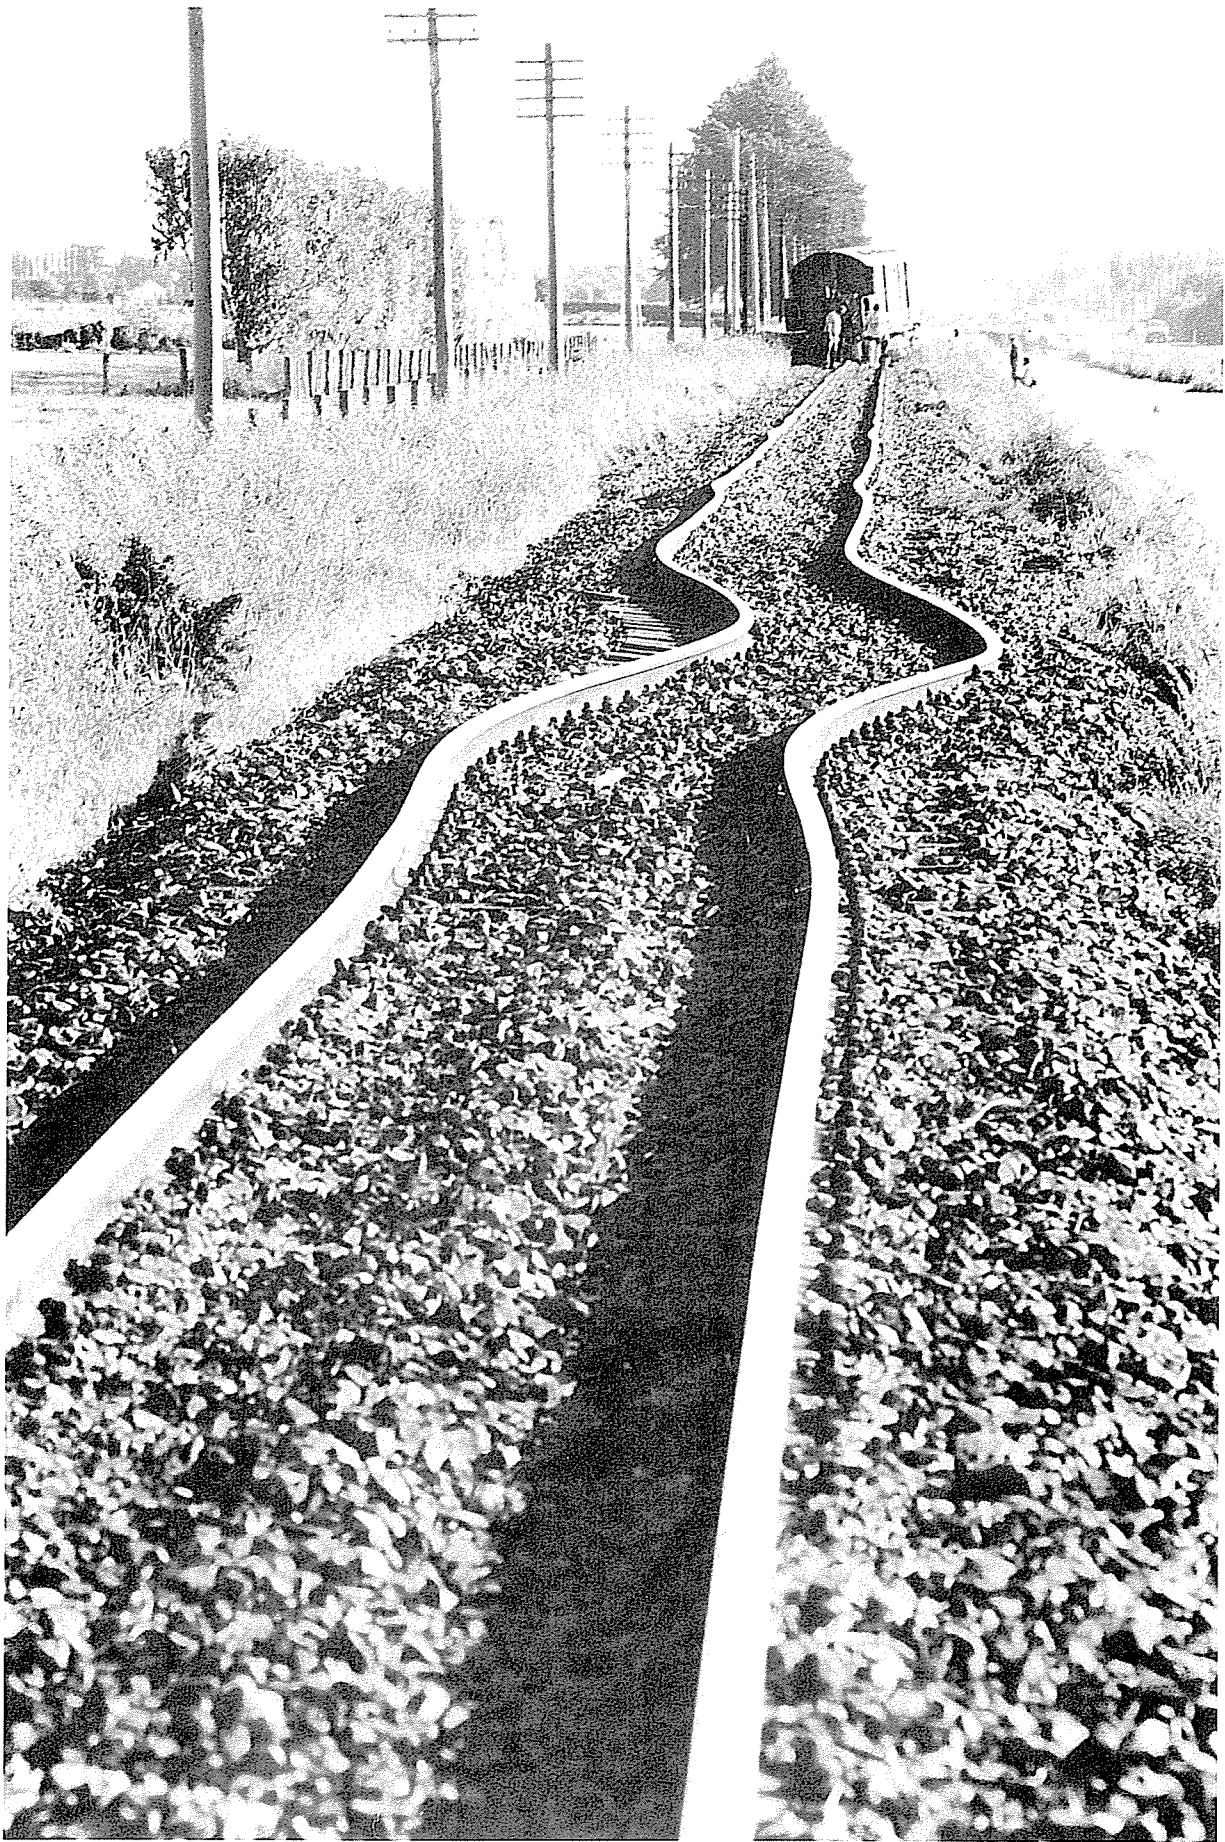
- 1.3 The LE was unable to bring the train to a halt in the space available, and although the locomotive and three passenger carriages remained on the rails, all wheels of the trailing vehicle, a luggage van, were derailed. There were no persons on board the luggage van and no injuries to passengers or crew on the train. A photograph of the buckled track and the derailed luggage van is shown as Fig. 1.

Fig 1: General view of derailment scene  
*Photograph supplied courtesy of the Southland Times*

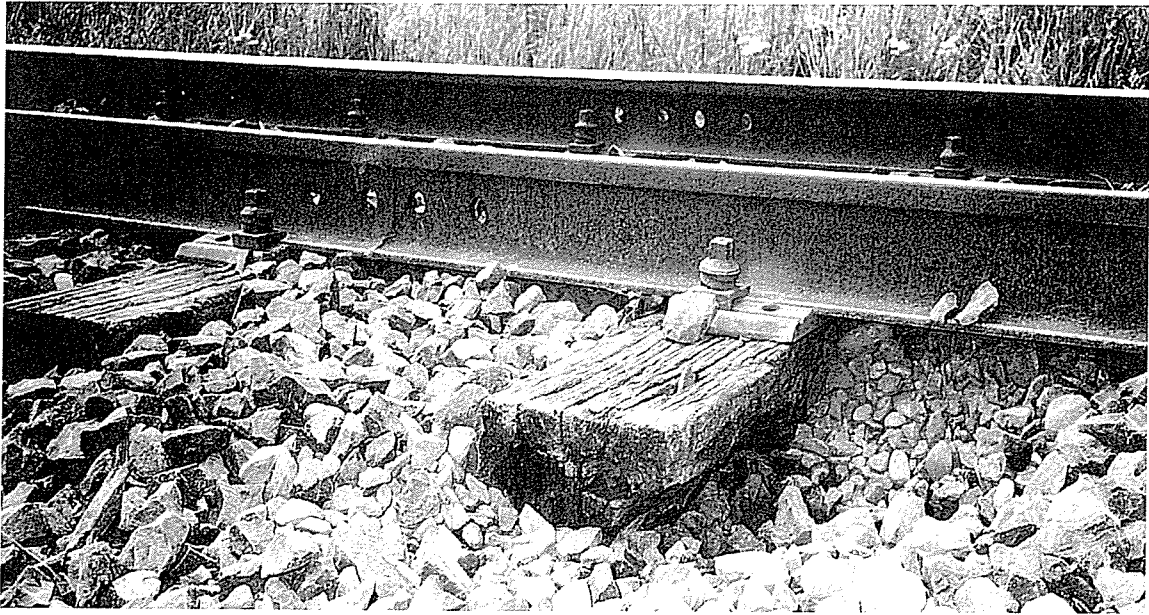
- 1.28 The site was inspected a week following the derailment, and the following points noted:
  - 1.28.1 An estimated 50% of the sleepers were significantly decayed underneath and in the centre. (see Fig 3)

**Fig 3: A jarrah sleeper partly exposed by the removal of ballast. The sleeper appears reasonably solid on top, but has extensive decay underneath.**

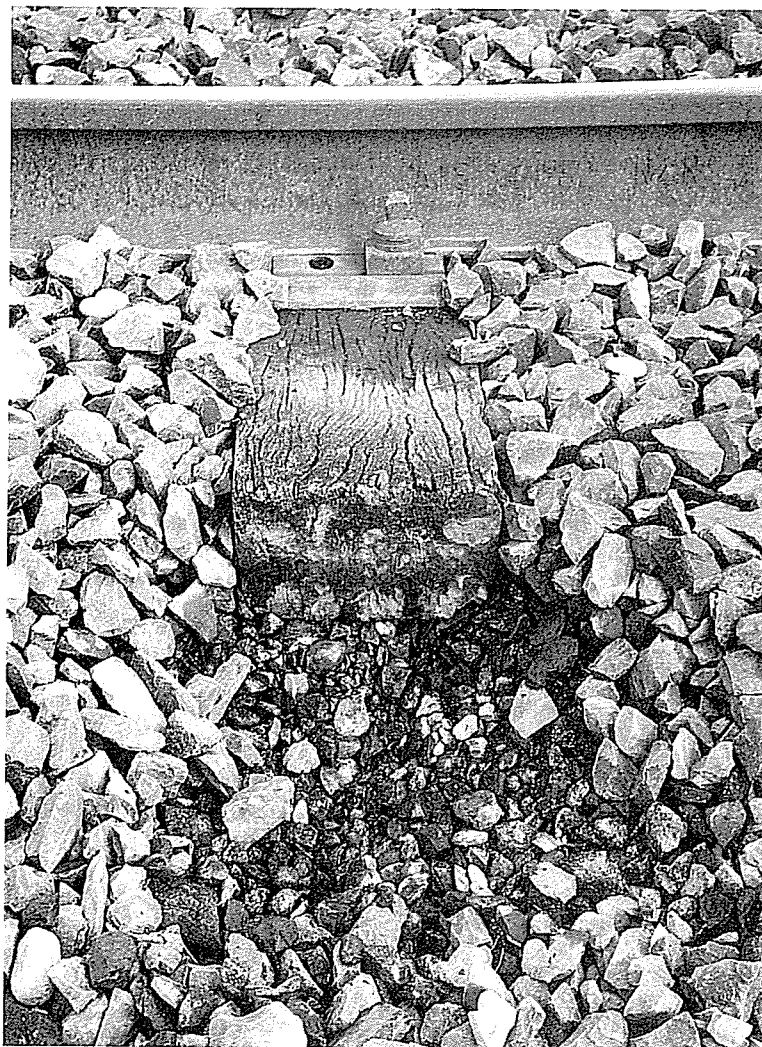
- 1.28.3 The ballast profile on the shoulders (i.e. at the ends of the sleepers) was less than the standard laid down by NZRL for CWR track.
  - 1.28.4 The grading of the ballast below the sleepers was well below new ballast standard. While the surface ballast was of reasonable quality and grading, the ballast under the sleepers was mostly small and rounded material, wet in places, with a high proportion of fines and dirt. (See Fig. 4)

**Fig 4: The careful removal of the ballast shoulder clearly reveals the difference between the top ballast and the small dirty material under the sleeper. At this location near the derailment site, the bottom ballast was wet, indicating a possible drainage problem.**
