NO 94-129

COLLISION WITH MOTOR VEHICLE

NEAR OMIHI

23 DECEMBER 1994

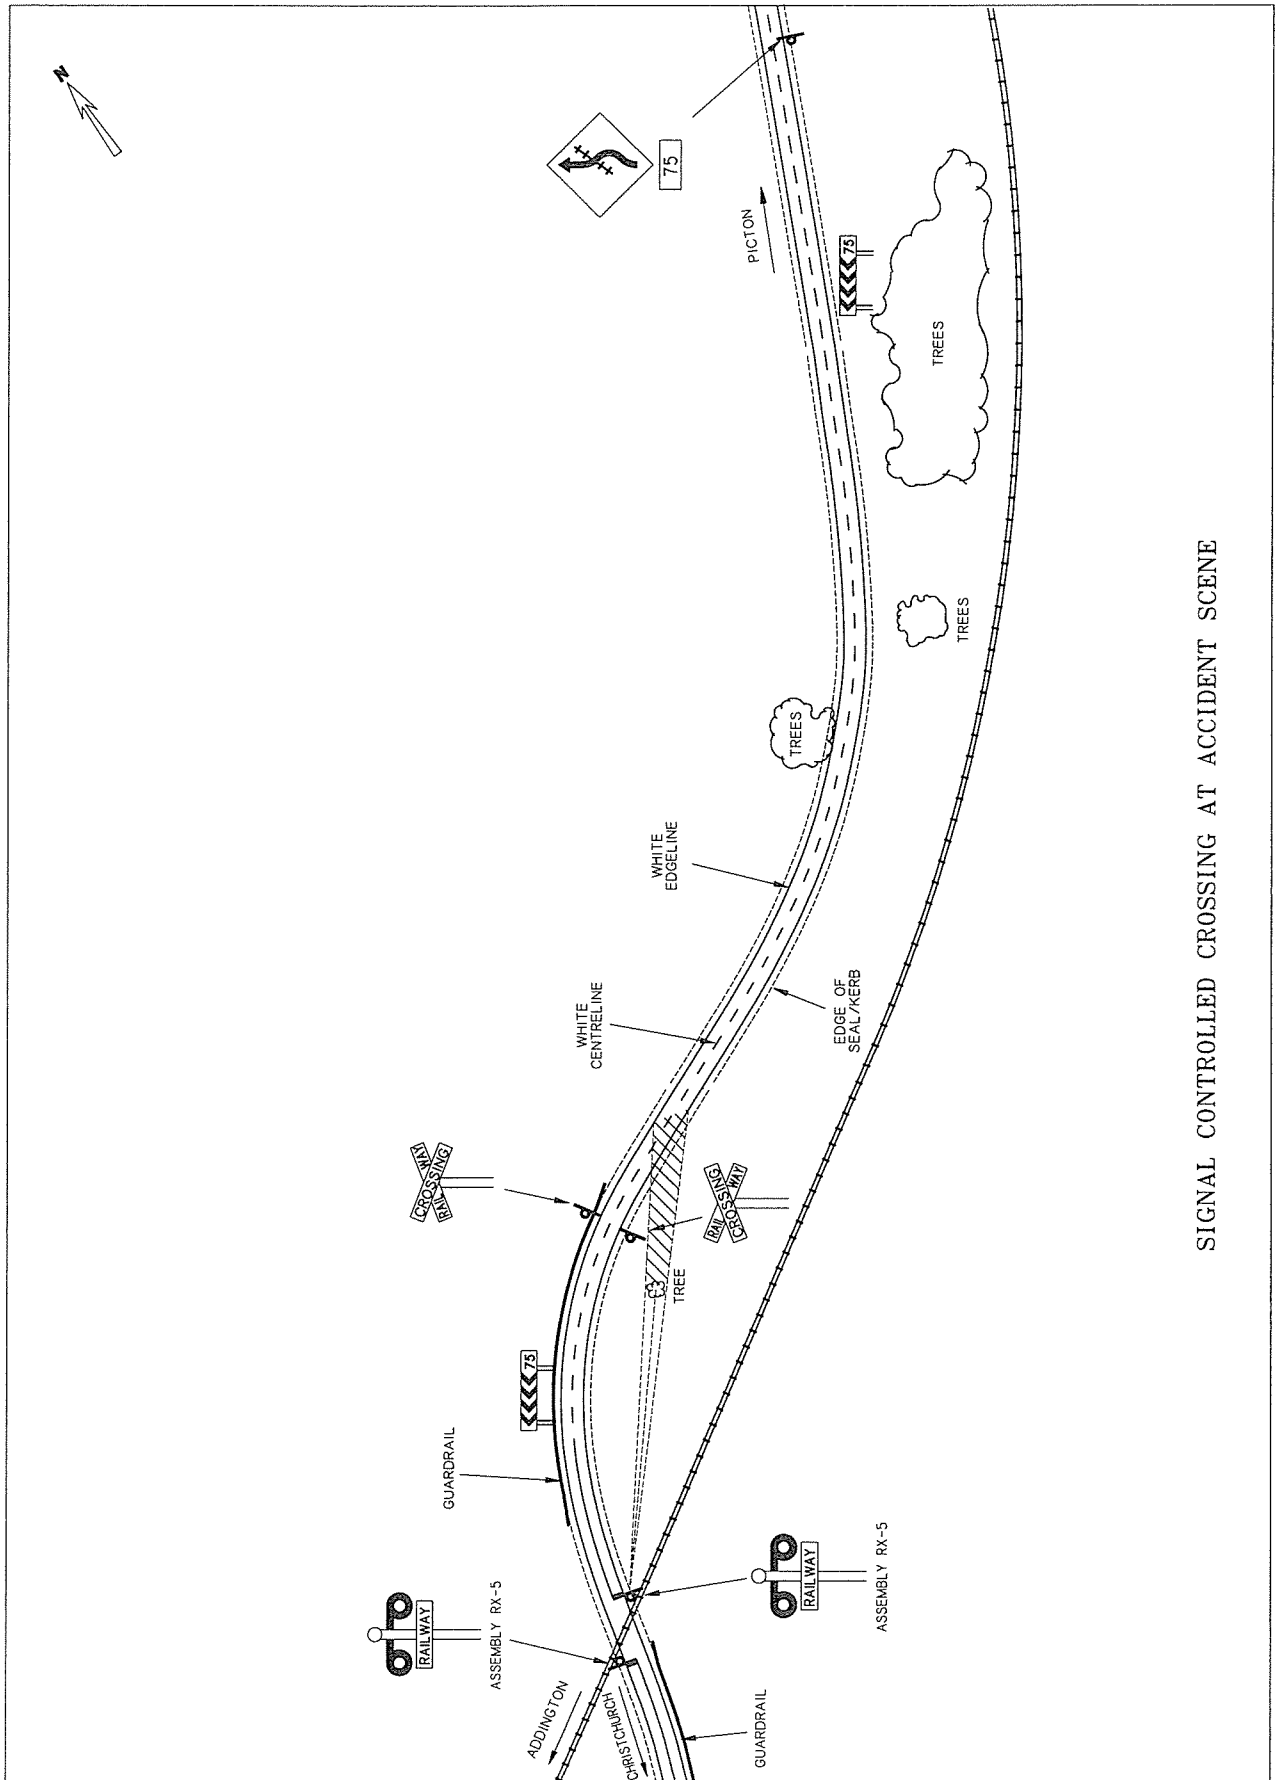
Figure 1
Signal Controlled Crossing at Accident Site

- 1.6 The emergency services started to arrive some 20 minutes after the accident occurred.
- 1.7 The various road signs (See Figure 1) which were intended to draw the Falcon driver’s attention to the existence of a railway crossing the highway were not noticed by him. As a consequence he was puzzled by the action of the driver of the car in front in slowing down on the highway. While he was adjusting to the apparently erratic behaviour of the driver of the Honda his wife, who was sitting beside him, drew his attention to the crossing alarm lights operating and he braked heavily. He was unable to prevent his car colliding with the rear of the Honda which the Falcon shunted onto the track.

- 1.16 The approach to the level crossing from the north is through a "cup hook" configuration of roadway. The straight approach has trees to the left which camouflage the rail track on the left side of the road. At the end of the straight is a standard PW 13, yellow, road sign (Illustration 1) which depicts, accurately, the alignment of the road and shows a rail crossing ahead. The curve of the road is dominant on the sign and the indication of the rail track not readily apparent to a driver approaching the curve at normal driving speed. The drivers interviewed stated that they saw it only as advice of a bend in the road. Transit New Zealand confirmed the primary purpose of the sign is to provide warning of a road alignment requiring a reduction in speed.

- 1.17 The PW 13 sign precedes the crossing by 500 m and is followed 183 m later by a further 75 km/hr speed advisory alongside black and silver chevrons in a horizontal sign for the right hand curve of the "cup hook". Further on are two black on white St Andrews railway crossing signs at 116.5 m before the crossing. Next is a further horizontal 75 km/hr speed advisory for the left hand bend which completes the cup hook. Finally the double white limit line alongside the mast for the flashing lights and bells is situated 2.3 m back from the nearest rail of the railway track. (See Figure 1)

- the existence of the curved approach to the crossing at the scene is within the safe stopping sight distance (about 175 m at 100 km/hr). The curve continues to within about 60 m of the crossing. The safe stopping sight distance is the distance taken to sight the crossing warning light and stop before reaching the intersection at the maximum speed permitted on the road. (Although the approach to this crossing was subject to 75 km/h advisory speed signing the motorists interviewed indicated that on a dry road they found it practicable to maintain 100 km/h).
- the absence of a “no overtaking line” in the centre of the road on the approach to the crossing. The new code proposes a no overtaking centre line commencing 200 m from the crossing stop line.
- the absence of painted information on the road surface. The word “rail” and a large white “X” are proposed in the approach lanes.

- the alignment of the white “Stop” limit lines on the road, with the mast for the bells and flashing lights. LTSA and Transit recommend these lines precede the crossing alarms by a minimum of 2 m.

- the siting of the St Andrews railway crossing notices well within the safe stopping sight distance for 100 km/hr and thus closer to the crossing than proposed. (ie 117 m versus the 175 m which is proposed).

- 2.4 The marking of the roadway and attendant signs was in accord with present practice
- 2.5 The marking of the roadway and attendant signs was not adequate to advise motorists that they were approaching a railway crossing.

- 2.6 The standard of road marking and signage at this crossing did not meet the applicable criteria of the proposed code for such information to drivers.

Until the proposed "Code for Road Signs and Markings for Level Crossings" is ratified, he arrange for the presence of the railway level crossing 1 km north of Omihi be drawn to the attention of motorists by enhanced signage and/or roadmarking. (026/95)

- (a) review with NZ Rail the alignment of the flashing lights and adjust as necessary;*
- (b) install red backing boards to the “Railway Crossing” signs (PW-14) and adjust position of the northbound direction to maximise driver awareness; and*
- (c) paint the message “Rail X” on the road on either side of the crossing point, again ensuring adequate prior warning for drivers.*

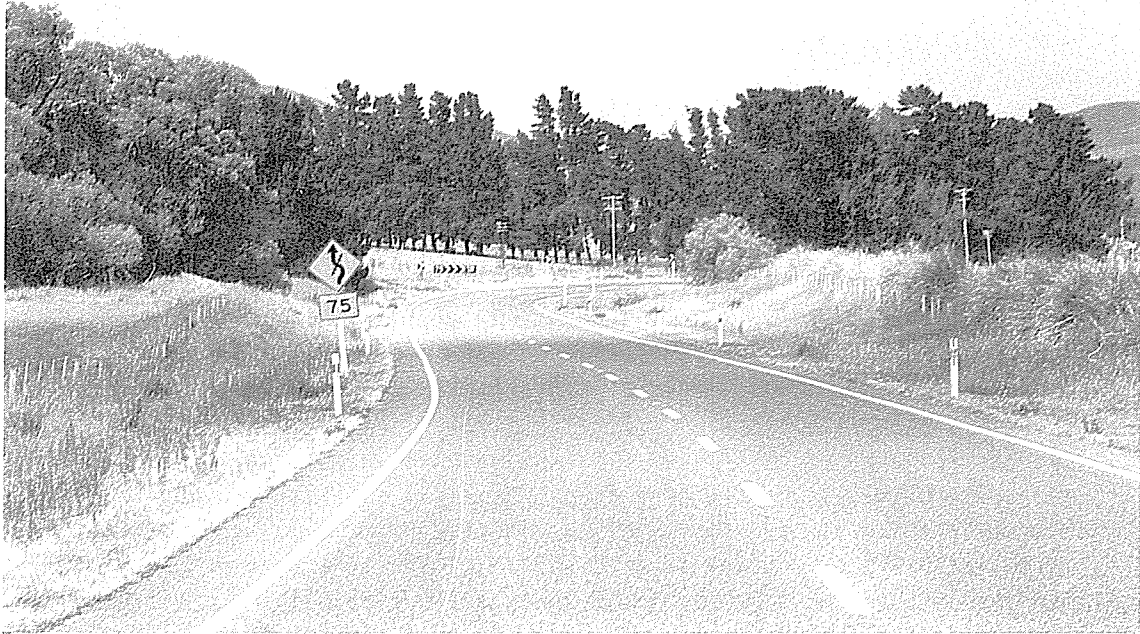
Illustration 1

- the use of a combined road curve and railway track sign as the first indication of the level crossing. A separate railway crossing ahead sign in the form of a silhouette of a steam locomotive on a yellow background is proposed.
