Addendum

Report 95-008

Piper PA 28-161, ZK-MBI

missing after departing from Gisborne

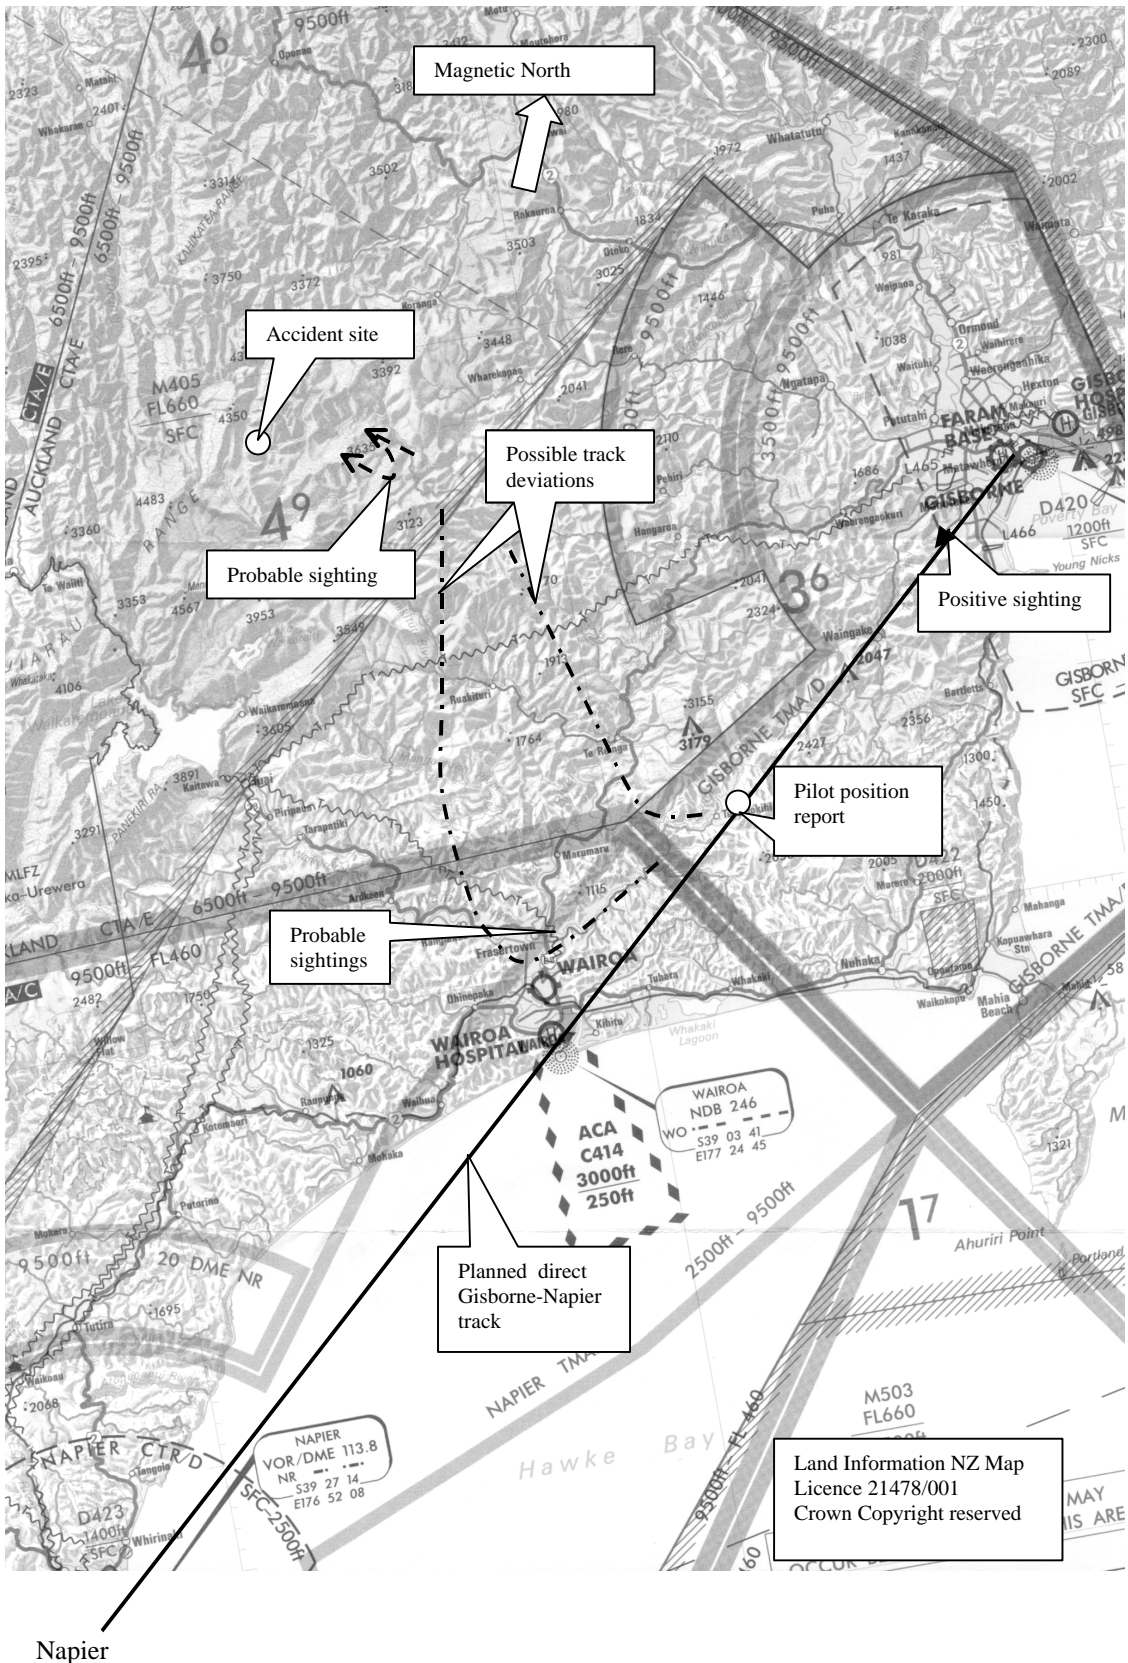
Figure 1
Possible track deviation and accident site ZK-MBI

- 2.2 The location of the accident site in relation to the planned track from Gisborne to Napier was not readily explained. ZK-MBI had been seen to depart from Gisborne on track, to the south-west, towards Napier. The pilot's radioed position reports to Gisborne and Napier Towers indicated that he had flown some 25 nm on track, and was at 3500 feet. The witness reports in the vicinity of Wairoa, together with the overheard transmission from Massey 703 referring to Wairoa, did suggest that the aircraft had flown that far, some 33 nm, along the correct track. It would have been possible for ZK-MBI to fly to near Wairoa then to the accident site some 28 nm north-north-west within the 0.7 hours flight time, with some manoeuvring as reported by the witness near the Urewera National Park. If this had happened, a prompt right turn would have been required through 110° onto a heading away from the coast, towards high terrain and bush and the lowering sun, for about 20 minutes.

- 3.1 During the return flight from Gisborne towards Napier the aircraft had deviated off track by a large amount, to fly inland for some 20 minutes.
- 3.2 No explanation for the track deviation was found.
- 3.3 The aircraft was probably capable of normal operation.
- 3.4 There was no evidence of pilot incapacitation.
- 3.5 The aircraft was probably in controlled flight when it collided with high terrain.
- 3.6 The pilot's view of the mountainside ahead may have been compromised either by the low sun or by local cloud.
