**NO 95-009**

**BELL 206B JET RANGER III**

**ZK-HDI**

**TRANSPORT ACCIDENT INVESTIGATION COMMISSION**  
**AIRCRAFT ACCIDENT REPORT NO 95-009**

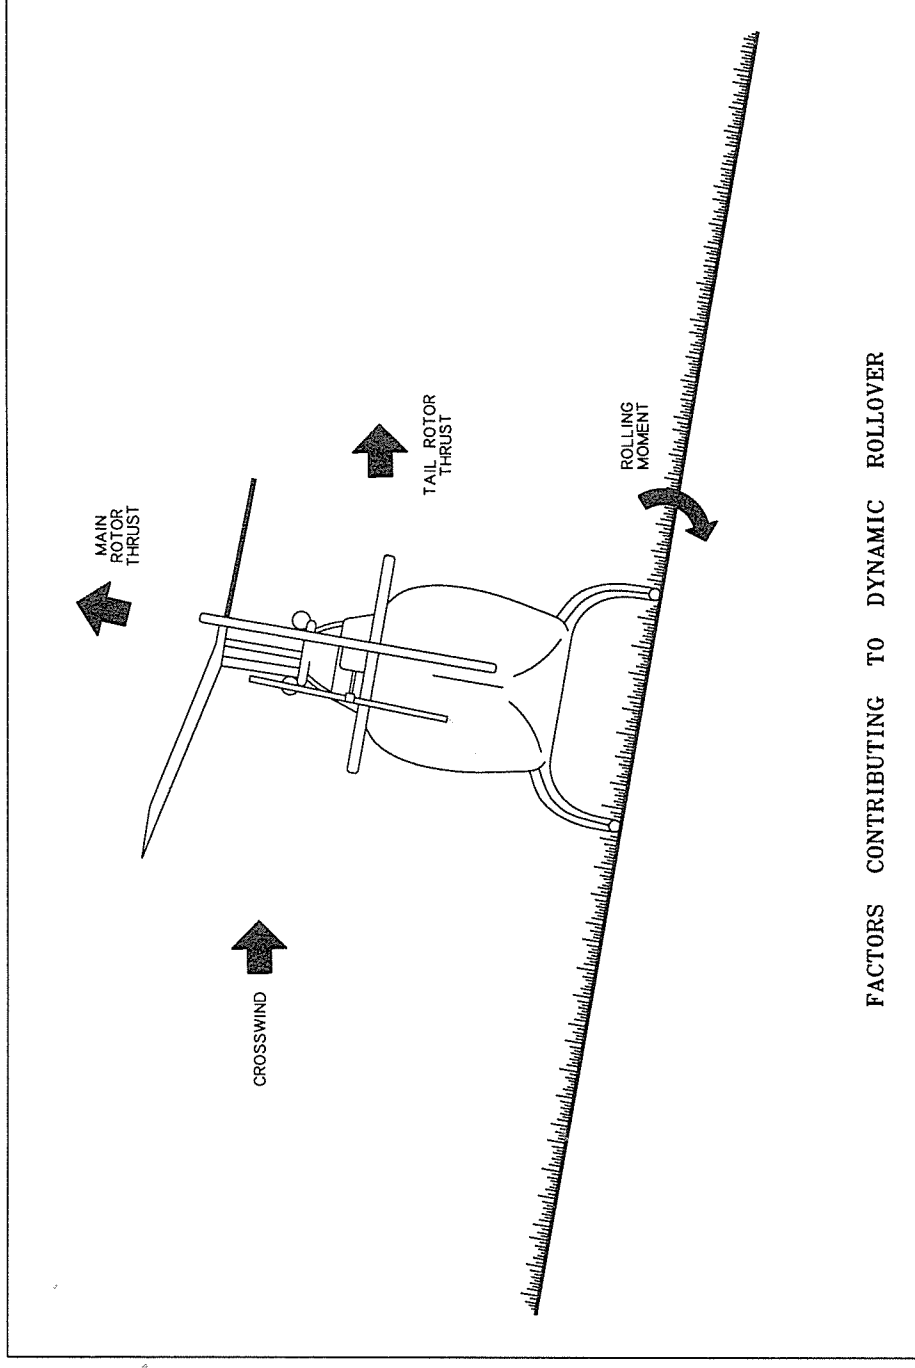
- 1.17 The pilot's report, and the circumstances surrounding the accident to ZK-HDI, were consistent with the occurrence of dynamic rollover.
- 1.18 'Dynamic rollover' is the tendency of a helicopter to pivot around one of its skids. This usually occurs during slope operations but can happen on level ground.

- 1.19 Several factors can contribute to dynamic rollover. The main factor is the thrust of the main rotor when it is tilted from the vertical. If the rotor system is not tilted or if there is no thrust, then dynamic rollover will not occur.

- 1.20 Other factors which contribute to dynamic rollover are the tail rotor thrust, especially when it is located high up on the helicopter, and a downslope crosswind. Also, in order for a rollover to occur, the skids must be in contact with a high friction surface. If the surface is slippery, the helicopter will tend to slide and not pivot if a sideways force is applied. In addition, a helicopter with a high centre of gravity (CG) and/or on narrow skid tracks is more susceptible to dynamic rollover than one with a low CG and/or wide skids.
