Report 95-011

de Havilland DHC-8, ZK-NEY

controlled flight into terrain

9 June 1995

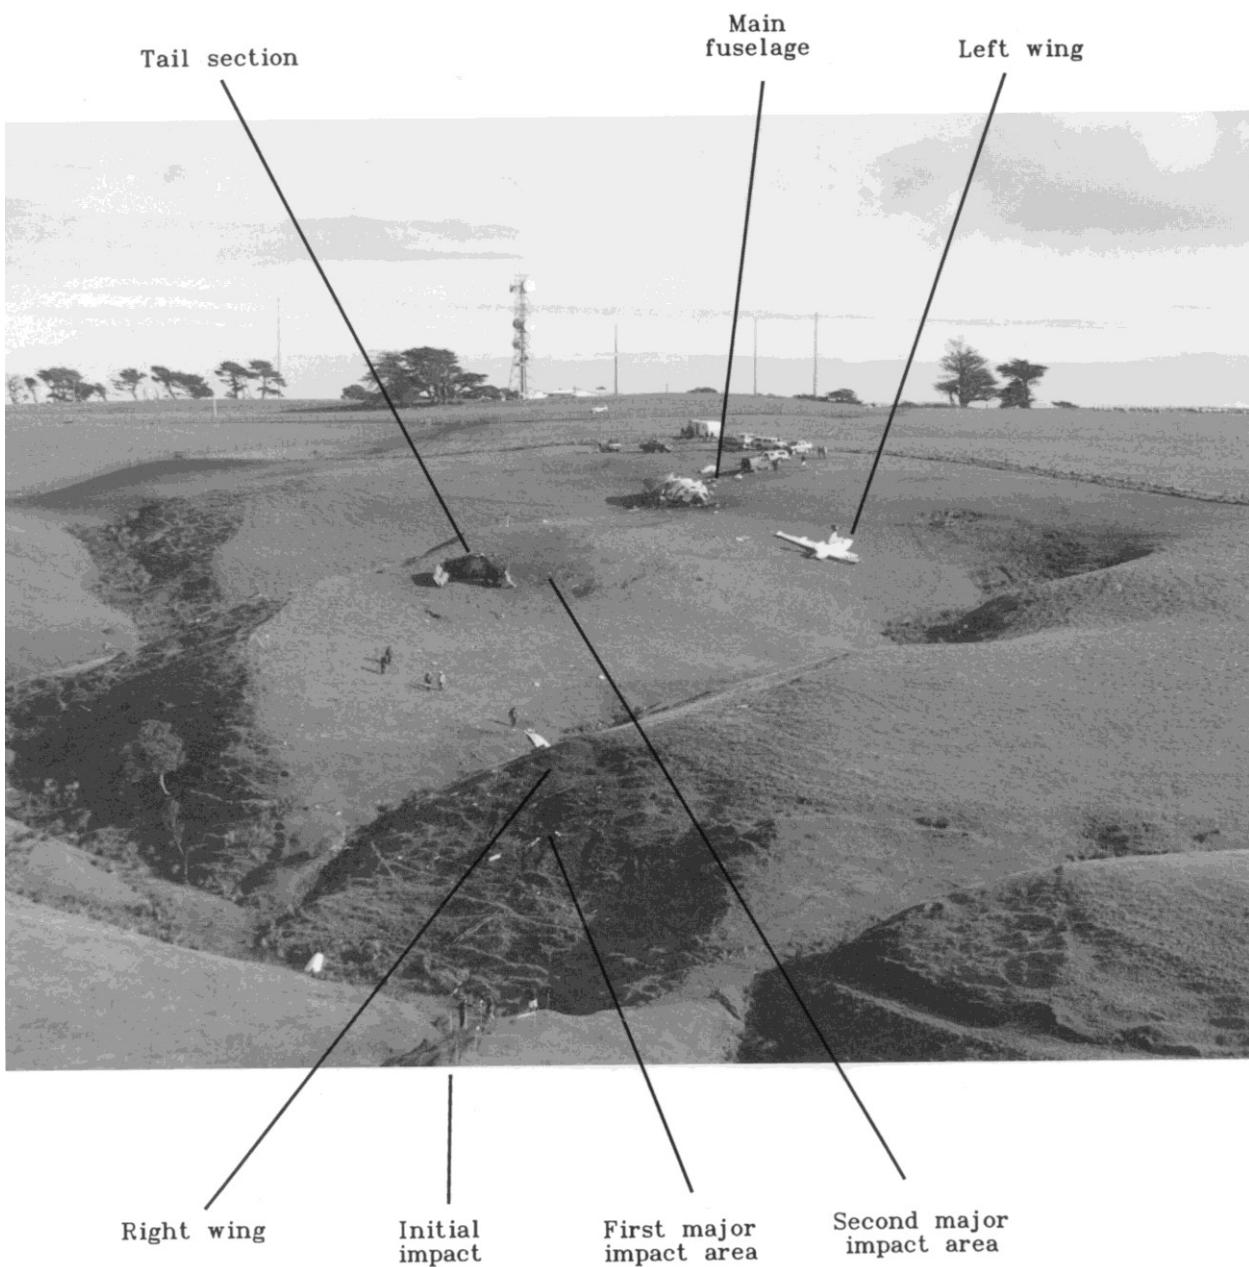
Accident Site - General View

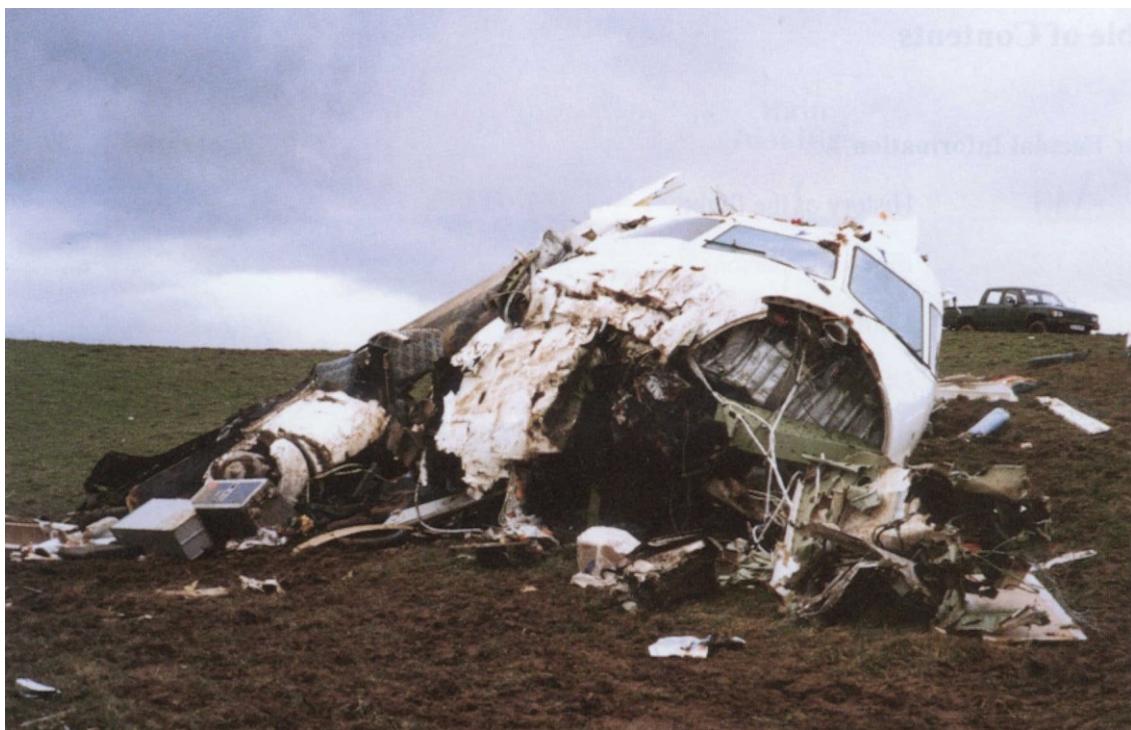
ZK-NEY looking aft

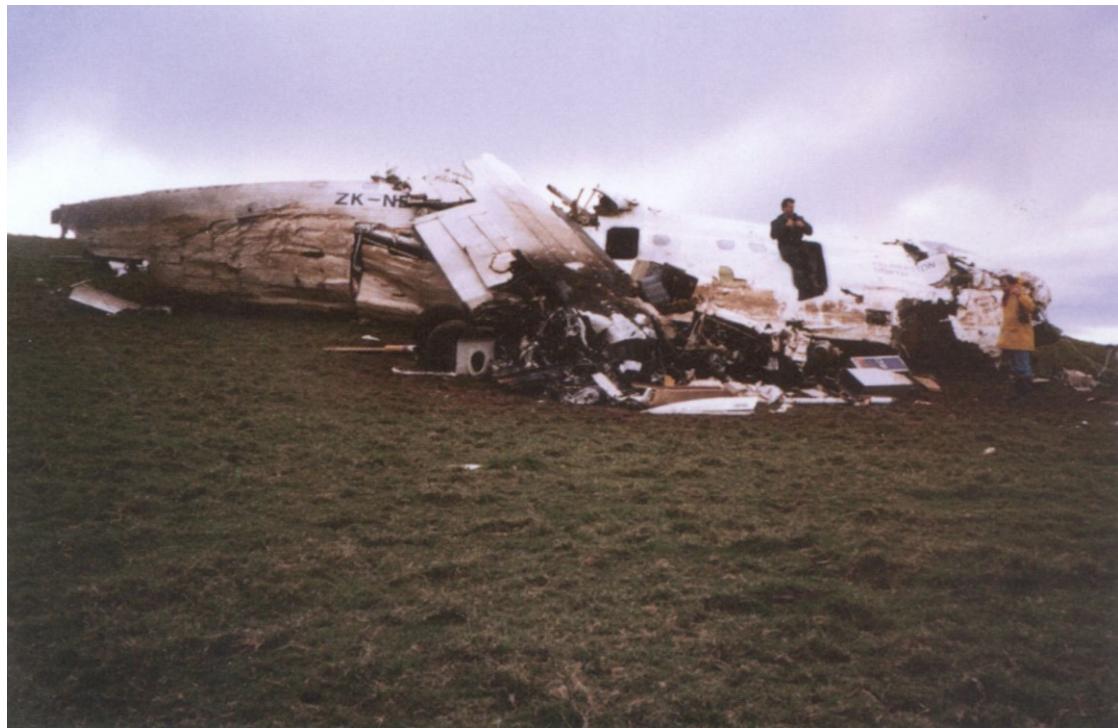
ZK-NEY right side

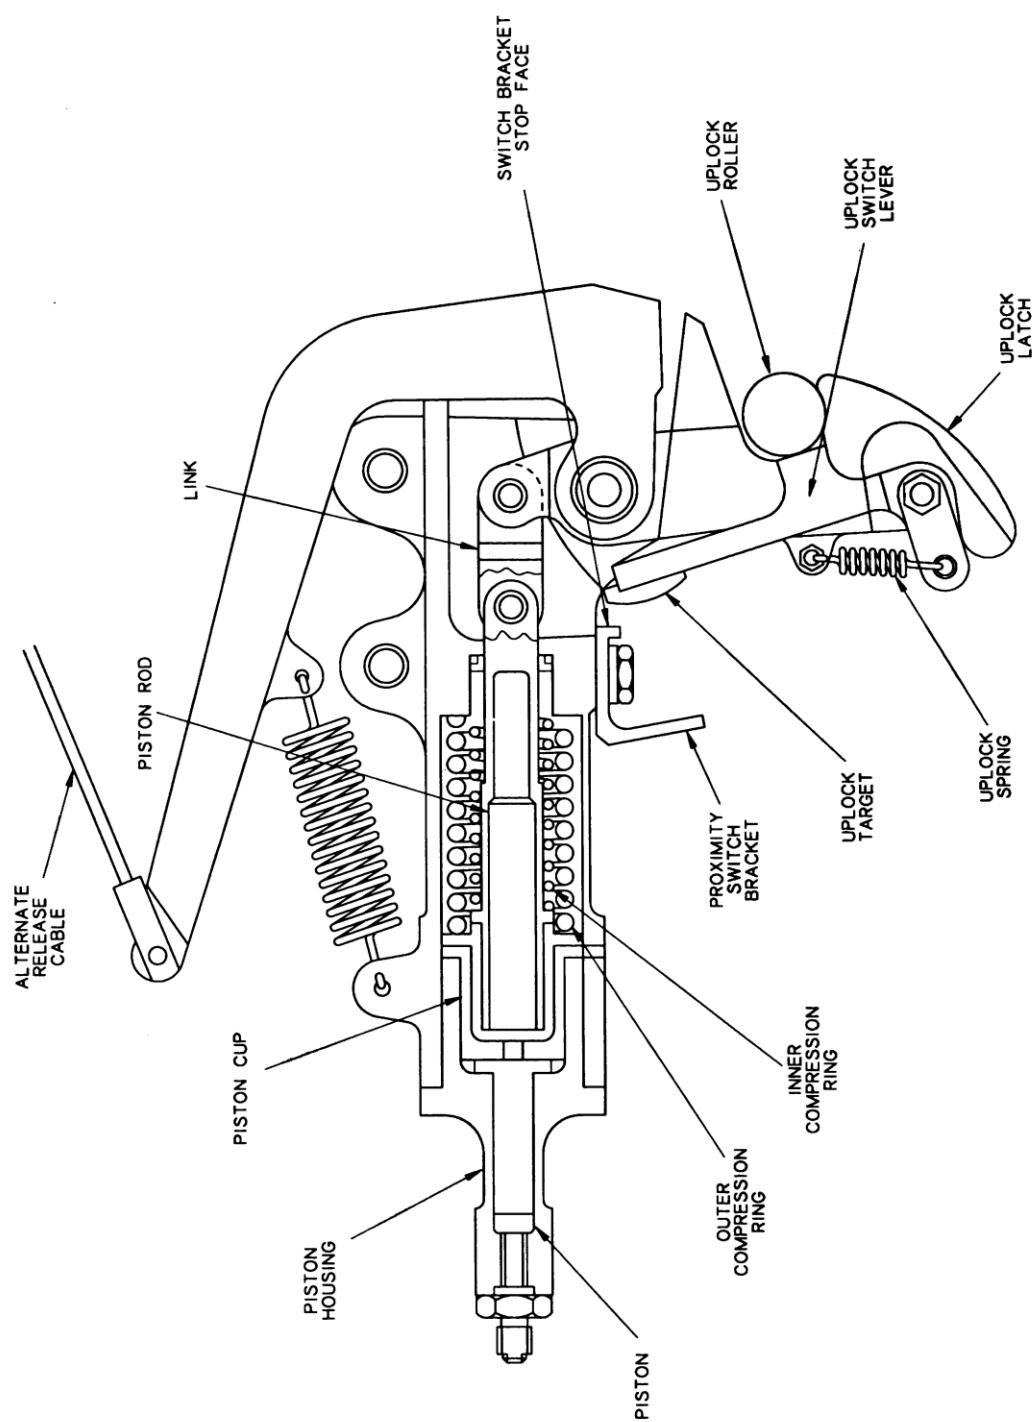
Figure 2
Uplock assembly view
(Not to scale)

- 1.6.24 The main undercarriage uplocks fitted to the Dash 8 aircraft were designed to restrain the respective undercarriage leg in the retracted position under all flight conditions without the aid of hydraulic pressure. They comprised a latch assembly installed within the rear of the engine nacelle which engaged with a roller mounted on the undercarriage leg when the undercarriage was fully retracted, thus mechanically holding the undercarriage leg in the “UP” position. (See Figure 2.) With the uplock latches engaged and the forward, centre and aft doors closed, the solenoid selector valve was de-energised to isolate hydraulic pressure from the system.

- 1.6.47 The AOM also advised that pre-modification 8/1828 (SB8-32-98) or 8/1764 uplocks were sensitive to latch wear and that worn uplocks tended to show progressive operational problems which might start with a single main undercarriage releasing late or with a bang. If left uncorrected this might result in the affected main undercarriage failing to release using the normal system.

- 1.6.42 Service Bulletin SB8-32-98 Mod 8/1828 which was issued by de Havilland Canada dated 14 August 1992 introduced a re-designed uplock actuator assembly to overcome the problem of main undercarriage “hang-ups” due to failures of the original uplock to disengage after a normal “DOWN” selection. The new uplock unit was designed to minimise the hang-up problem and eliminate spurious indications that the main undercarriage had failed to lock down.

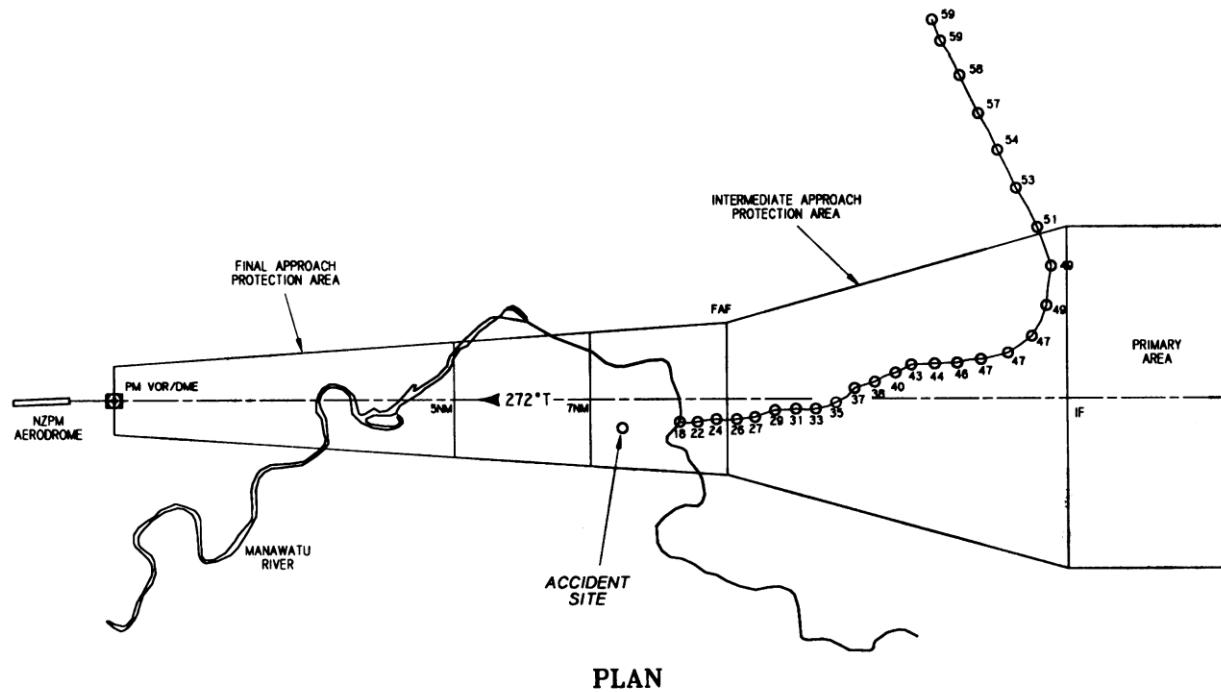
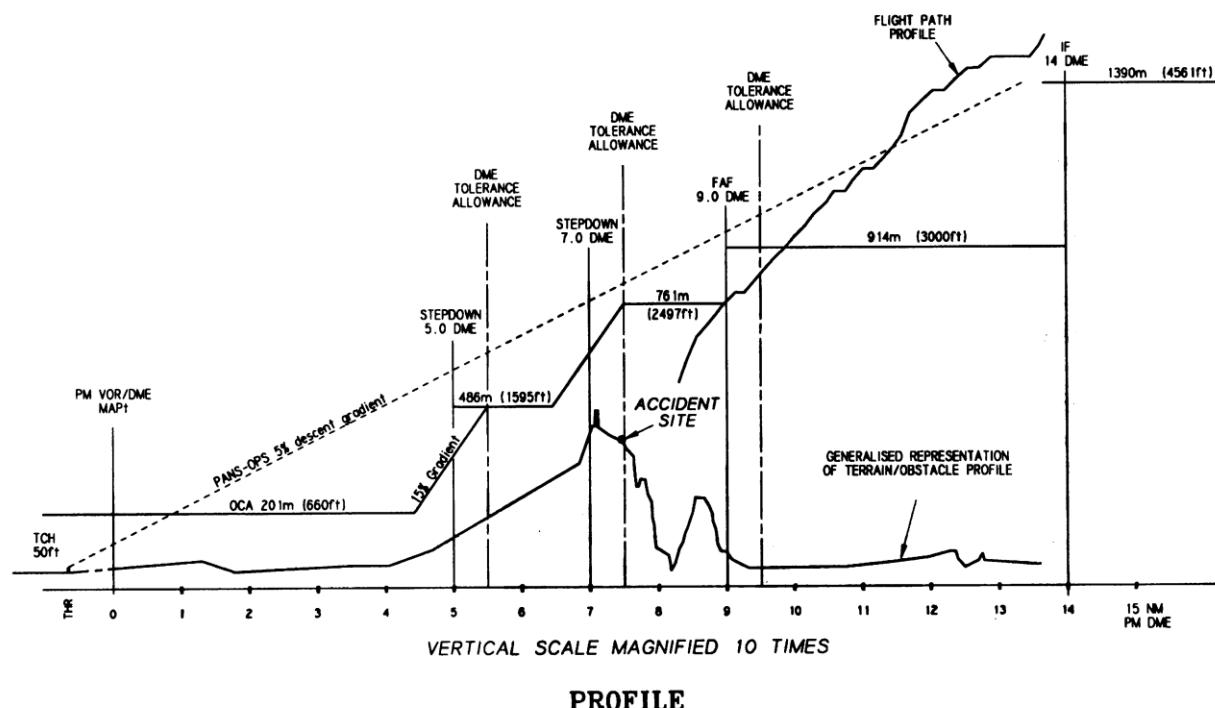
Figure 3
Copy of simplified procedure design
with radar data overlaid

- 1.8.20 The study of the radar recording after the accident showed that the Mode C altitude data on the final approach, in conjunction with the aircraft’s position, could have enabled a radar controller to monitor the aircraft’s compliance with the instrument approach procedure while it was being carried out.

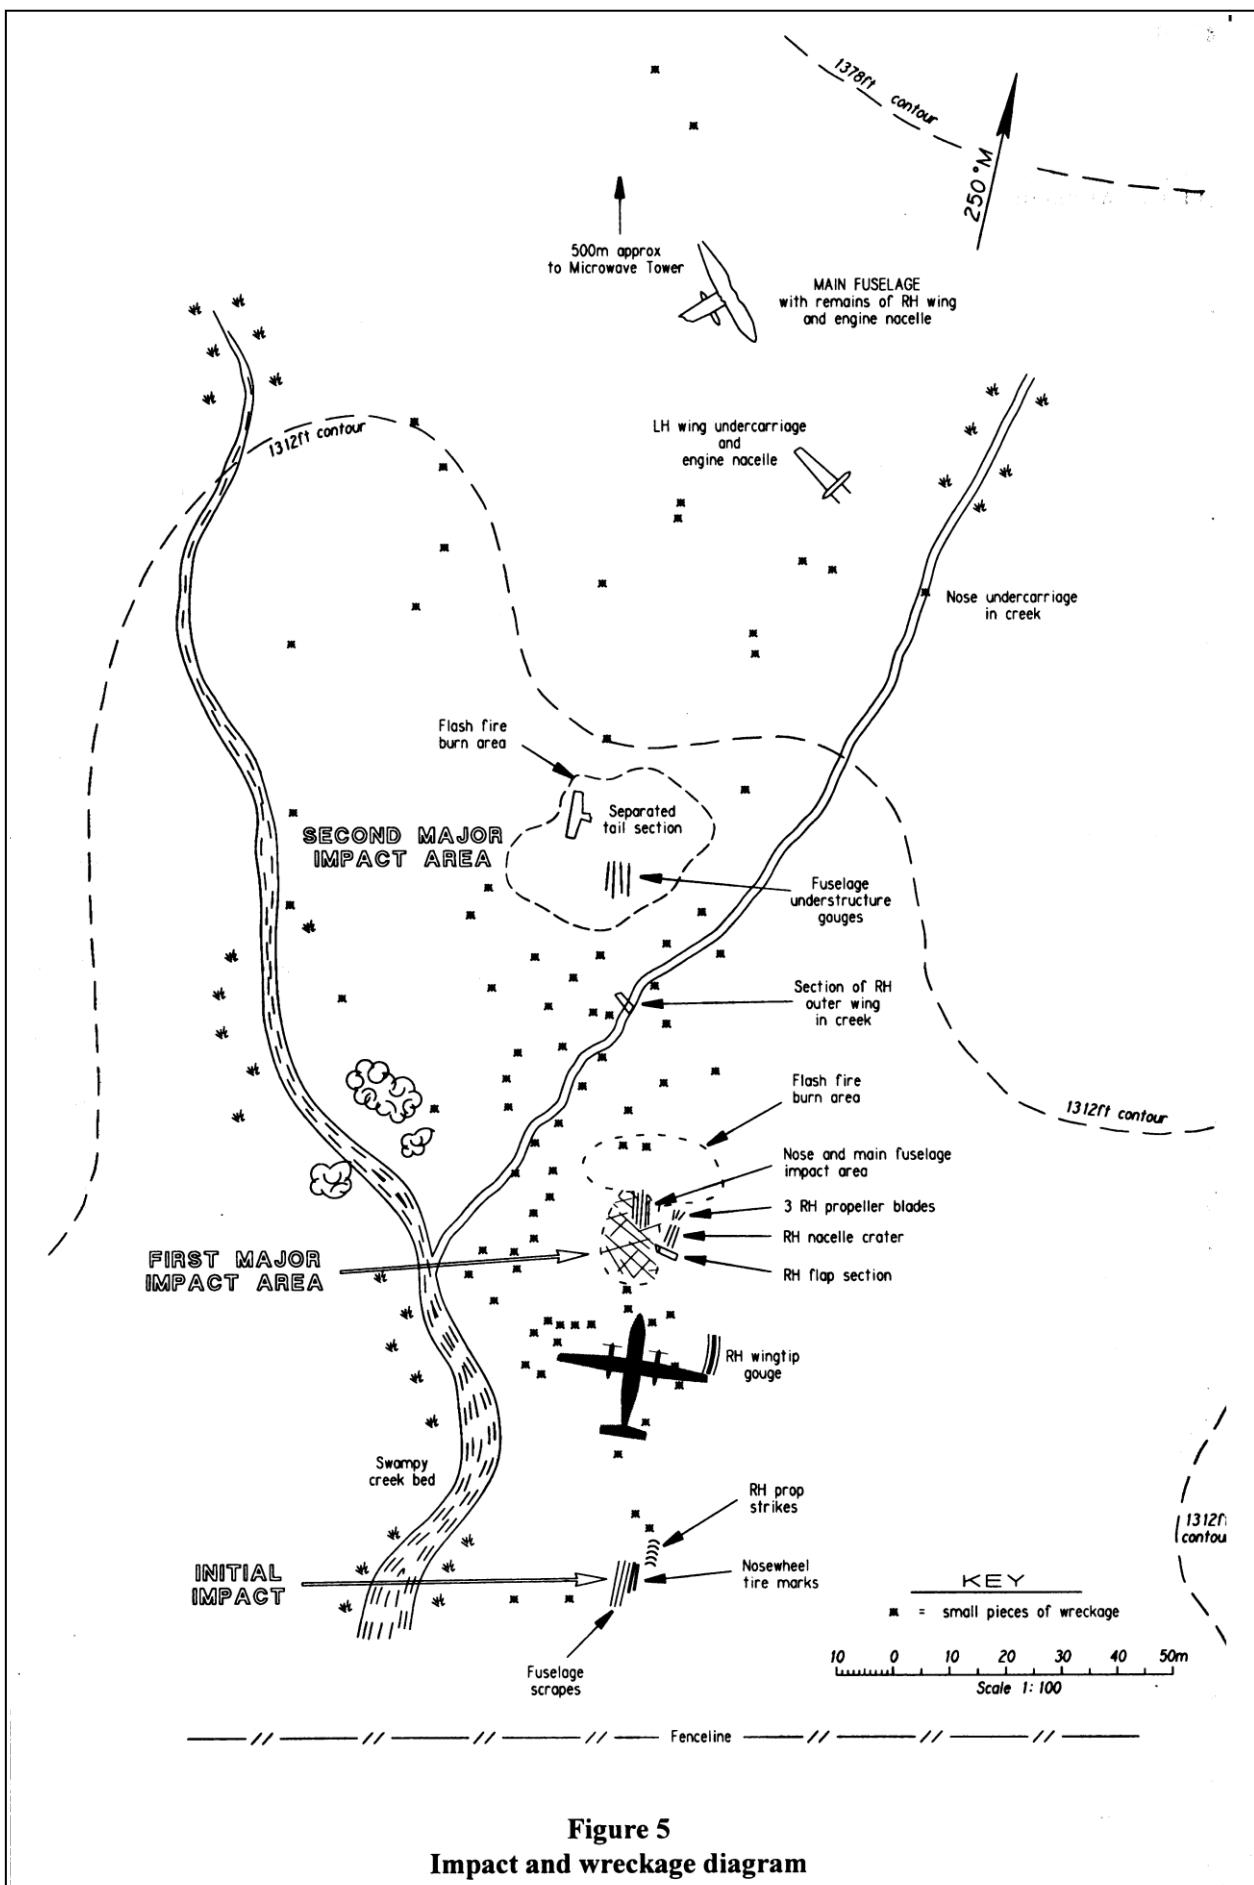
Figure 5
Impact and wreckage diagram

- 1.12.4 The initial ground impact occurred as the nosewheel of ZK-NEY contacted a gently rising grassy knoll which had an overall up-slope of about 5°. The aircraft was approximately level laterally at the time.

- 1.12.13 Approximately 28 m further on and 70 m beyond the grass knoll, the aircraft struck a terraced grass spur which had an upslope, in the impact area, of about 30°. The orientation of the spur was such that the major impact was absorbed by the aircraft's fuselage, right engine and right wing assembly. Three of the four already damaged right propeller blades detached from their hub and a four-metre-long section of the right outboard wing flap, together with smaller portions of other components from the lower fuselage and right side of the aircraft, were strewn over this impact area.

- 1.12.17 The damaged fuselage section comprising the flight deck and cabin, with the remains of the right wing and right engine installation loosely attached, continued uphill until brought to rest against a bank on the hillside, having traversed a total distance of about 235 m from initial impact. The fuselage was slewed through some 150° and lay across the slope on a heading of 040°M partially rolled onto its left side, at an elevation of 1345 feet amsl.

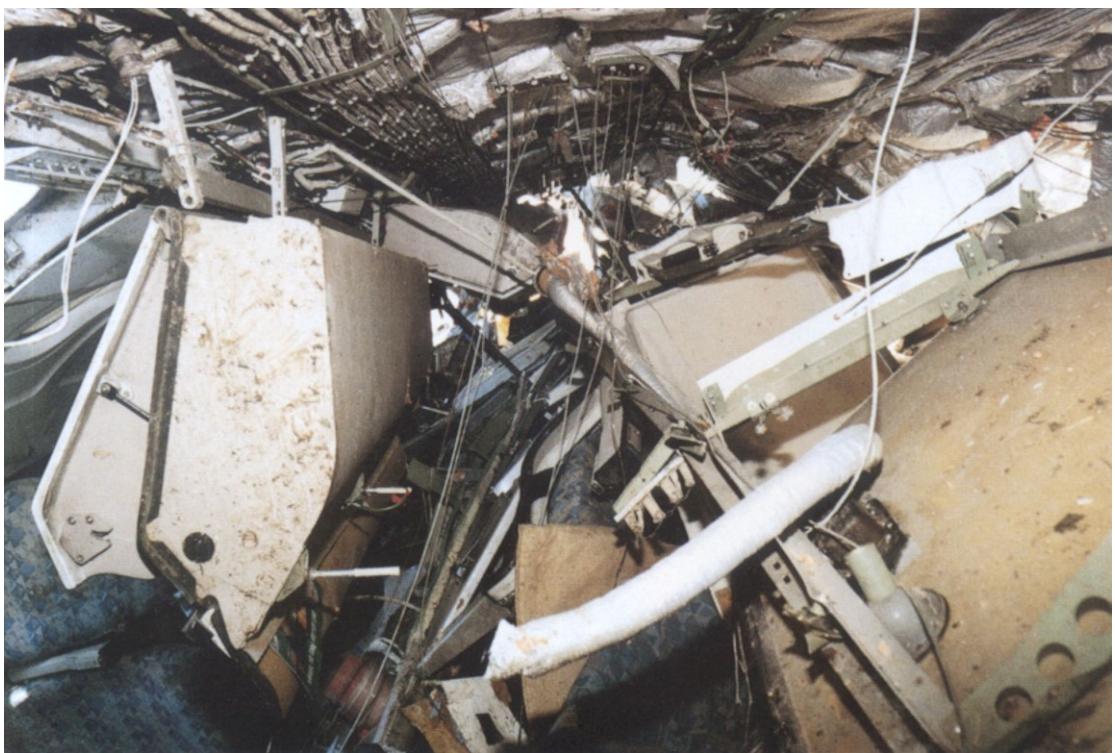
Figure 6a
View of passenger cabin looking aft

- 1.13.3 Prior to coming to rest the lower part of the fuselage structure failed and split longitudinally, resulting in a height difference of up to a metre between the right and left halves of the cabin floor.

- 1.13.5 During the initial vertical impacts, many of the mountings for the cabin ceiling and the baggage lockers failed, resulting in a partial collapse of the ceiling and lockers. Most of the disruption to the baggage lockers occurred in the wing root area.
