Report 95-021

Robinson R22 Alpha

ZK-HUH

Aircraft Accident Report 95-021

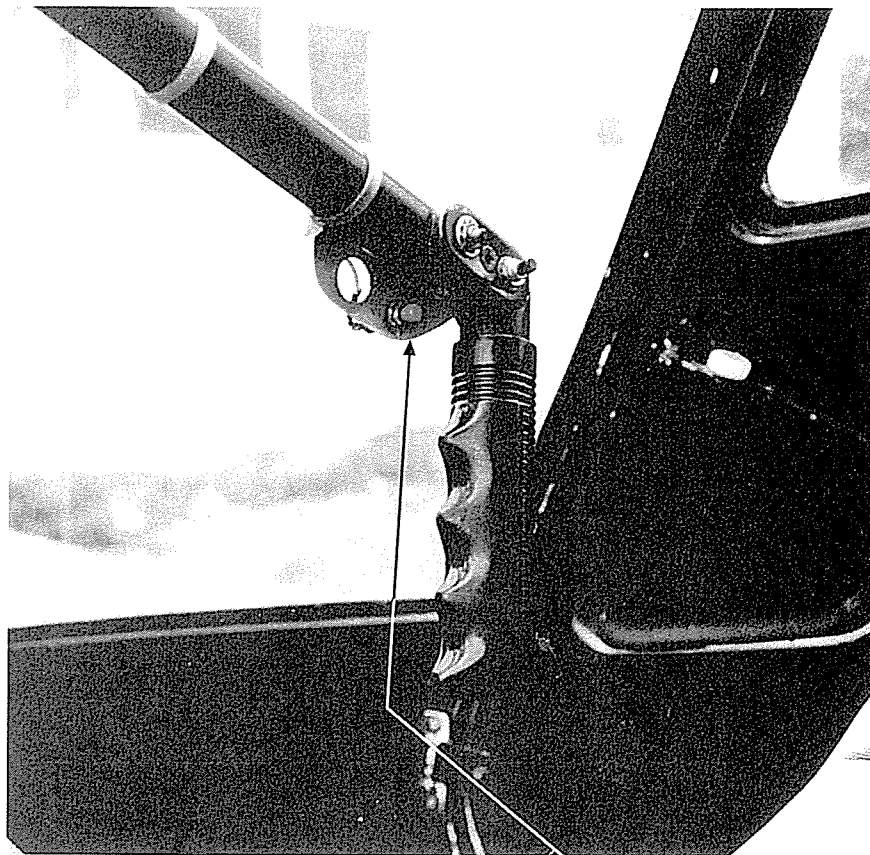
Figure 1
Cargo hook electrical release (red button)

- 1.24 The installation in ZK-HUH included a “push to operate” electrical release switch mounted on a bracket attached to the pilot’s cyclic control (see Figure 1). The switch “button” was not shrouded but the attachment of the mounting bracket to the forward side of the cyclic control tubing partially protected the switch within the elbow of the control handle. This was in contrast to the nearby “press to talk” RTF and intercom switches which were positioned just above the control handle for ease of operation during flight.

- 1.26 The CB wired for this purpose was one of several spares located among the double row of CB’s in the panel. It was rated at 25 amps and was placarded ‘HOOK’. The pilot was unaware that the electrical hook release could be dis-armed by this means. The extent of the shooter’s knowledge of the cargo release electrical system was not known.

- 3.10 The circumstances indicated that the pilot and shooter were unaware that the cargo hook electrical release switch could be dis-armed readily, and consequently this precautionary action was not taken prior to the flight.

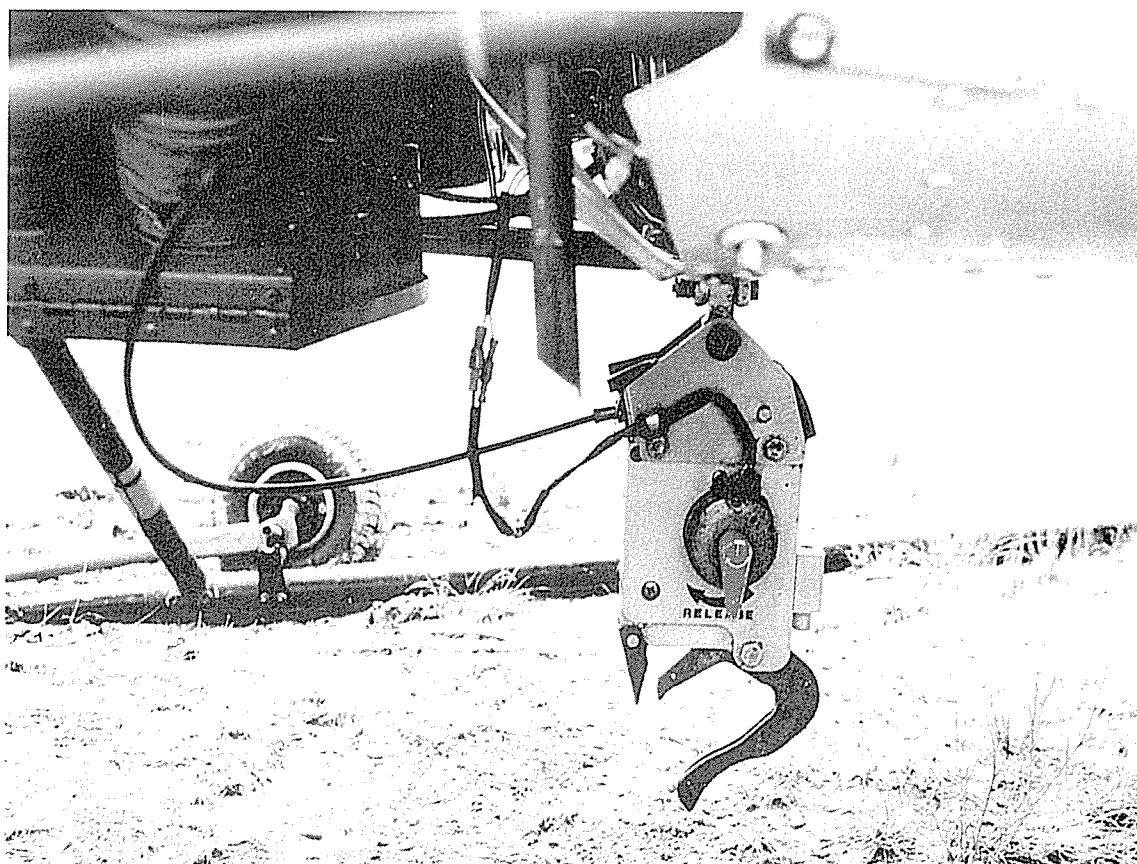
Figure 2
Cargo hook installation (hook open)

- 1.31 When ZK-HUH was examined following the accident the cargo hook was open (see Figure 2). There was no marking or other evidence to indicate that the cargo hook assembly, or its load beam, had been subjected to unusual loading by the strop being mis-positioned or mis-aligned in some manner when it was attached.

- 1.32 Functional tests at the time, with no load on the hook, showed that the hook reset normally, and the electrical and mechanical release systems operated satisfactorily.

- 3.9 No post-accident defect was found in the cargo hook, or the electrical or mechanical release systems, to account for the premature in-flight opening of the hook.

- 3.14 A conclusive cause for the opening of the cargo hook was not established.
