NO 95-106

TRAIN 258

COLLISION WITH PEDESTRIAN

NEAR NGARUAWAHIA

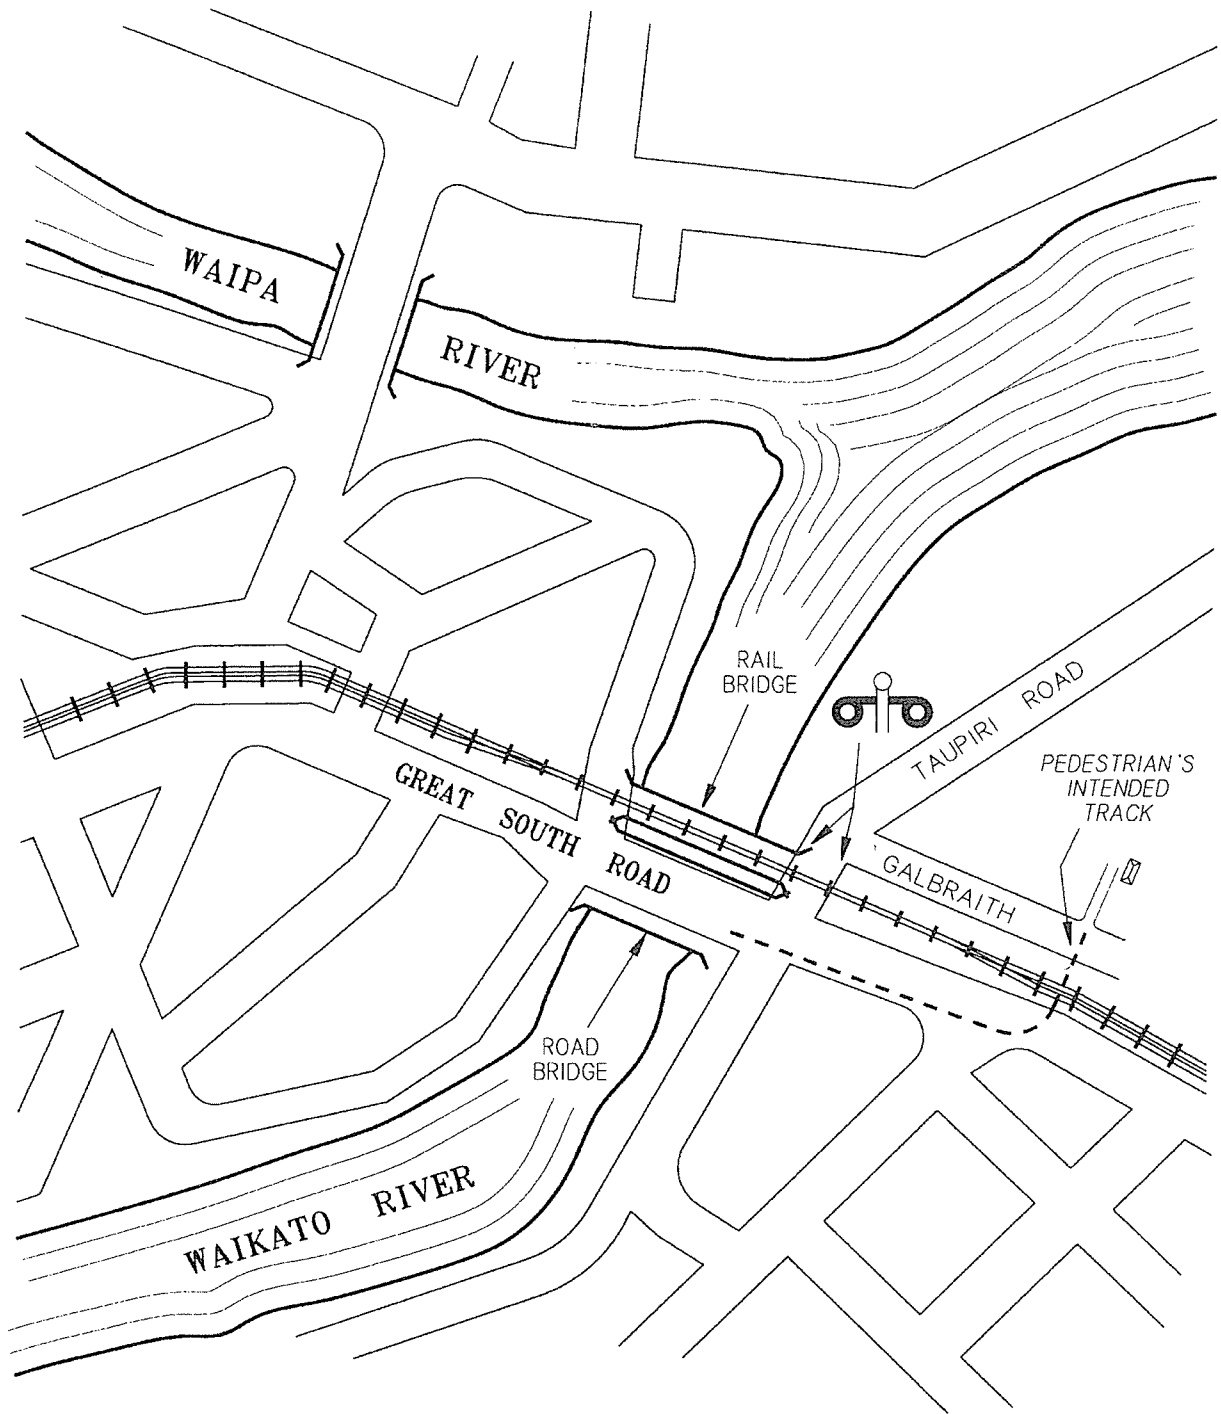
SKETCH OF ACCIDENT LOCATION

- 1.4 The point at which the tracks were crossed is only some 50 m from a road level crossing which is protected by flashing lights and bells. The bells are however time switched not to operate after 2230 hours. Nevertheless there is the normal miniature St Andrews Cross prior to the crossing (to advise the Locomotive Engineer (LE) of a level crossing ahead) and the LE of Train 258 said he sounded the locomotive's horn when he sighted the cross as was his normal practice.

- 1.5 Prior to this point a northbound train is hidden from sight by the steel bridge superstructure and a curve in the line. Information from his family indicated that the pedestrian preferred to cross the tracks to the north of the level crossing as he considered it was less hazardous due to the difficulties in sighting an approaching northbound train. He had similar concerns about sighting northbound road traffic which was hidden by the hump in the road bridge and he therefore believed it preferable to cross both the road and the rail track in line with the driveway to his house. The northern end of the road bridge is almost due west of the northern end of the rail bridge.

- 1.6 While it would be human nature for the victim to have stayed with his friends and walked until he was opposite the entrance to his home before crossing the unfenced tracks, the level crossing nearby would have provided a surer footing and crossed a single line only. In addition the crossing was well lit by a number of street lights whereas the probable path of the pedestrian was in the shadow of a group of trees and across an area of poor footing for a pedestrian where the single line branched into double track.
