NO. 95-109

TRAIN 860

RUNAWAY WAGON

TRANSPORT ACCIDENT INVESTIGATION COMMISSION

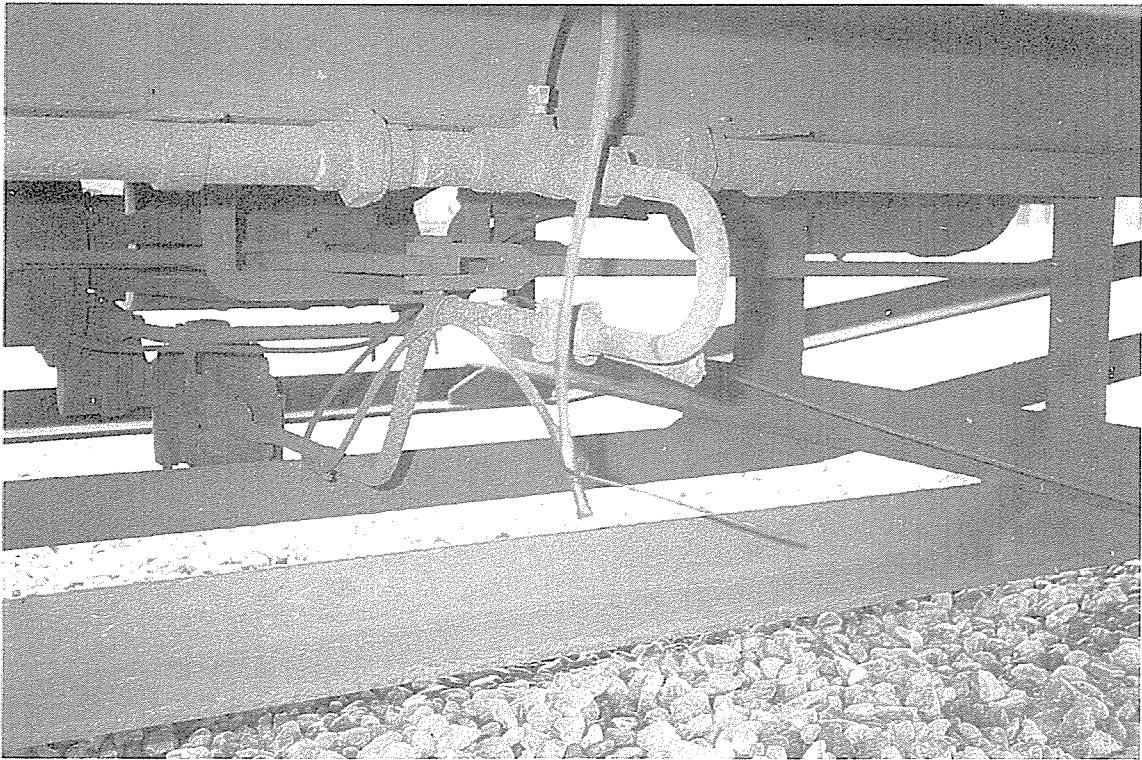
Fig. 1
Underside of wagon UR 3683 showing crimped and tied nylon tube

- 1.15 Investigation and testing of wagon UR 3683 revealed substandard temporary repairs had been carried out involving the crimping and tying of a leaking 10 mm diameter nylon tube feeding train pipe air to the release valve. (Fig. 1) This had rendered the brakes on the wagon inoperative.

- 1.20 The original leak in the connecting tube did not affect the operation of the release valve as there was sufficient train pipe pressure to overcome the leak and reseal the valve. As soon as the tube was crimped and tied there was no means of resealing the release valve following the first discharge of the auxiliary reservoir thereafter. Thus whenever train pipe pressure was applied there was a major air leak from the unsealed release valve as it vented air from the triple valve which was intended to recharge the auxiliary reservoir. As the auxiliary reservoir did not recharge brake application was not possible.

- 2.4 The parting of couplings and detachment of wagon UR 3683 was a predictable result of such a derailment.
- 2.5 The failure of the brakes to apply on wagon UR 3683 was the result of substandard repairs to the wagon's braking system.

- 3.3 All Depot Managers were advised of the details of the original substandard repair and the result of that repair. A specific follow-up with all maintenance staff was made to reinforce the need for compliance with procedures for marking up vehicles with temporary repairs for attention at the earliest opportunity and certainly not later than the completion of the trip.
