**WHARF SHUNTING SERVICE
COLLISION WITH FRONT END LOADER
KINGS WHARF, WELLINGTON
18 MAY 1995**

RAIL ACCIDENT REPORT NO. 95-110

Train Type and Number:	Wellington Wharf Shunt
Date and Time:	18 May 1995, 0710 hours
Location:	Kings Wharf, Wellington
Type of Occurrence:	Collision with front end loader
Persons on Board:	Shunt: 2 Front End Loader: 1
Injuries:	Shunting Crew: 1 Serious
Nature of Damage:	Minor damage to locomotive and front end loader
Information Sources:	Transport Accident Investigation Commission field investigation
Investigator in Charge:	R E Howe

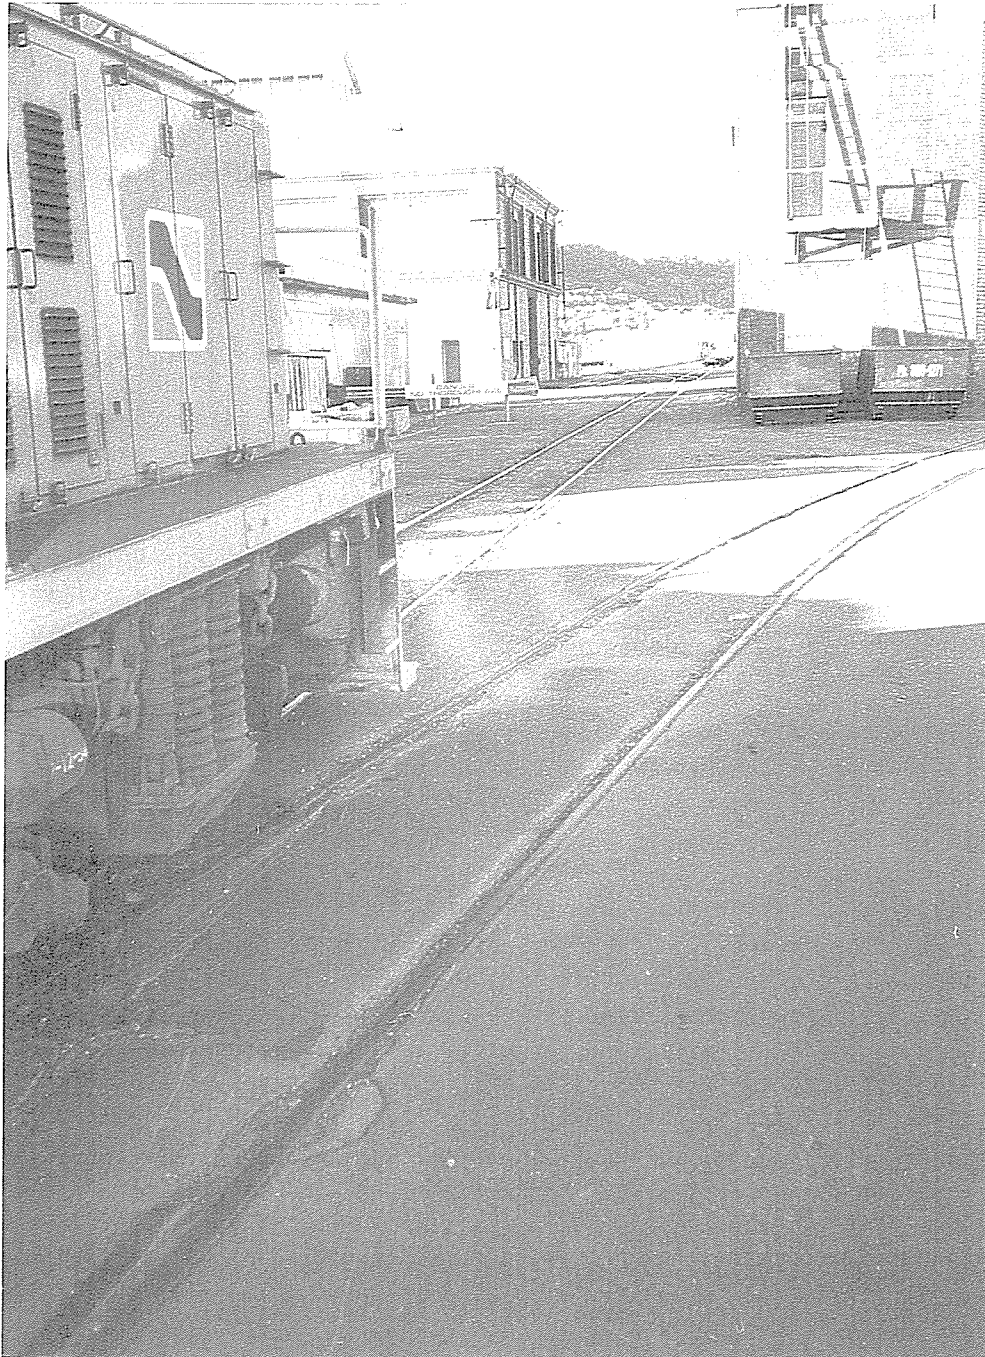
- 1.9 At a point approximately 18 m from the point of impact, the RCO saw the front end loader bucket appear on the left hand side of the track from behind the Maritime Building and moving towards the track. He realised the bucket was foul of the track, and his standing position, and immediately took evasive action by turning his back on the front end loader as he climbed over the buffer and took hold of the handrail on the opposite side of the locomotive.

Fig. 1
General view of the approach to the point of impact looking South
towards Kings Wharf
(RCL in position it stopped)

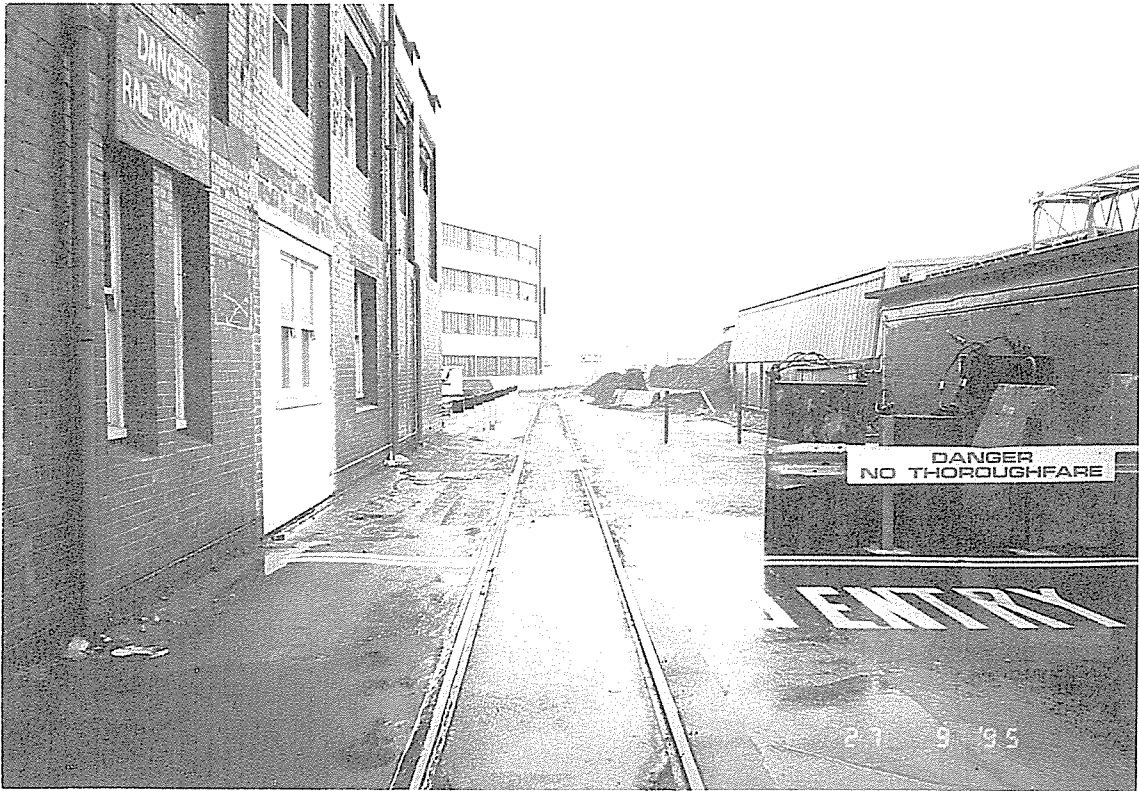
Fig. 2
General view looking North towards the impact point
from Kings Wharf level crossing
(Taken following the erection of the barrier fence)

- 4.1.1 The bark pile has been pushed back from the rail track and a drainage channel has been formed.
 - 4.1.2 A one metre high permanent Armco barrier has been erected between the rail track and the adjacent sealed area (a temporary barricade was erected immediately following the accident).

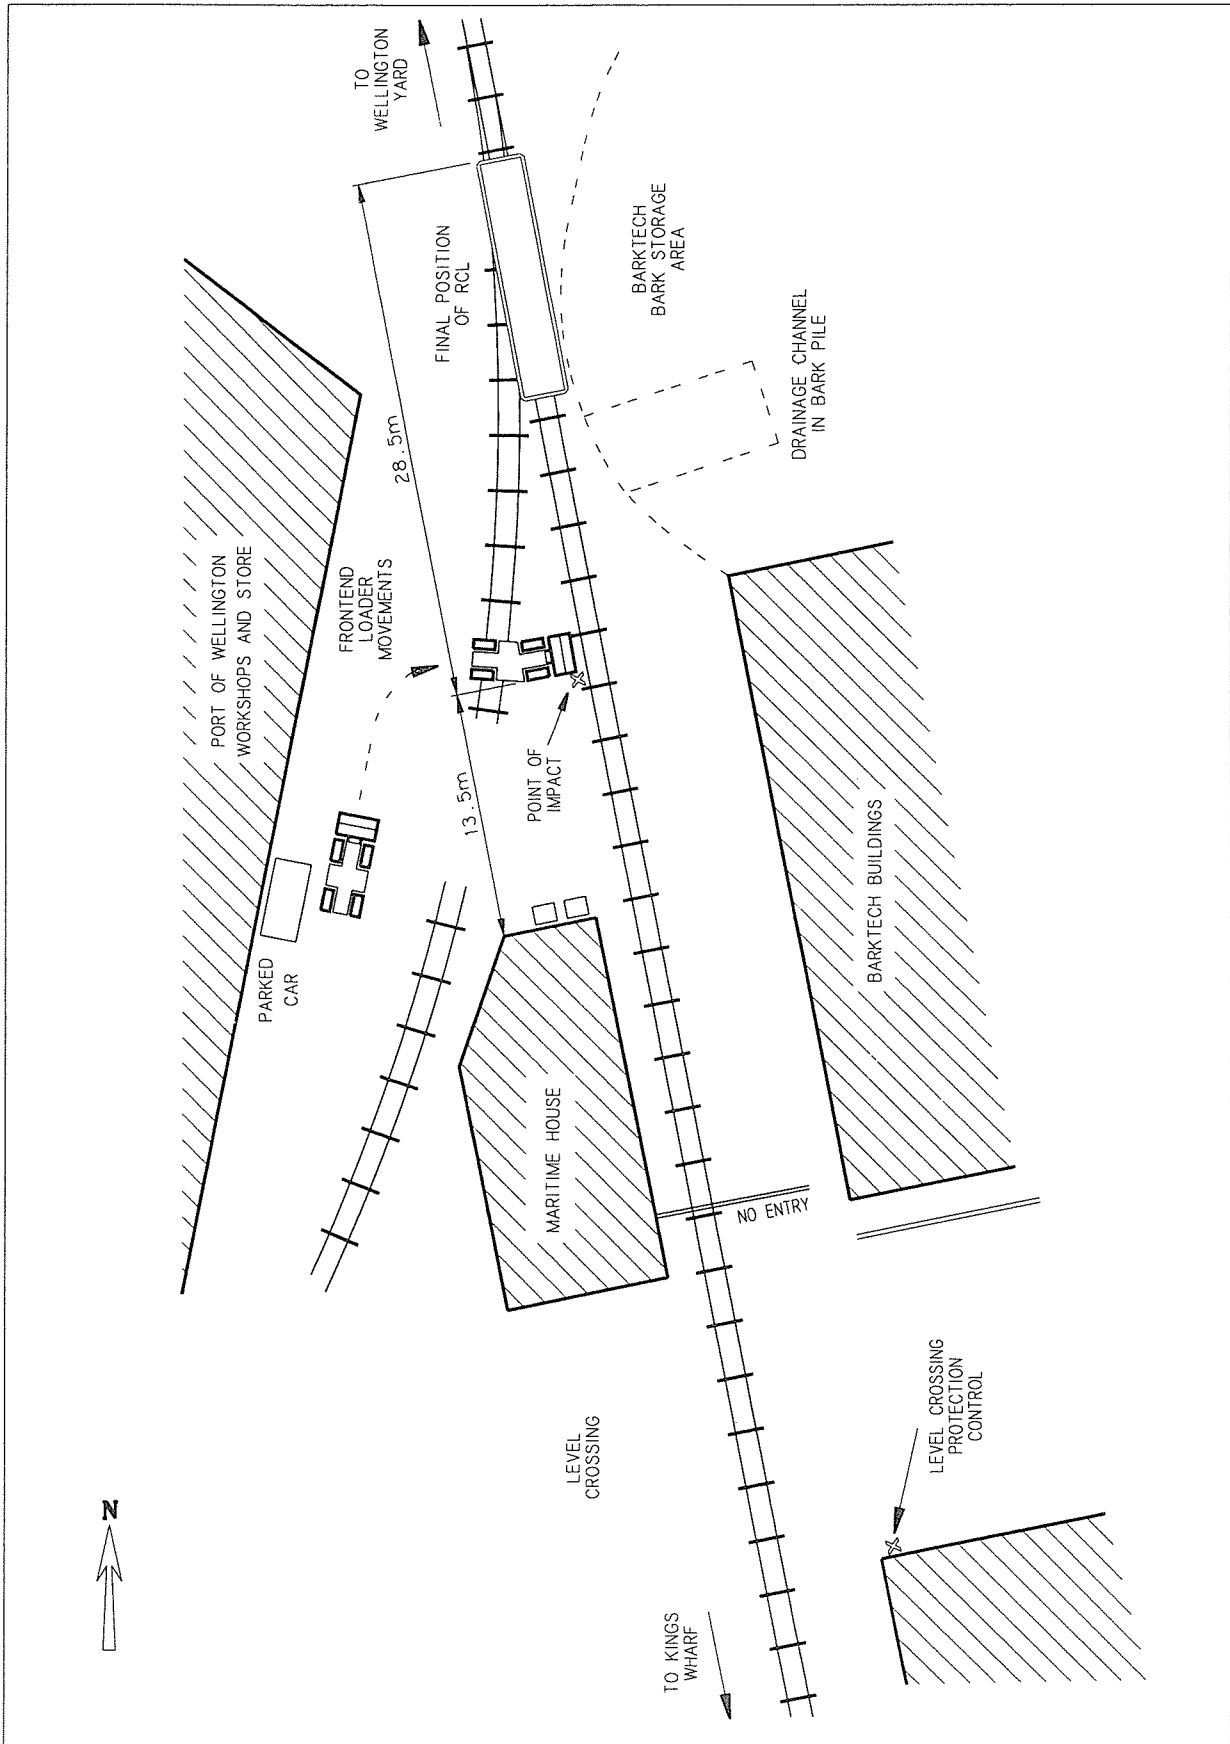
Fig. 3
 Layout Plan
 (Not to Scale)

- 1.14 On the morning of 18 May 1995 he had commenced his shift at approximately 0700 hours. On picking up the front end loader from its storage site he had driven it to the store, approaching from the south, and parked adjacent to it (refer Fig. 3). The front end loader headlights were not on but a flashing orange light on the cab roof was operating.

- 1.17 Eye witness reports and impact marks on the front end loader indicated that when stopped the front end loader was aligned skewed clockwise to the track (refer Fig. 3).

- 2.26 It was apparent that front end loader movements with the potential to foul the shunting leg were relatively common in the vicinity of the point of impact.

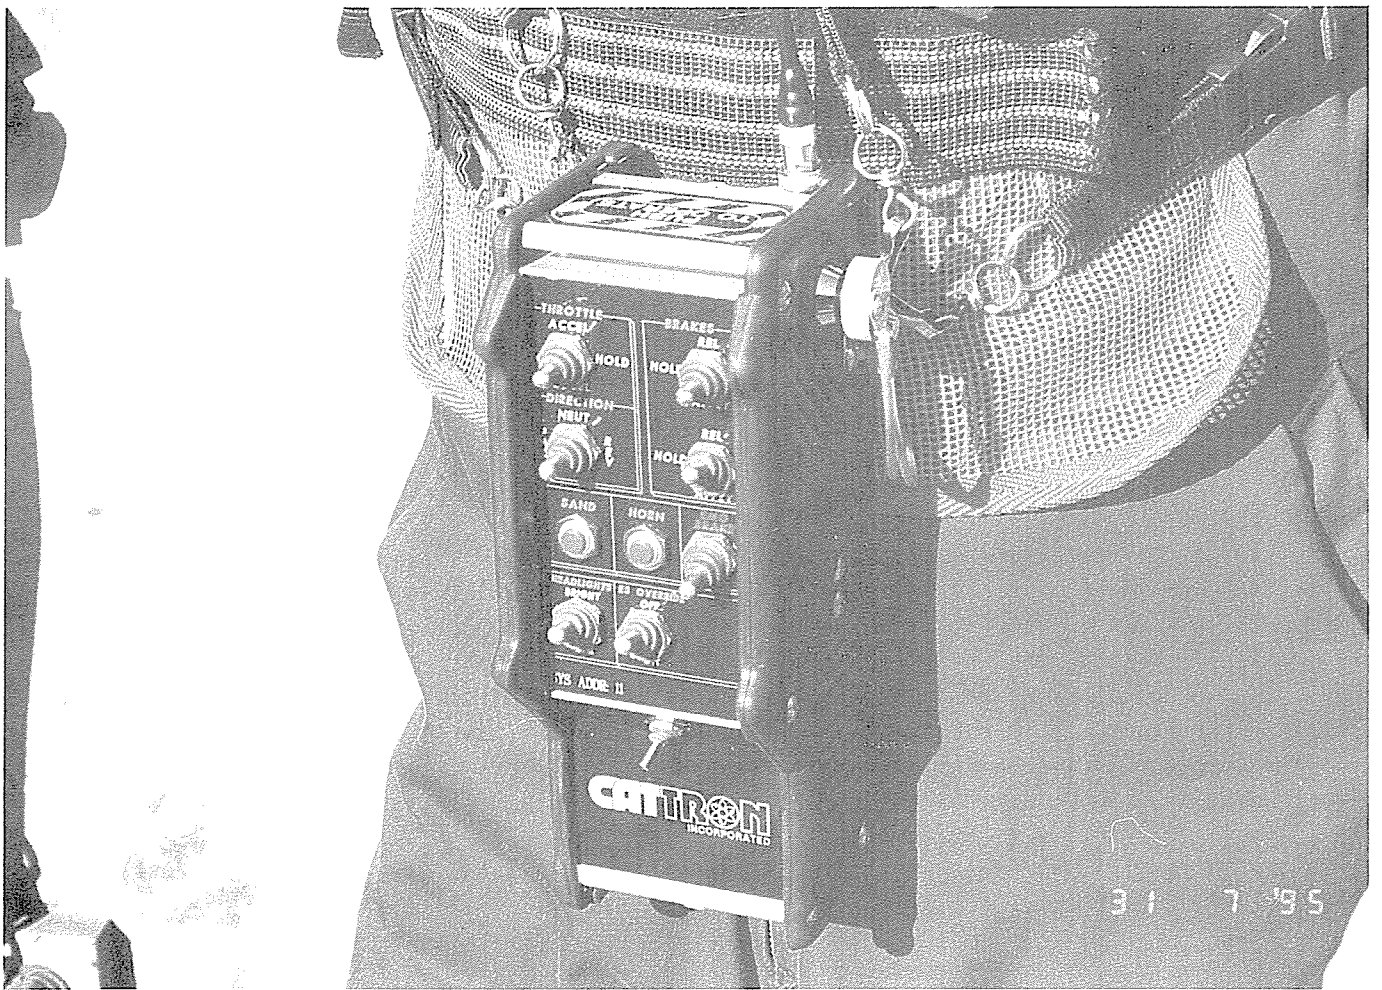
Fig. 4
Transmitter Control Box for Remote Controlled Operation

- 2.7 The main feature of the transmitter control box relating to this accident was the functioning of the PTO. The PTO must be depressed to operate the throttle and to release locomotive and train brakes. If the PTO is released the throttle will immediately dump to idle and the locomotive brakes will begin to apply.

- 2.9 The transmitter control box in use on the day of the accident was damaged and inoperable following the collision. The position of all control levers on the recovered box were consistent with the operation of the RCL prior to the impact based on the RCO’s reported action of releasing the PTO when taking evasive action, with the exception that the emergency brake control was in the “applied” position. This switch is not spring loaded and its position is considered to be a result of the damage suffered following impact.

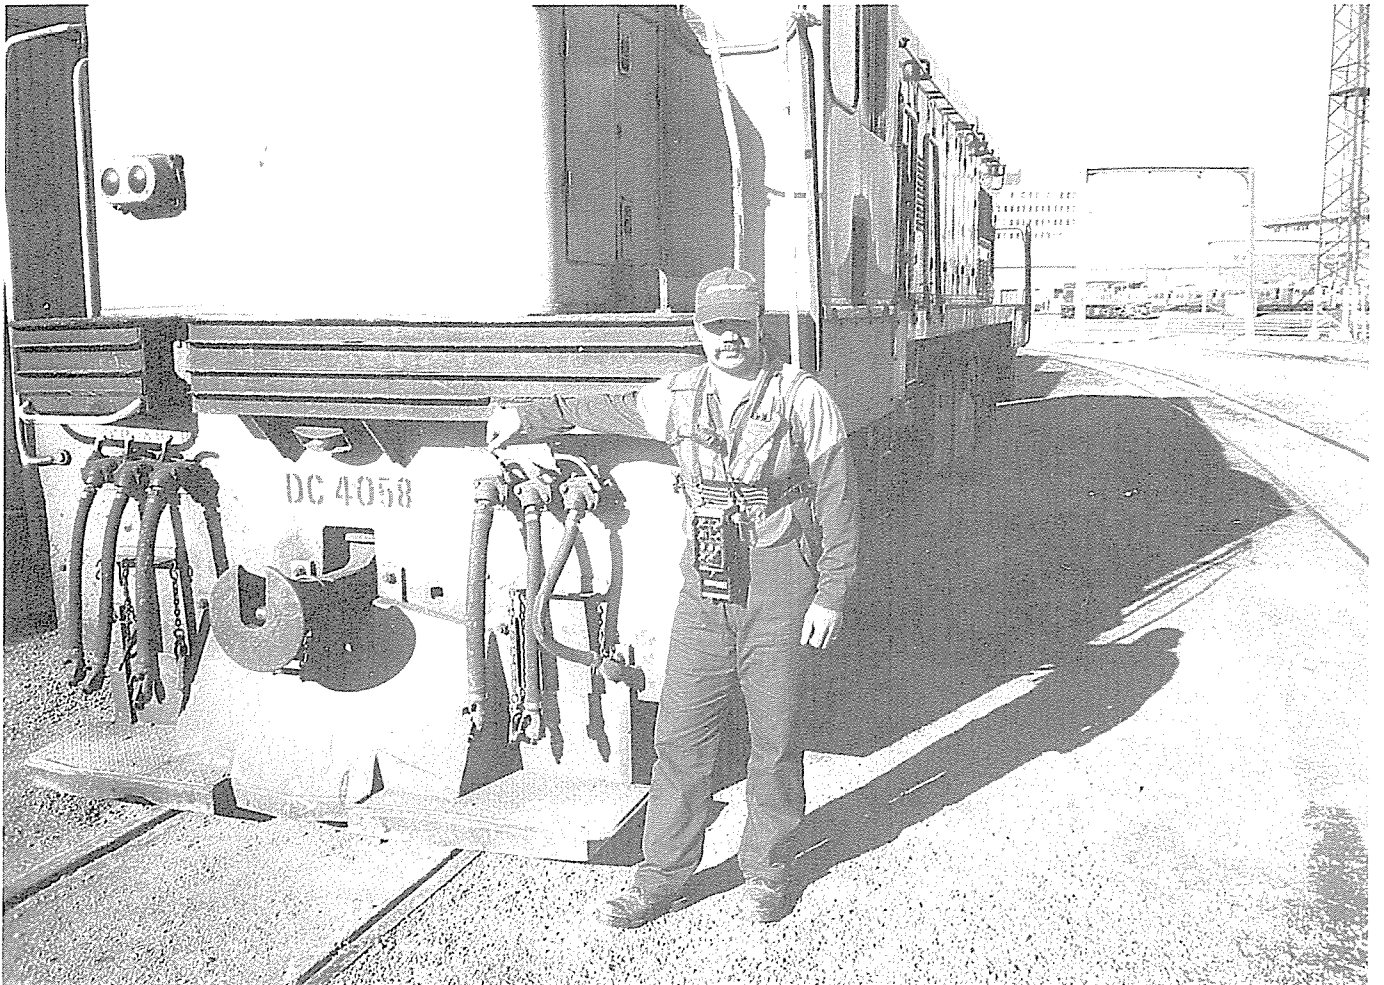
- 2.5 Remote controlled operation is based on controlling a locomotive using a radio transmitter (Fig. 4). As used on NZRL the transmitter is mounted on a high visibility chestpack worn by the RCO (Fig. 5).

Fig. 5
Chestpack mounting of controls for Remote Controlled Operation
