No. 95-111

Q2 Shunting Service

Gracefield

Rail Accident Report No. 95-111

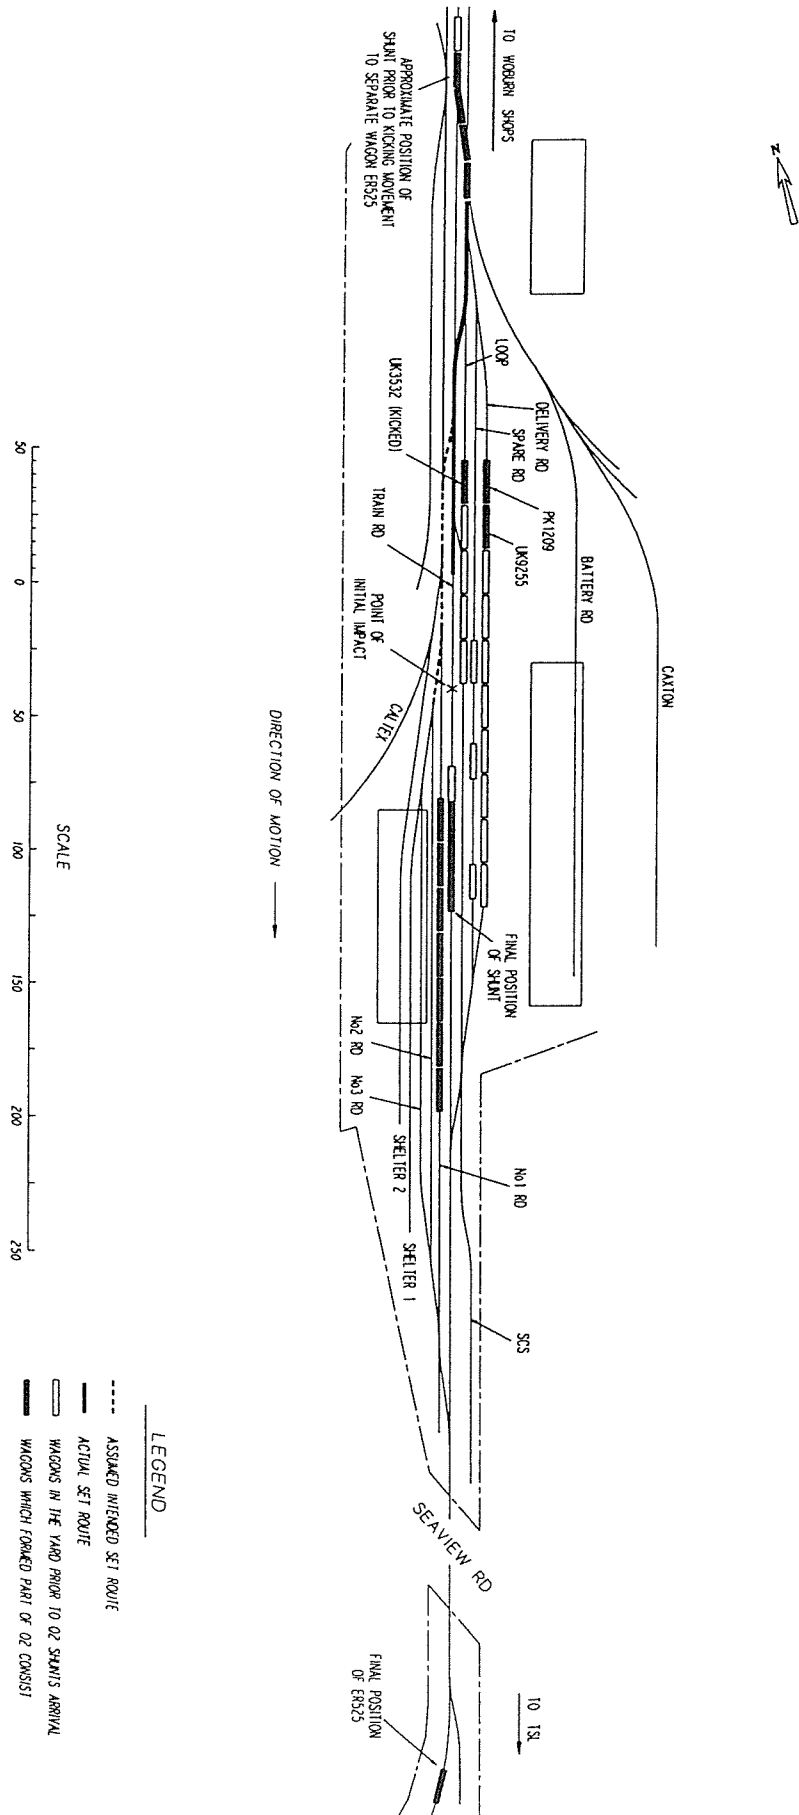
Figure 1

- 1.3 At 0730 hours the crew commenced breaking up the shunt and placing the wagons brought out from Wellington to their respective destinations.
- 1.4 A plan of the accident scene, including the general layout of the track work at Gracefield yard defining these destinations, is shown in Figure 1.

- 1.5 Prior to commencing the movement which preceded the accident, the shunt service was at the north end of the yard with the locomotive on the train road (refer Figure 1). The LE's driving position was on the east side, ie, on the left hand side in the direction of the proposed movement.

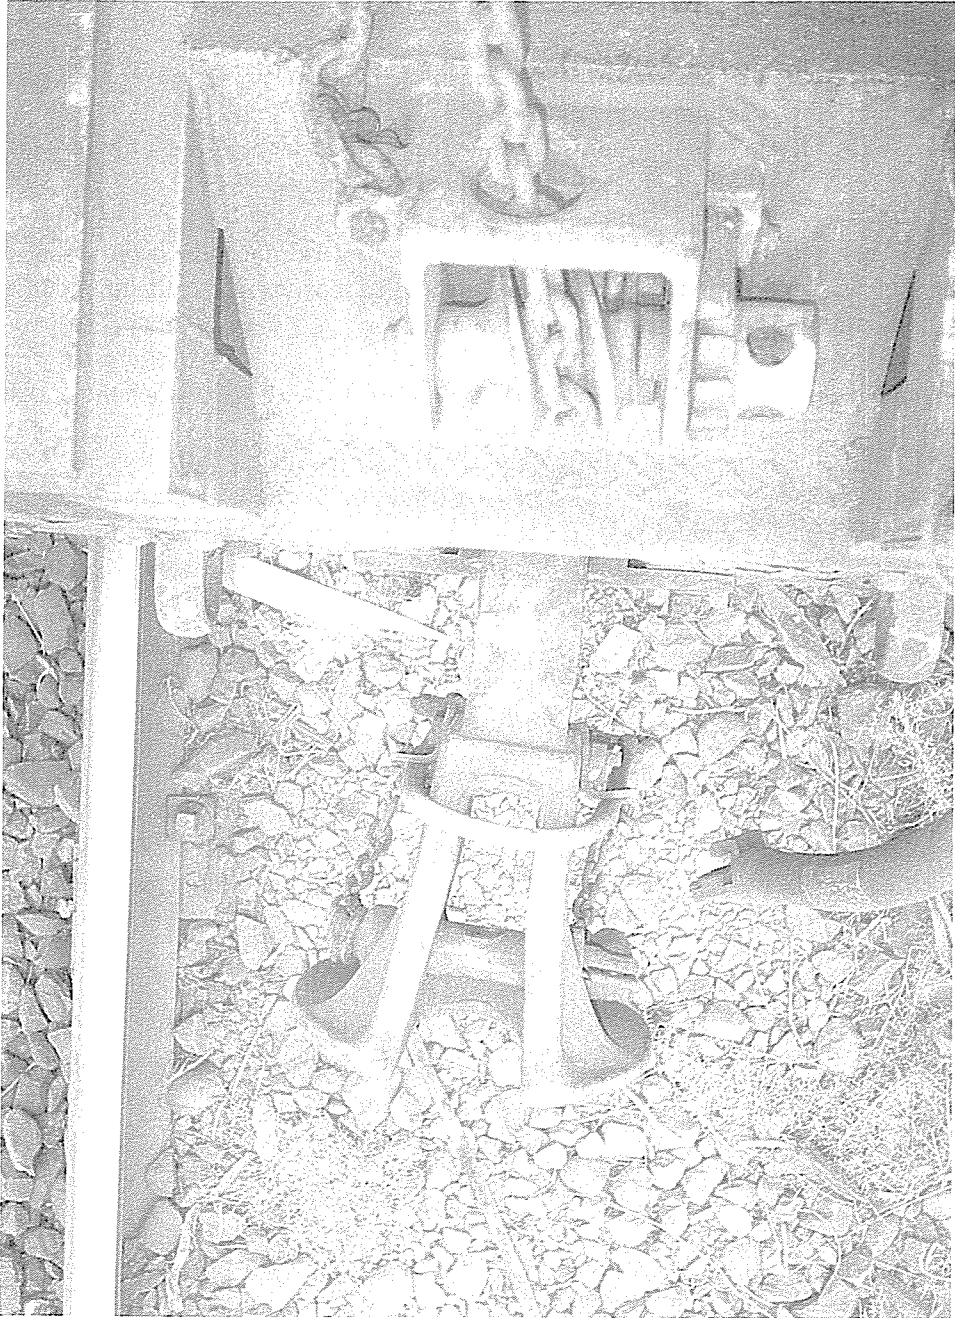
Figure 2
Bent drawbar on wagon ER525

Although 9.3 does not define “bent” there is general agreement amongst NZRL mechanical engineering staff that the bend in the drawbar of ER525 was such that it should have been withdrawn from service for repair i.e. “bad ordered” (Figure 2). The Depot Manager’s Field Inspection Form for ER525 following the accident classed the buffer as “unserviceable”.

- 2.17 ER525 had last been in the Depot on 1 May 1995 at which time minor repairs had been carried out and tests and services undertaken before a Certificate of Inspection was issued. There is no way of determining whether the bent drawbar had been in that condition on 1 May 1995

- 2.19 The NZRL code covering drawgear condition was revised in July 1995. The re-issue had no requirements relating to bent drawbars. The operator is taking steps to address this omission and to define limits of bend in buffers as detailed in this report Section 5, Safety Actions.

- 5.3 As a result of liaison during the course of the investigation the Mechanical Code is being amended to include a requirement to detect and set limits for bent drawbars and to clarify the intent of the code to measure drawbar heights under tare conditions.
- 5.4 The operator has issued instructions to prevent the painting of footsteps and the top surfaces of handbrake levers and to “bad order” any wagons found in this condition to have the paint burnt off. Full painting of handrails and handgrips will continue as in the past and a reminder instruction has been issued to all mechanical depots to confirm the practice.
- 5.5 The identification of loose shunting has been addressed and amended in the detailed mastery test associated with recertification and compliance tests.

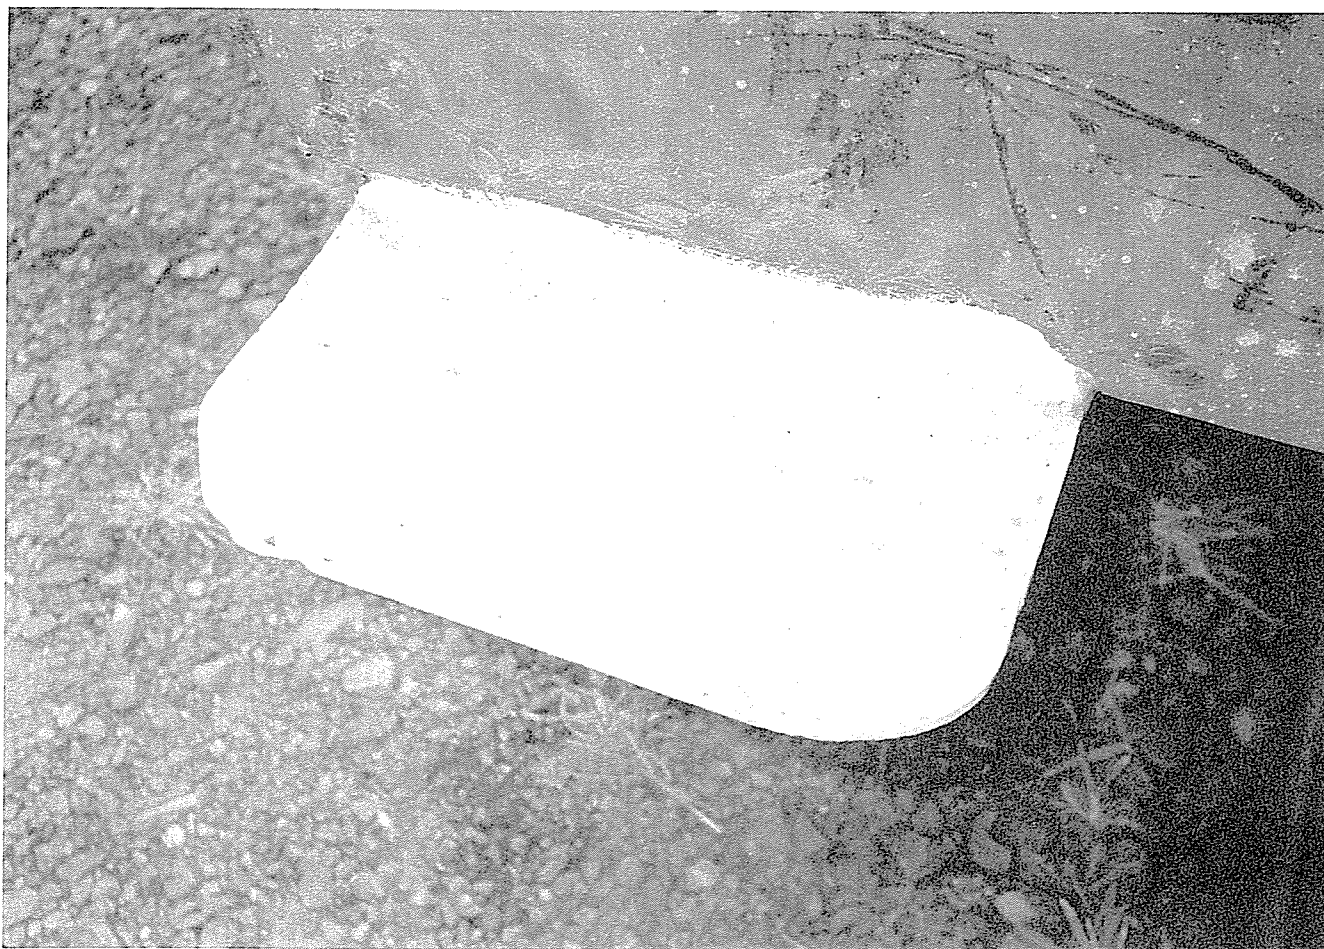
- 2.20 The painting of the footstep on ZP14796 reflected a recent relatively widespread NZRL practice of painting footsteps, handbrake levers, handrails and hand grips to make them stand out and be seen easily by Operating staff. This came into effect without formalisation and despite specific requirements in wagon upgrade or major repair specifications not to paint footstep tread surfaces and the detailed painting and lettering and stencilling diagrams for specific wagons which restrict painting of surfaces such as the top of footsteps and the top surface of handbrakes. The operator has taken steps to correct this situation as detailed in the this report Section 5, Safety Actions.

- 2.21 The paintwork on the footstep of ZP14796 was relatively new and had not worn through on the raised grip providers (Figure 3). It is difficult to assess what effect, if any, this may have had on the RO’s footing.

Figure 3
Painted footstep on ZP14796
