No. 95-112

Te Rapa North Shunt

Frankton

31 May 1995

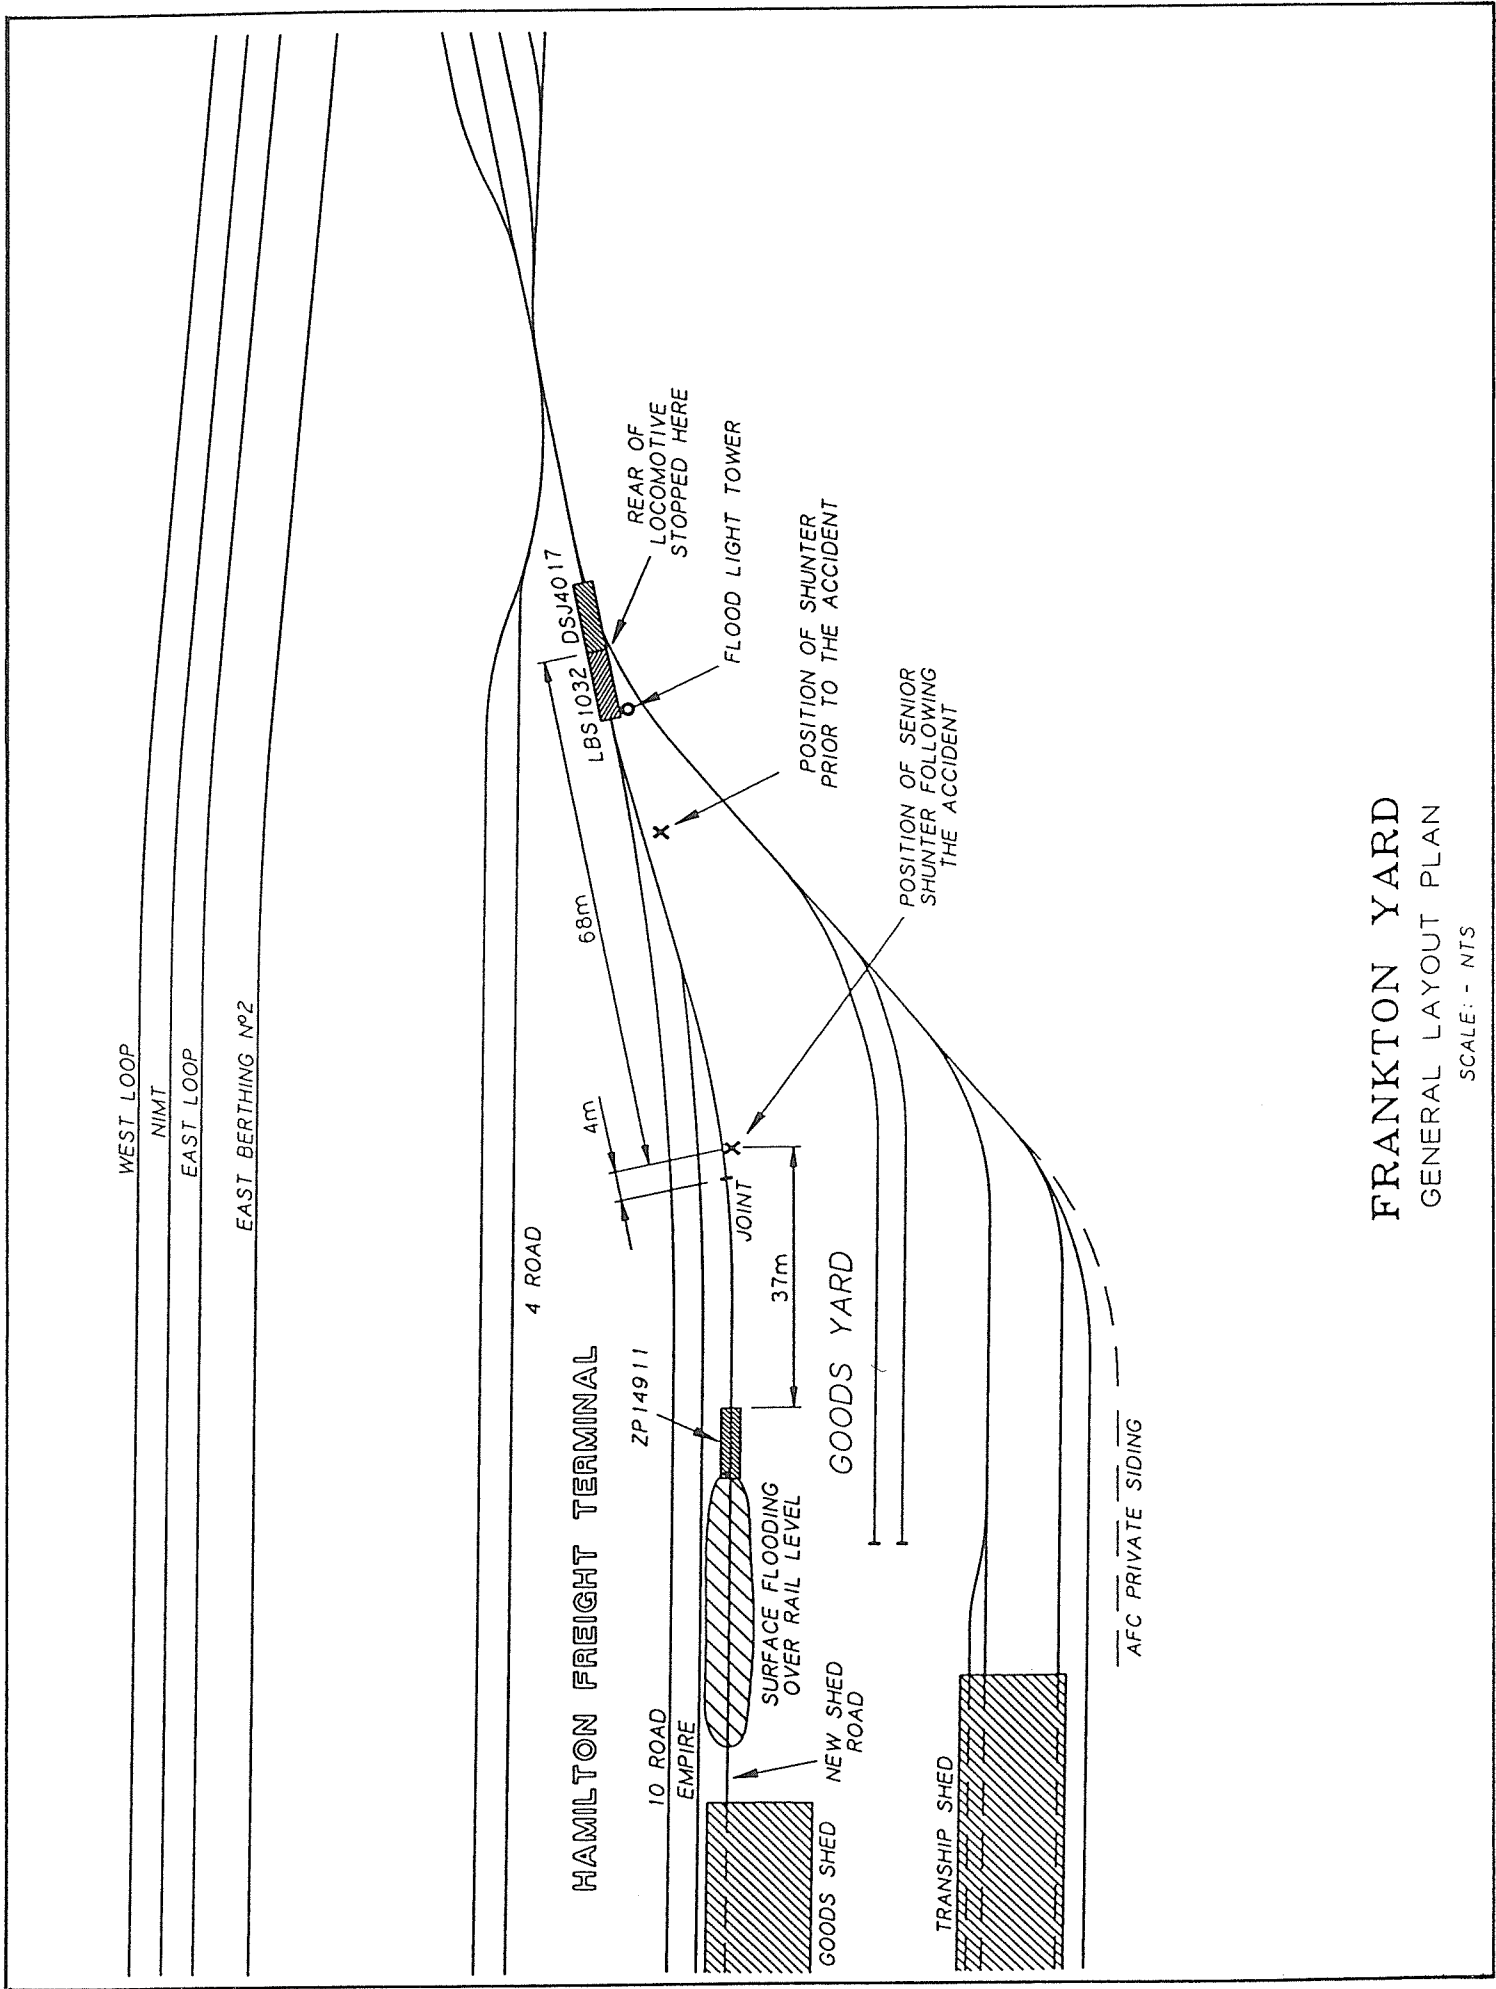
Figure 1

FRANKTON YARD
 GENERAL LAYOUT PLAN
 SCALE: - NTS

- 1.18 The wet weather had resulted in extensive surface flooding over the south end of the New Shed Road (refer Figure 1) with standing water above rail level.
