No. 95-114

Y3 Shunt

Ravensbourne

Rail Accident Report No. 95-114

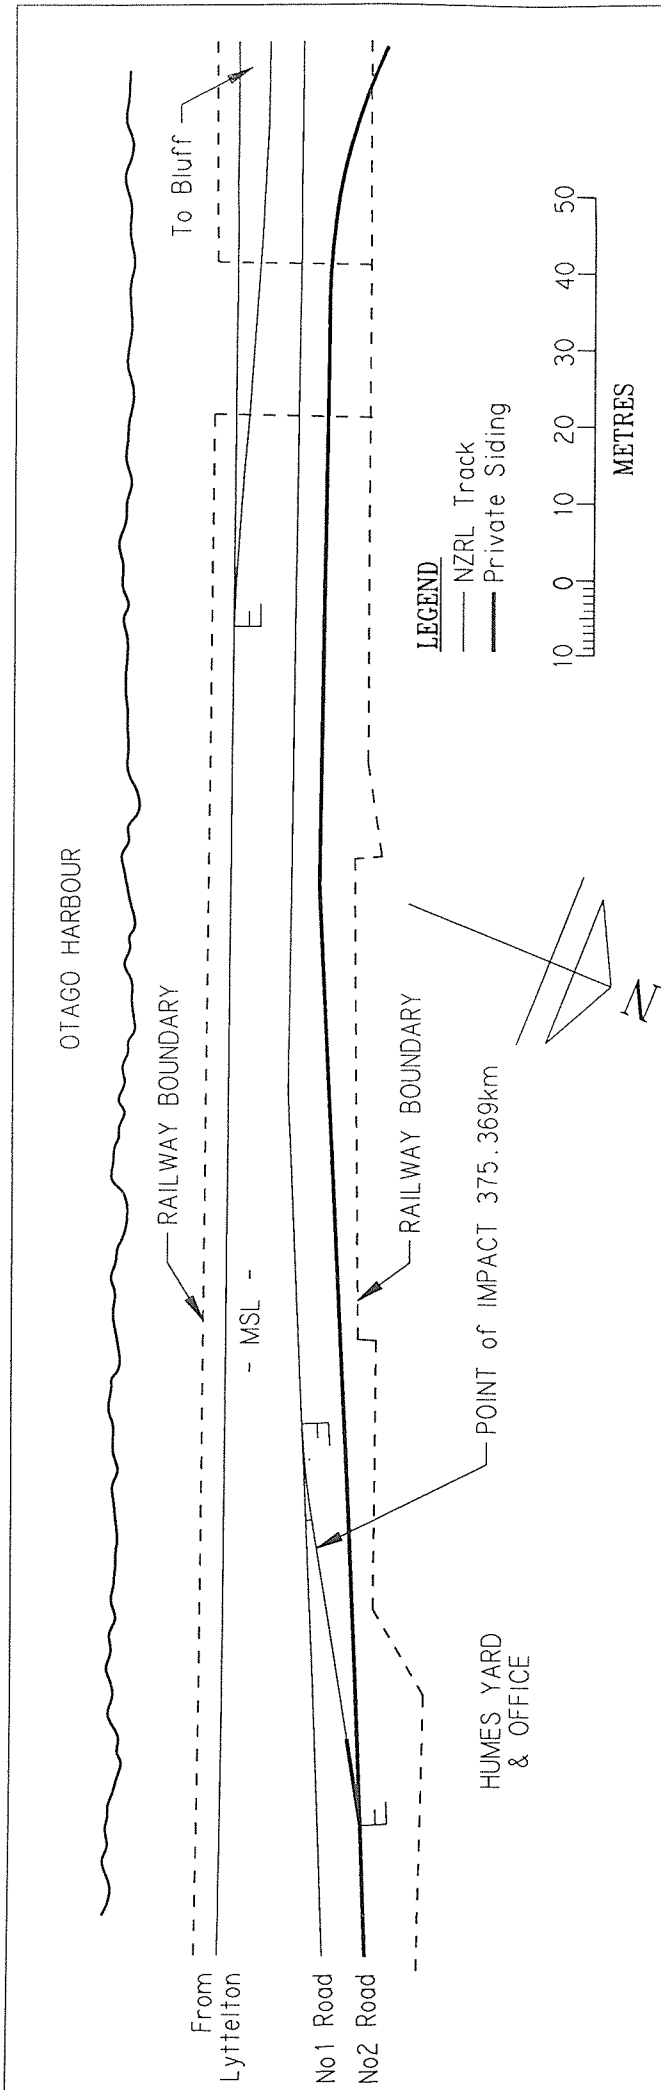
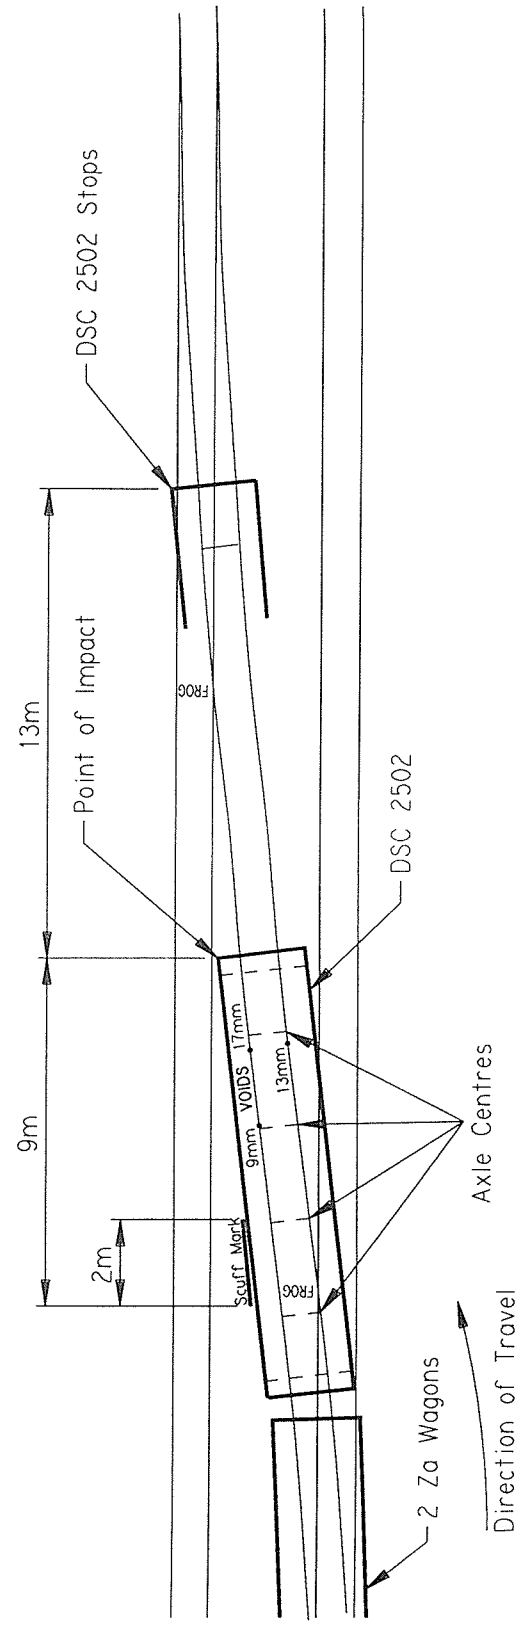
Figure 1

- 1.3 A plan of the accident scene is shown in Figure 1.
- 1.4 As the locomotive negotiated the crossover between No. 2 Road and No. 1 Road the left hand side of the footplate caught under the head of the rail of the converging track.

- 1.28 The point of impact occurred on track owned and maintained by NZRL although the shunt had just travelled through a turnout forming part of the siding servicing Ravensbourne Fertiliser Co-operative Limited (refer Figure 1).

- 1.30 The private siding (northend) turnout was installed with second-hand materials in 1992. It was a 1 in 7½ turnout (sharp angle) and replaced a 1 in 9 turnout (shallow angle). Reports indicate that the replacement in this manner resulted in a reduction in the crossover length from 17 m to 15 m approximately. The nominal ascending grade through the crossover was approximately 1 in 120 although due to the low and moving track an effective grade of 1 in 60 applied over 8 m just prior to the impact point.

- 1.32 Movement under load indicated by the tests referred to in paragraph 1.26 above prompted a full measure-up of track geometry including vertical movement (voiding) under load. This showed a low uneven and moving joint 5 m prior to the point of impact. The right rail was approximately 45 mm lower than desirable to transition smoothly from No. 2 Road to No. 1 Road with a further 9 mm voiding. The left rail was correspondingly 60 mm lower than desirable with an additional approximate 7 mm voiding. The track was thus low and

effectively canted 13 mm to the left (towards the adjacent No. 1 Road) under load. Similar measurements taken approximately 2.5 m prior to the point of impact showed:

- 1.40 A recent impact was indicated by a fresh heavy score mark on the outside web of the right rail on No. 1 Road. This score mark ran from opposite 375.369 kilometres Main South Line for 2 m towards the point where the right rail of No. 1 Road and the left rail of No. 2 Road met and crossed (frog of the turnout). It started 1.2 m from the centre line of No. 2 Road which is the distance to the outside edge of the shunters' footplate on a DSC locomotive.
- 1.41 Between 7 m and 9 m prior to the impact point a recent deep scuff mark was found in the ballast on the left hand side of the crossover road, parallel to it, and approximately 1.1 m to 1.2 m from the centre line of the crossover road.
- 1.42 The rear shunters' footplate on DSC 2502 showed signs of ballast dust on the lower horizontal surfaces.

- 3.6 The low and voiding track on the crossover road approaching No. 1 Road allowed the left hand leading edge of the shunter's footplate on DSC 2502 to enter under the head of the right rail on the adjacent No. 1 Road.

Develop appropriate track maintenance standards and inspection procedures governing the relative heights of converging lines. (083/95)
