Report 95-121

Runaway Wagons

Raupunga (near Wairoa)

11 December 1995

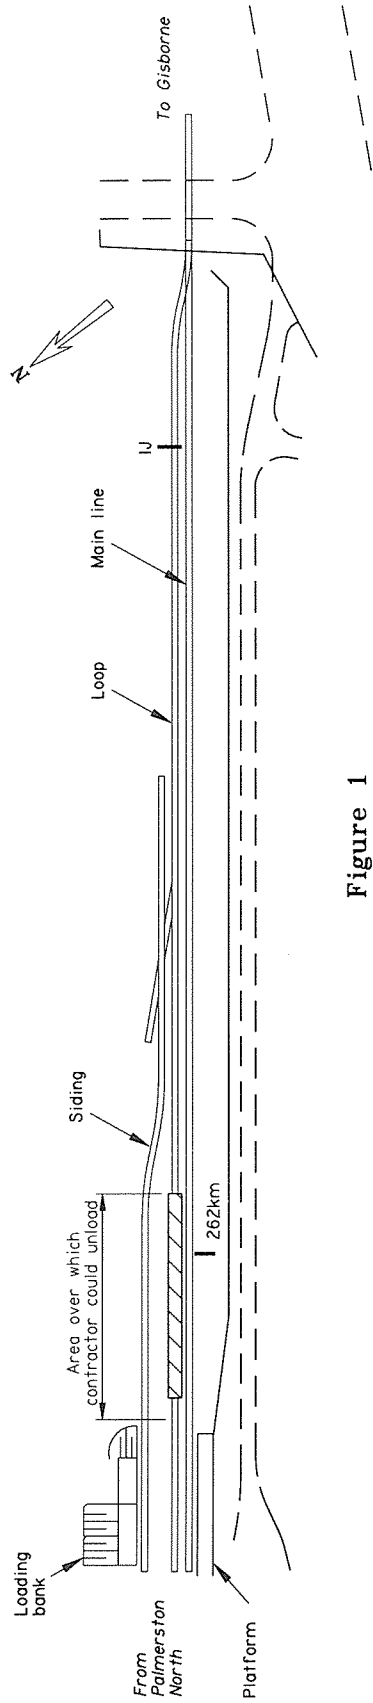
Figure 1
7 wagons as placed 5/12/96

- 1.3 TRL had placed 27 loaded wagons into Raupunga loop prior to unloading commencing. Seven of these wagons were placed on 5 December (refer Figure 1) and at time of placement were reported as having three handbrakes applied and a piece of wood placed under the wheel at the north end. On 8 December a further 20 wagons were placed into Raupunga from the north end by train 664. The locomotive engineer (LE) doing the ground shunting for train 664 watched the rake¹ of 20 contact the seven standing wagons and was sure the hook had dropped, although he did not specifically check that this was the case. To enable the locomotive of train 664 to clear the insulated joint (IJ) at the north end and thus switch off the level crossing alarms the LE stated it was necessary to propel the original wagons approximately 25 m south. The LE on the ground noted there were three handbrakes applied on the original seven wagons and then applied the first three handbrakes at the south end of the rake of 20 dropped off. Air brakes were reported as applied before the rake was uncoupled. The final position of the 27 wagons as reconstructed from reports is shown in Figure 2.
