Report 95-122

Train 2650

Taita

Rail Incident Report 95-122

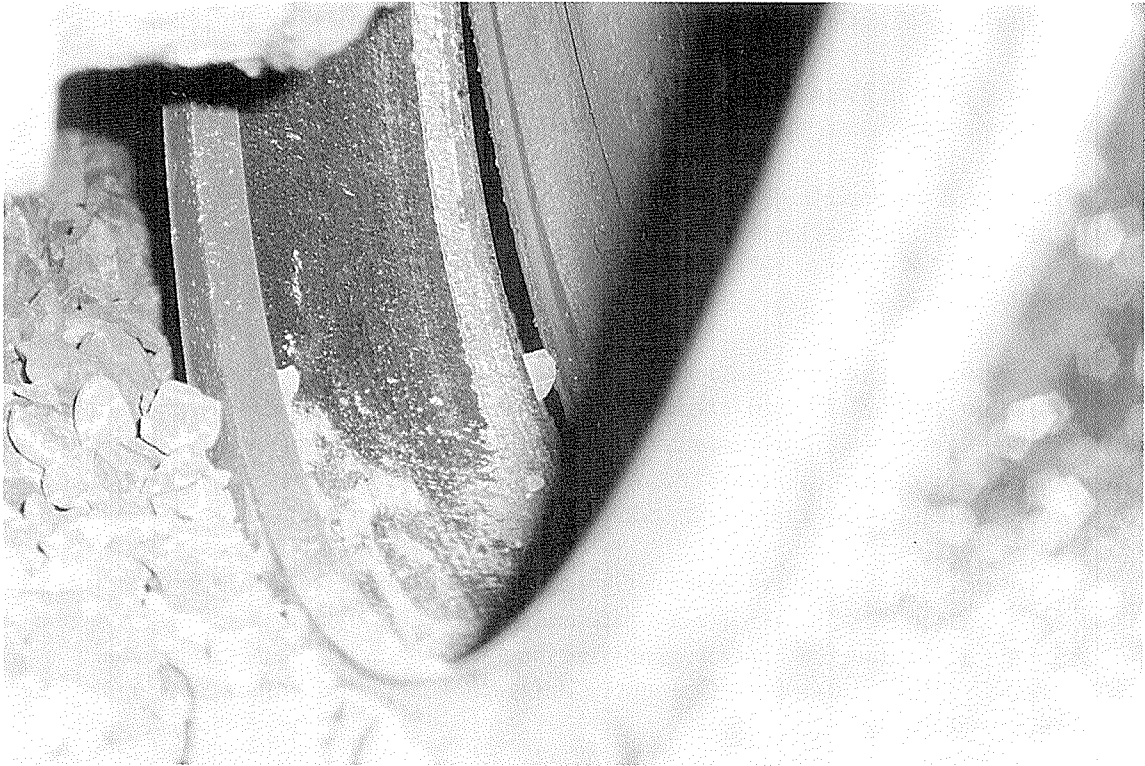
Figure 1

- 1.10 EM 1494 came to rest with the four wheels of the trailing bogie derailed to the right in direction of travel. The tyre on wheel B2 (the right hand wheel on the leading axle of the trailing bogie) had separated from the wheel and was displaced to the right. (Figures 1 and 2.)

**Wheel B2 on EM 1494 from RHS in direction of travel
(derailed to RHS with tyre displaced to the right)**

- 1.11 The tyre was fitted with a standard Gibson Retaining Ring, which is a circular split locking ring fitted to the tyre to inhibit its lateral movement on the wheel for a period of time should the shrink fit lose its clamping force. After the derailment the Gibson ring was found to be heavily worn and no longer restrained the tyre.

- 3.1 The derailment was caused by the loose tyre on wheel B2 being able to move laterally on the wheel and take the wrong road at a crossing nose.
- 3.2 The tyre was able to move laterally because the relative movement of the wheel on the tyre had resulted in the wearing away of the Gibson Retaining Ring.

5.1.1 Introduce procedures to record and retain all details of the fitting of new tyres for a minimum period of 10 years. (025/96)

5.1.2 Give priority to developing a suitable solid wheel option to replace tyred wheels on Electric Multiple Units. (038/96)

5.1.3 Review the periodicity and suitability of pit inspection to detect loose tyres on Electric Multiple Units before lateral movement on the wheel is possible. (039/96)

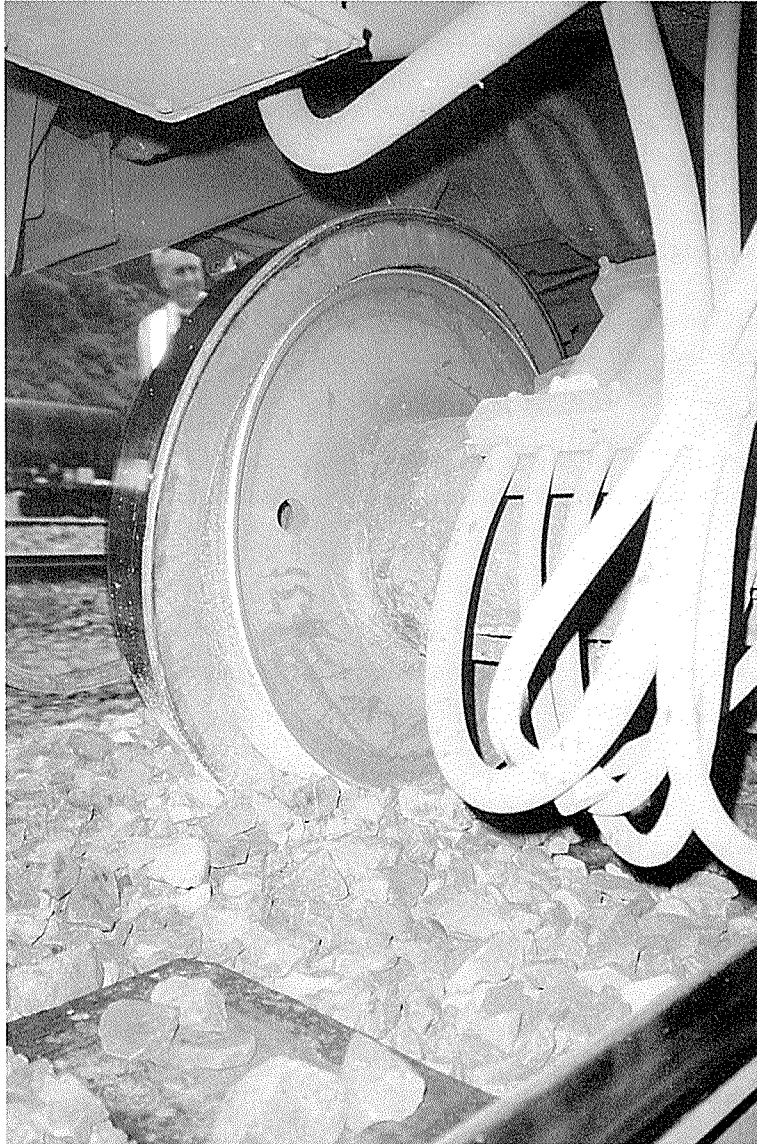
Figure 2

**View of wheel B2 on EM 1494 from LHS in direction of travel
(tyre displaced fully off the wheel to the right)**
