No. 95-123

Collision Between Hi-Rail Vehicles

Maxwell

18 December 1995

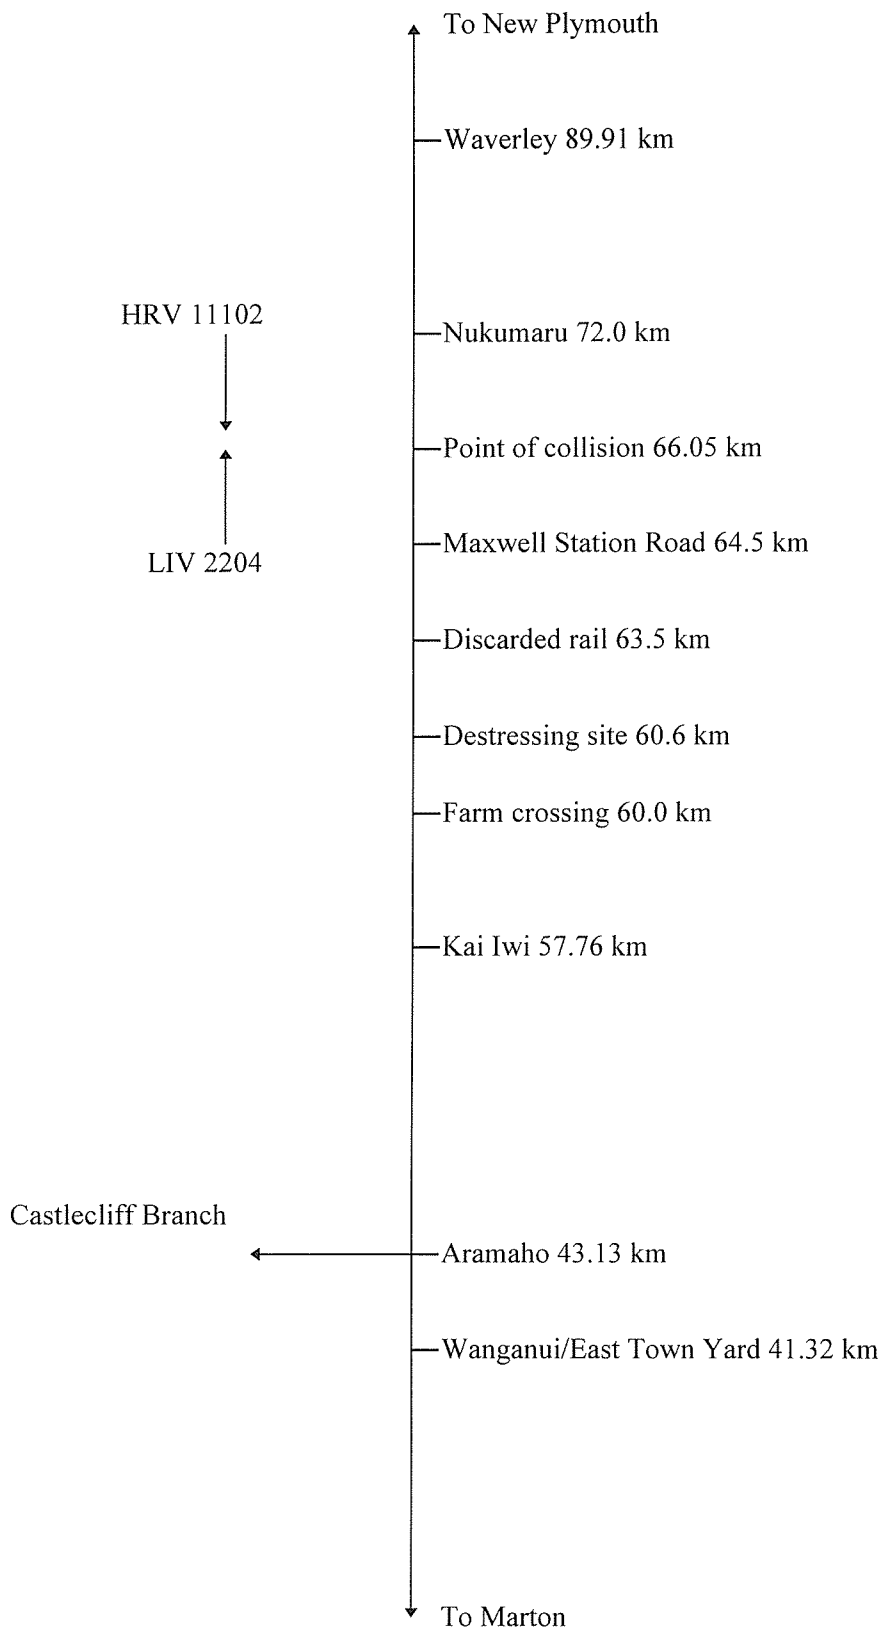
Figure 1
Relative positions on Marton - New Plymouth Line
(not to scale)

All sections of the line referred to are in Track Warrant Control territory. (See Figure 1 for a diagrammatic layout of the relevant points.)
