**NO. 95-202**

**BULK CARRIER MV. *ALLTRANS* VKBE**

**PORT OF BLUFF**

## MARINE ACCIDENT REPORT NO. 95-202

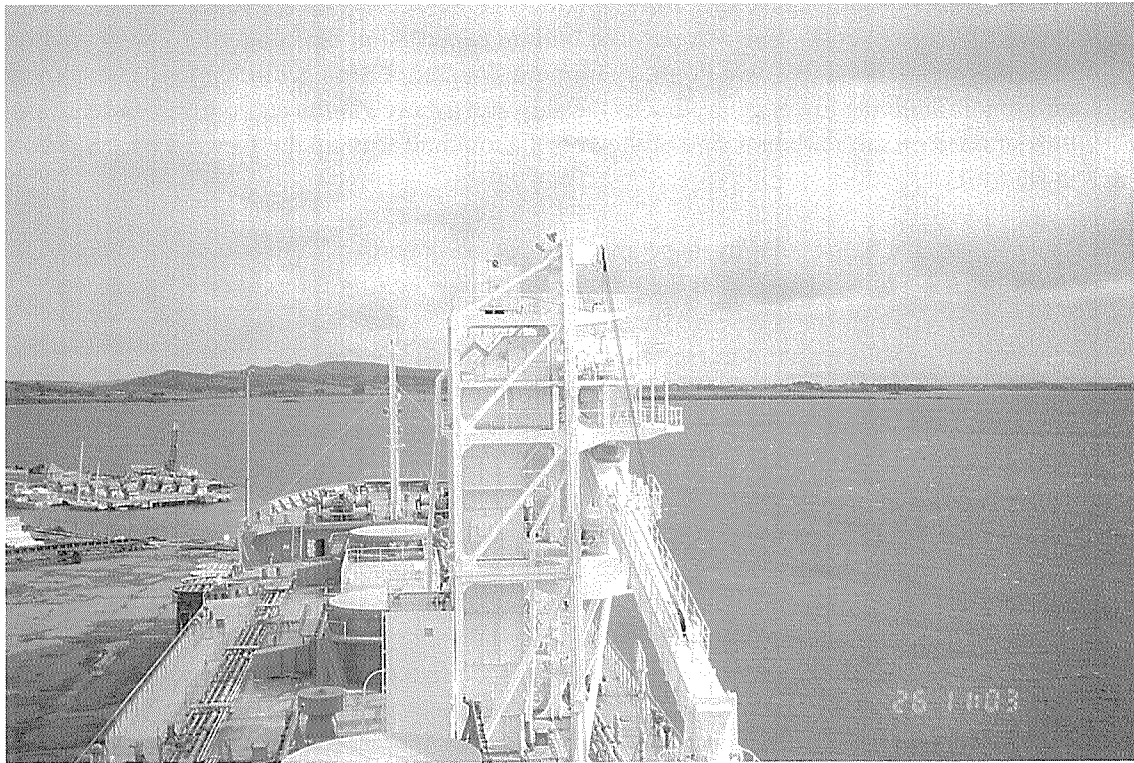
**Figure 1**

- 1.2 The cargo tower is irregular in shape and constructed in parts of lattice-work steel and effectively creates a blind sector from the navigating bridge looking forward (see figures 1 and 2).

View forward from centreline of the *Alltrans* wheelhouse  
(Pilot's conning position)

- 1.15 The Pilot was “conning” the vessel from a position close to the centreline and forward in the wheelhouse as the vessel entered the channel at Number Three Beacon. The position of the cargo tower in relation to where the Pilot was standing is shown in figures 1 and 2. Since the vessel departed during hours of darkness the cargo tower was visible only as a faint outline against the dark night sky to seaward.

- **The cargo tower** - As can be seen from figures 1 and 2 the cargo tower does create a blind sector forward making it necessary for those on the bridge to move around to keep an effective lookout. Although the cargo tower was visible as a faint outline against the dark night sky to seaward, it was possible the Pilot forgot its presence and its effect on visibility when his attention was focused on other matters.

- 3.3.2 Circulating a memo to all Sea Staff advising the importance of time management on board with regard to making use of available time to obtain sufficient sleep. (034/95); and
- 3.3.3 Constructing a diagram showing forward blind sectors created by the cargo tower on the foredeck of the *Alltrans* and any vessel with a similar obstruction, and having this diagram displayed permanently on the bridge and incorporated on the existing Pilot Information Card. (035/95)

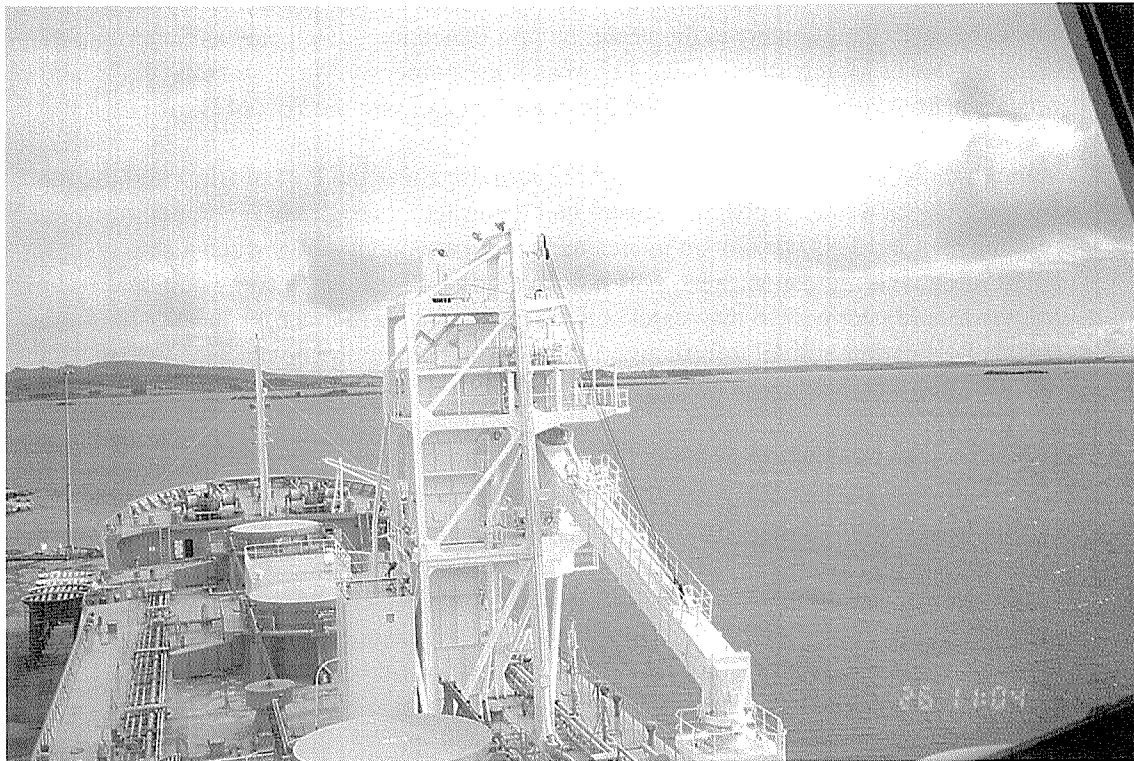
View forward from port side of the *Alltrans* wheelhouse  
(Master's favoured position)

- 1.16 The Master had positioned himself on the port side of the wheelhouse as this position afforded him a view slightly across the starboard bow and an unrestricted view to port. He often moved around the bridge to counter the blind sector created by the cargo tower and to orientate himself with the various port navigation aids.

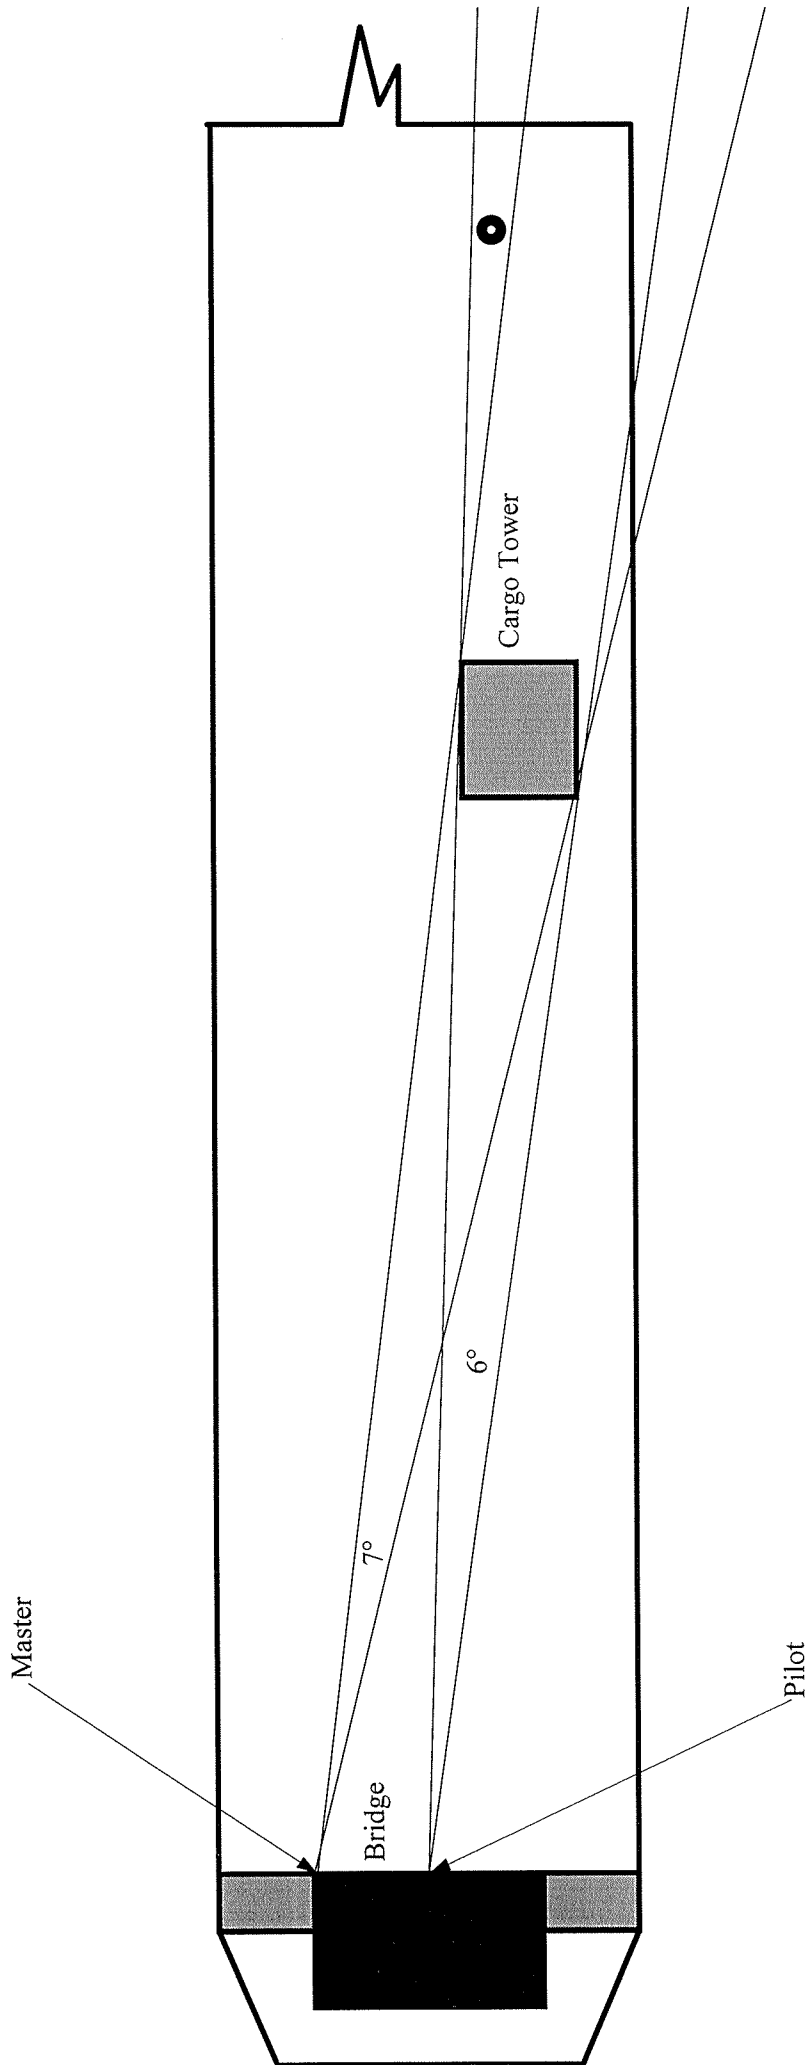
**Figure 2**

**Diagram showing forward blind sectors created by cargo tower**

Note: Any object in the sector marked ● would be visible to the Master but not the Pilot

- 2.10 The blind sectors created by the cargo tower on the foredeck of the *Alltrans* could have been an additional contributing factor to the grounding.
