**No. 95-205**

***FV Awanui 6129***

**Westport**

## Marine Accident Report No. 95-205

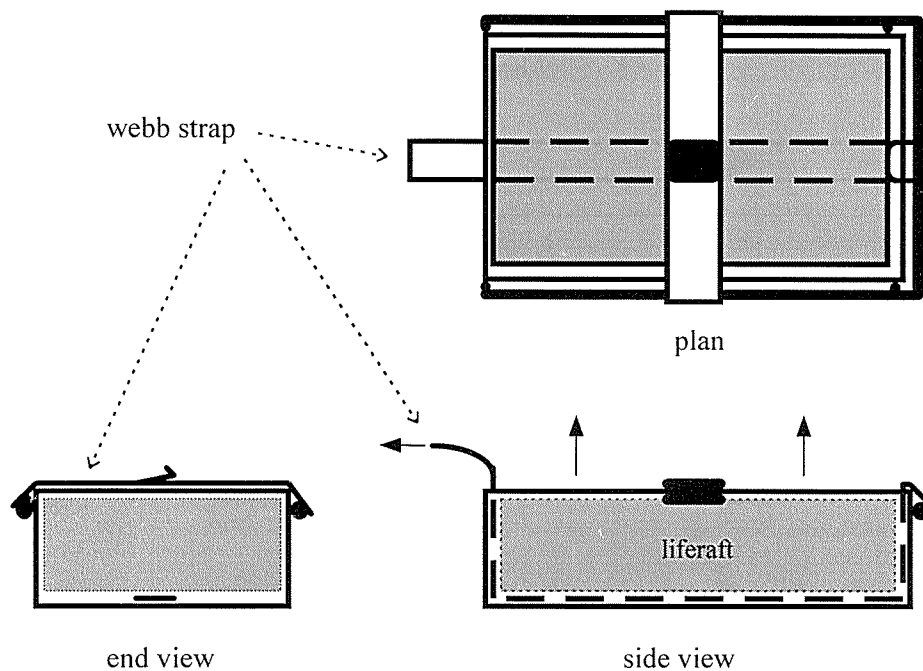
Figure 1

- 1.2.3 The liferaft was located on top of the wheelhouse tightly housed, flush in an aluminium box. It was not fitted with a hydrostatic release, but instead was secured with a web strap fitted with a diver's type cam buckle to guard against accidental release. A second web strap was fitted that led under the liferaft and was free at one end enabling the raft to be popped out of its housing when required (see figure 1). The liferaft release line was attached to the vessel.

Diagram showing the stowage arrangement of *Awanui*'s liferaft

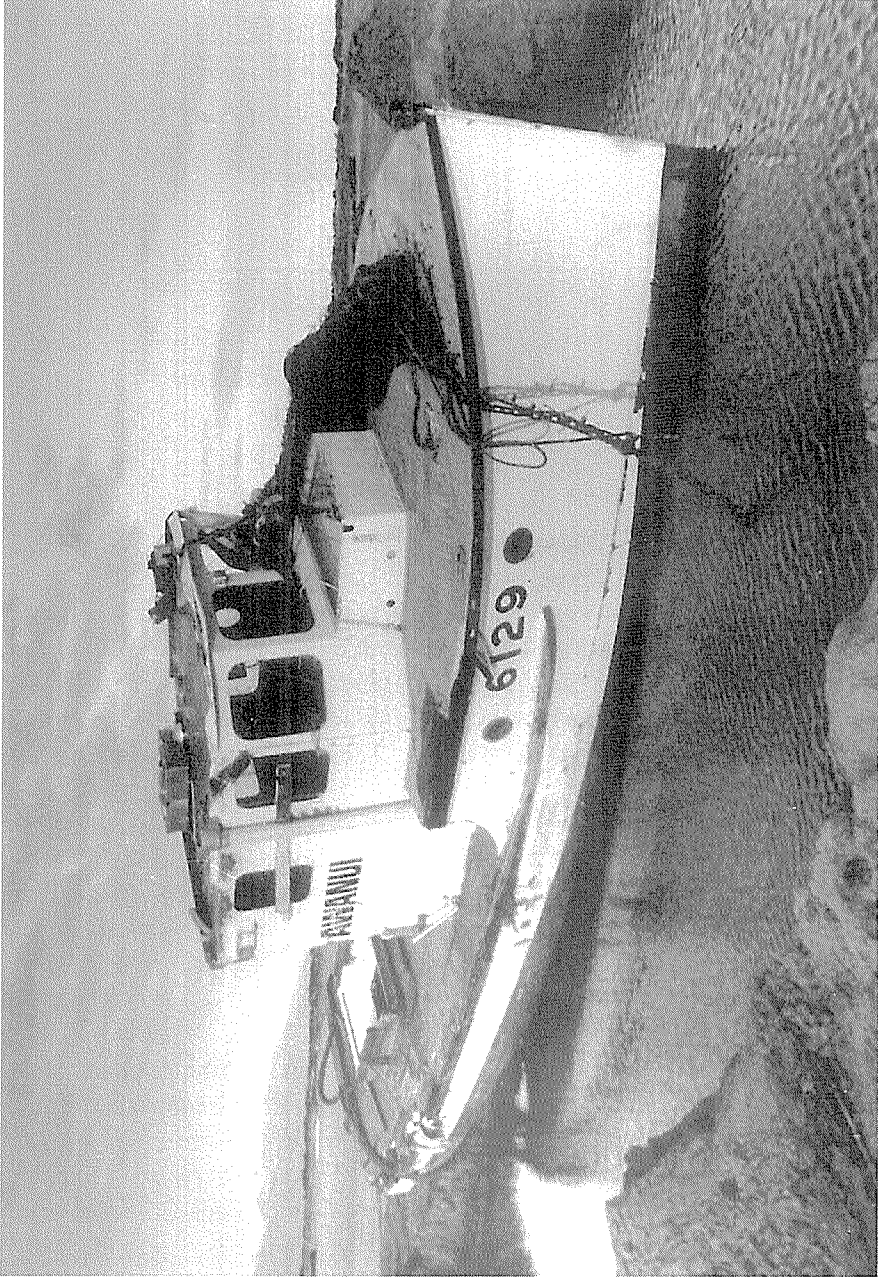
**Figure 2**  
*Awanui after capsized*

- 1.3.2 The gantry and all hand rails were broken off at deck level. The top of the aluminium wheel house was set down by approximately six centimetres and scoured, with some deep scrape marks, consistent with having been inverted and pounded on to a sandy bottom pitted with occasional rocks. All of the wheelhouse windows were missing. (See figure 2)

- 1.3.3 Most of the hull planking had been disturbed or sprung and the hull showed evidence of extensive wracking. The deck planking on the aft working platform was disturbed indicating extensive breaking out of the deck beams beneath.

- 1.3.4 The fish hold hatch cover was missing and the fish hold, accommodation and wheel house were partially filled with sand.
- 1.3.5 There were deep gouge marks in the wooden planking along the port side of the hull consistent with the boat having been dragged over or past rocks. A three metre section of planking was missing from the hull on the starboard underside. There were two holes in the port side hull each approximately 300 mm square.

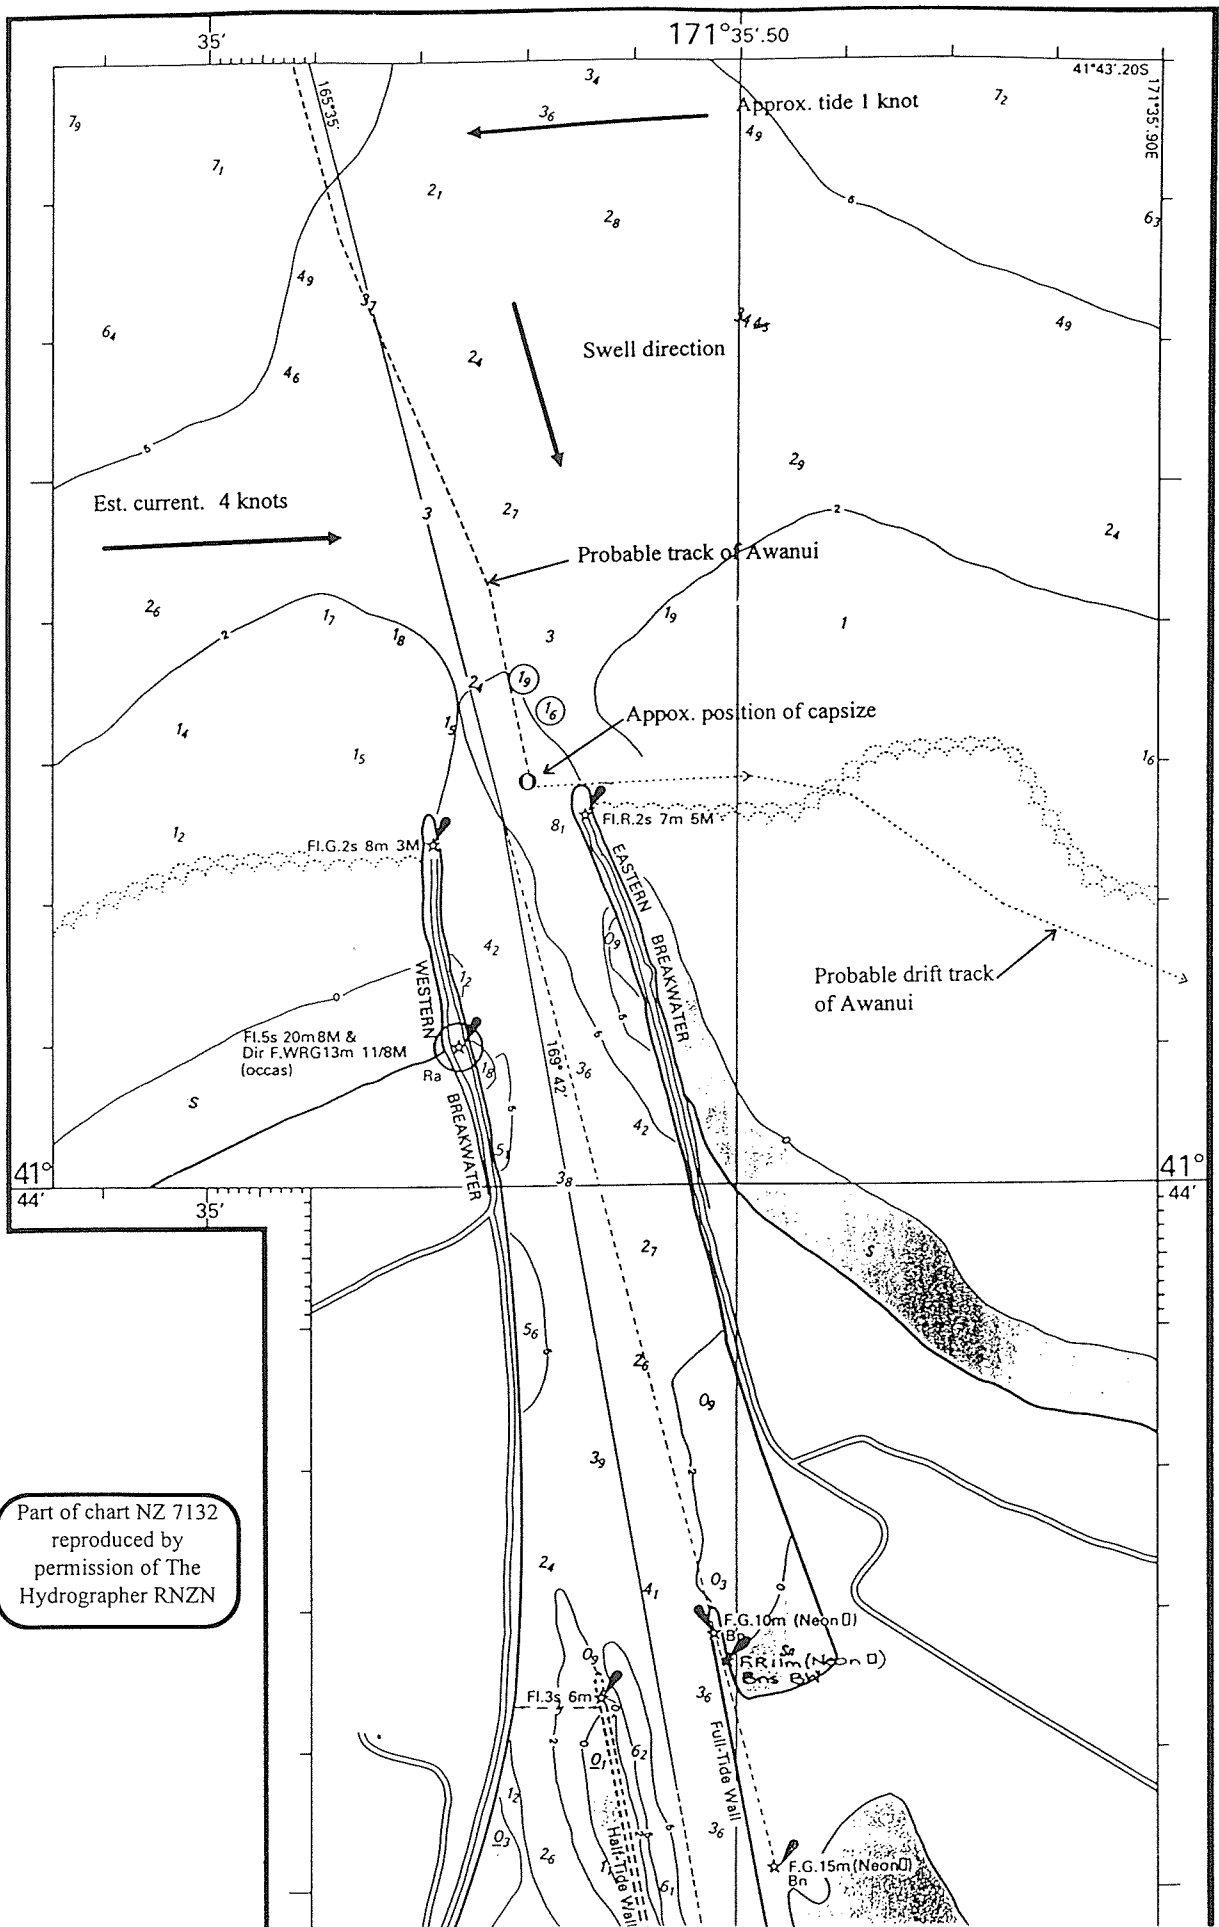
Figure 4

- 2.13 As the *Awanui* progressed across the bar she would have passed from the west-going tidal flow into the strong east-going current that was flowing across the entrance to the river (see figure 4). Due to the calm weather conditions the Master was probably not expecting such a strong flow in that direction and, with his perception of the leading lights being interfered with by the bright lights from the shunting yards and (possibly) the car headlights, he may not have detected that the vessel was setting rapidly across to port of the leading line until it was too late to retrieve the situation.
