No. 96-003

Cessna 337

N10R

Aircraft Accident Report No. 96-003

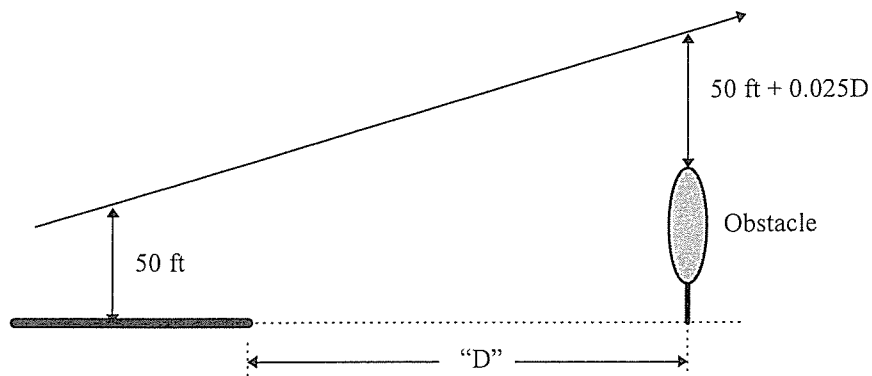
Figure 3
Obstacle clearance

- 1.18 The expression “50-foot obstacle” referred to in the performance data can be misleading. During certification flight testing of an aircraft type, the take-off distance is determined using standard FAA certification criteria of 50 feet and 1.2 V_S , that is, the take-off distance includes the ground run plus the airborne distance required to reach 50 feet at 1.2 V_S (in this case the 77 mph given in the table). The 50-foot “obstacle” is in fact a theoretical screen, and in practice, the presence of actual obstacles in a take-off path requires that those obstacles themselves be cleared by at least 50 feet. This is illustrated in Figure 3.

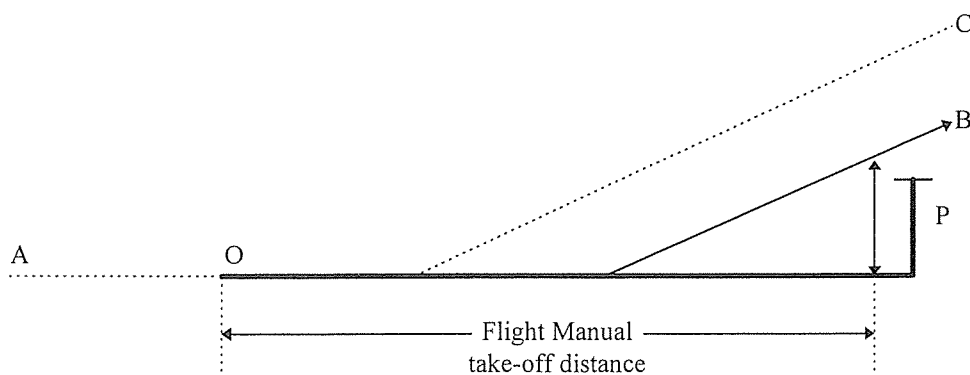
Figure 4

- 1.19 Taking into account the presence of physical obstacles in the path of N10R, in the form of 28.7-foot high power lines, the effect on the required take-off distance is shown in Figure 4. The origin of the required take-off distance is then displaced to about 1667 feet (508 m) from the obstacle, basing the calculations solely on the Flight Manual performance. However, the actual take-off commencement point was constrained by the presence of a permanent fence and an adjacent small watercourse, and based on a 1:20 obstacle clearance gradient, the actual take-off distance available was only about 200 m. There is no consideration of the effects of the failure of one engine on any of these figures.

- 2.1 The dominant factor in this accident was the inadequate space for a successful take-off. While there was almost 400 m available between fences, no account was taken of the presence of the power lines at the departure end. The take-off distance required on grass in the prevailing conditions was at least 390 m, which included a ground run of 180 m.
