Report 96-007

Hughes 369D

ZK-HLE

Aircraft Accident Report 96-007

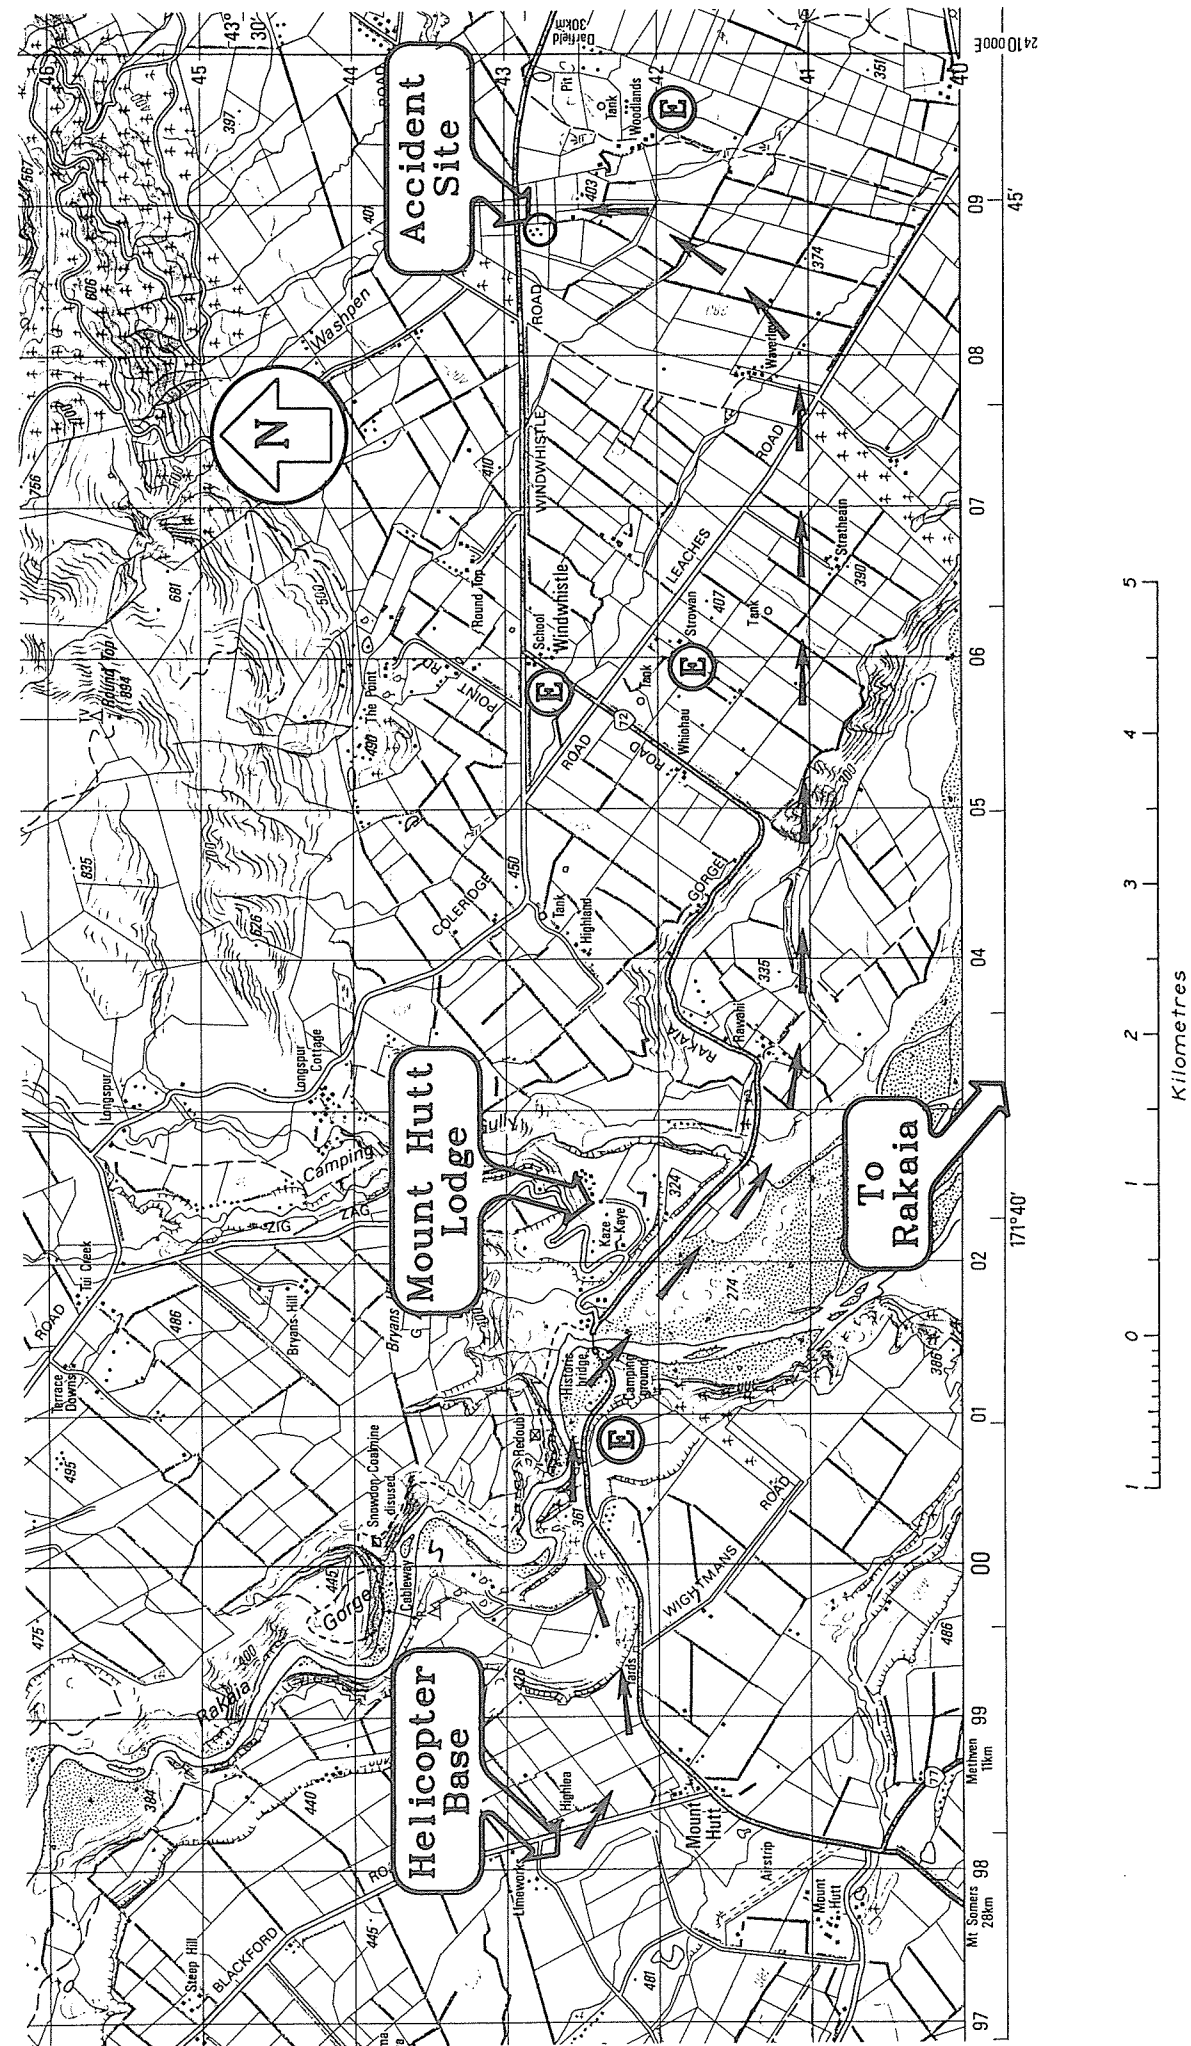
- 1.23 Another local report, from a resident in Windwhistle, was of clear conditions, with no fog, at 2230 hours.
- 1.24 Local enquiries established that the helicopter had been heard by various people in the area, but not seen. As a result its route could not be established in any detail. These ear witnesses were located at the Rakaia Gorge, at Windwhistle and at a farm 1 km south, and at the farm 1 km south east of the accident site. (See Figure 1.)
