Report 96-103

Train 622

Waipawa

Rail Accident Report 96-103

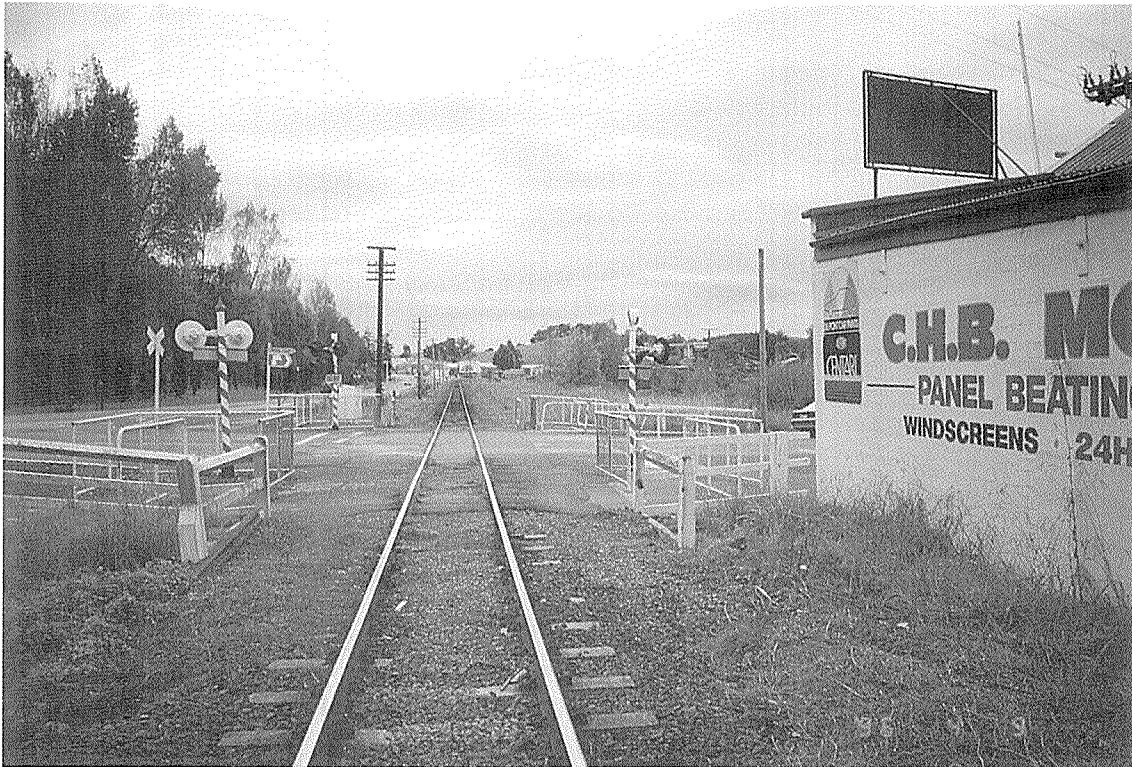
- 1.6 As the lead locomotive approached the crossing the LE's view on the right hand side was restricted to approximately seven metres from centreline by a building, and his first sight of an approaching westbound white Mazda utility was when he was approximately 15 m from the crossing.

Figure 1
Northbound LE's view of the utilities approach (right hand side)

- 1.14 The view lines² on the south-east quadrant of the level crossing were limited by a panelbeater's workshop which encroached within four metres of centre line of the track (Figures 1 and 2). Some trees on the right-hand side of the track south of the crossing were cut back on the day after the accident resulting in an approximate 100 m view line at the stop line 3.5 m from centre line, and an approximate 60 m view line at five metres from centre line. The view lines would have been less prior to the trees being cut back.

- 3.9 The limited view in the south-east quadrant of the crossing gave no time for the driver of the utility to see and respond to the approaching train or for the LE to see the approaching utility and give any additional whistle warning or reduce speed.

- 4.1 It was recommended to the Transit New Zealand that:
- 4.1.1 When liaising with Central Hawkes Bay District Council regarding alternative proposals to overcome the problem associated with access from SH2 to Victoria Street that priority consideration be given to options that include improved view lines in the south-east quadrant of the Victoria Street level crossing, either at its present site or by relocating the crossing to the north. (040/96)

4.3.1 When liaising with Transit New Zealand regarding alternative proposals to overcome the problems associated with access from SH2 to Victoria Street that priority consideration be given to options that include improved view lines in the south-east quadrant of the Victoria Street level crossing, either at its present site or by relocating the crossing to the north. (041/96)

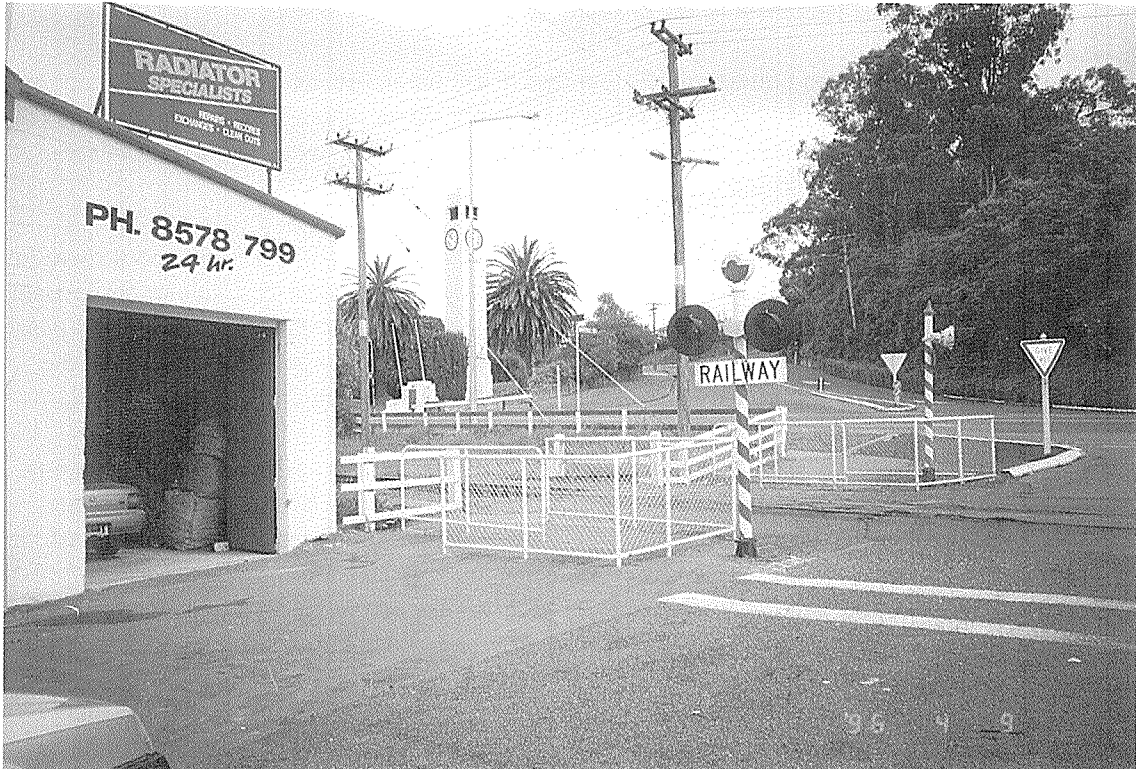
Figure 2
Westbound utility drivers view of the trains approach (left hand side)

- 2.4 All four accidents or incidents since 1993 have involved the south-east quadrant of the crossing. A common denominator is the restrictive effect of the building on sight distances. There are no regulatory requirements for sight distances at level crossings protected with FLBs. However an indication of what are considered as minimum view line requirements are included in Code Supplement CSG/417 "Level Crossings - Policy". This document defines minimum values for restart (five metres from centre line of rail track) view lines at crossings with active protection, but there are situations, as at this crossing, where TRL have no control over the factors influencing such view lines. In recognition of this, and of the appropriateness of the restart concept to such crossings, the TRL Code is under critical review and the requirement for minimum view lines at crossings with active protection is likely to be deleted.
