Report 96-104

Collision between Hi-Rail Vehicles

Kotemaori

2 May 1996

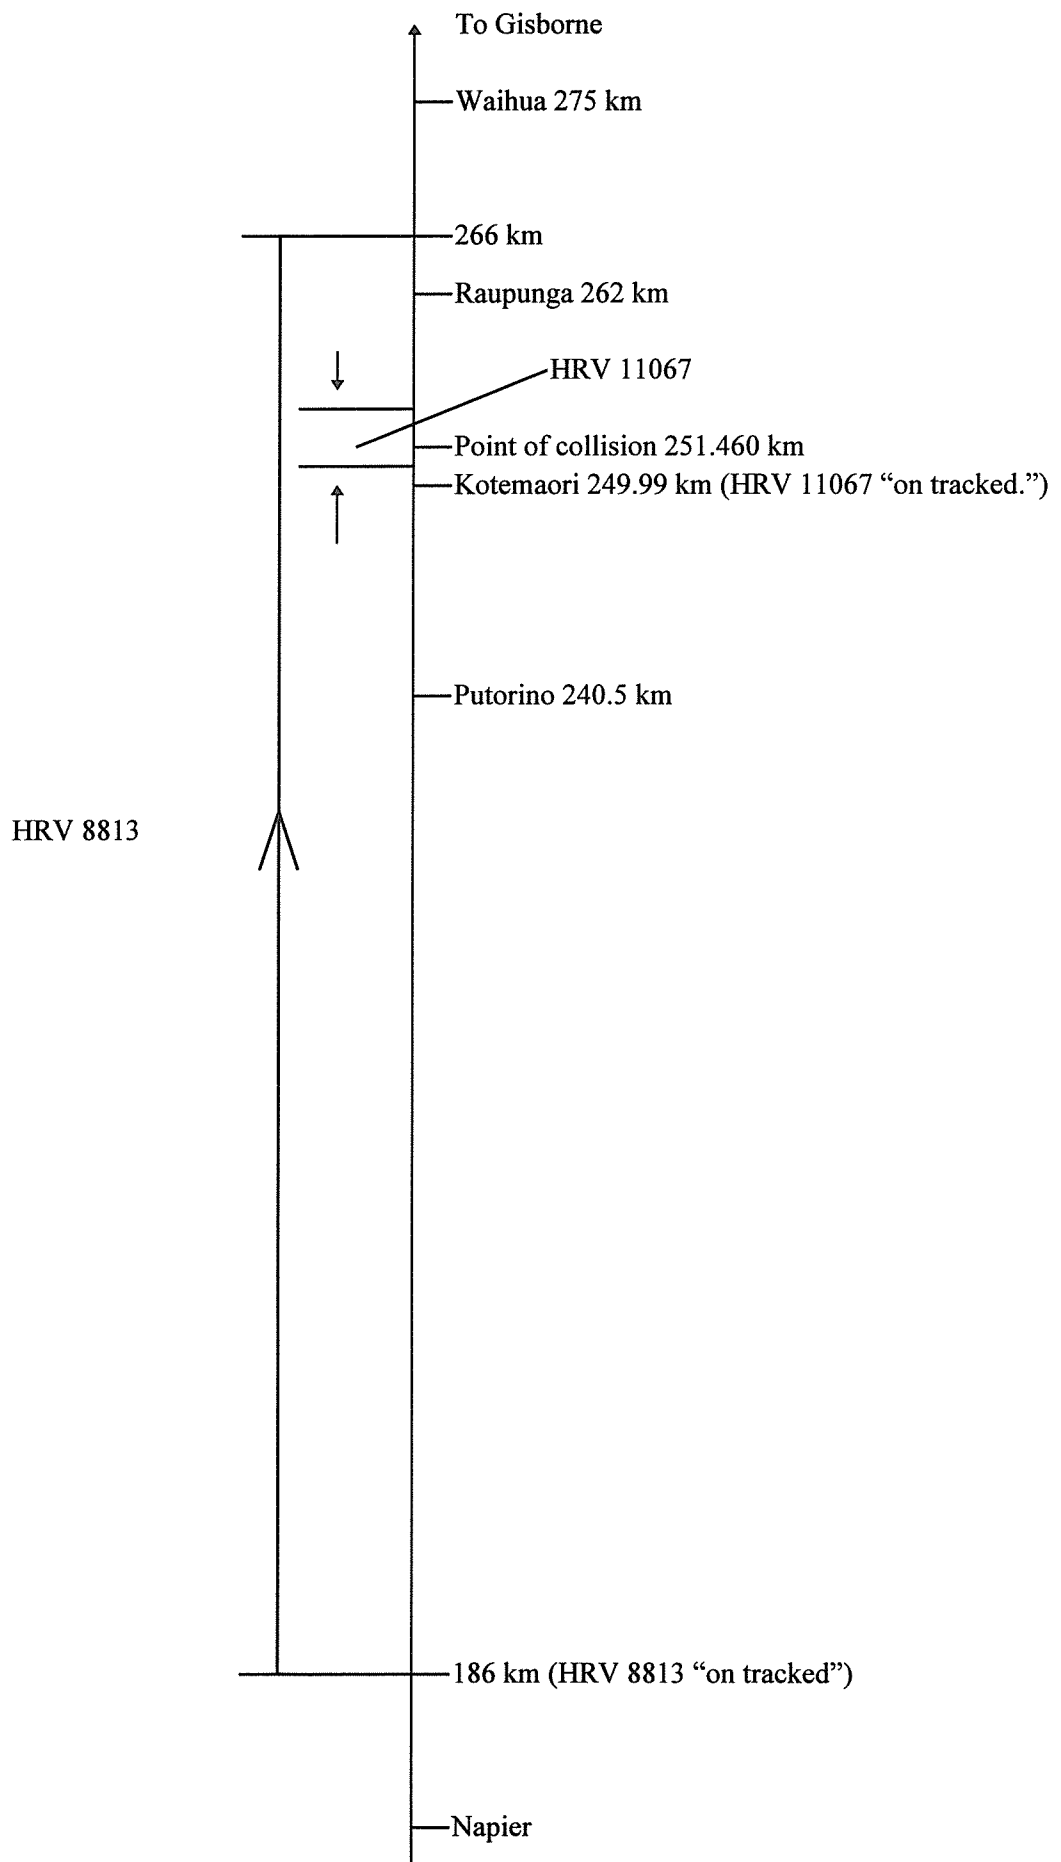
Figure 1
Diagrammatic layout of localities (not to scale)

- The movement of Hi-Rail vehicle (HRV) 8813 from 186 km (just north of Napier) to 266 km (just north of Raupunga) between 0830 hours and 1045 hours.
- HRV 11067 working between Putorino and Raupunga in the vicinity of 250 km commencing at 0845 hours with a requirement to make a check call to Train Control at midday. (See figure 1 for a diagrammatic layout of the relevant localities.)
