**Report 96-106**

**Train 903**

**Collision with Motor Vehicle**

**Templeton, Canterbury**

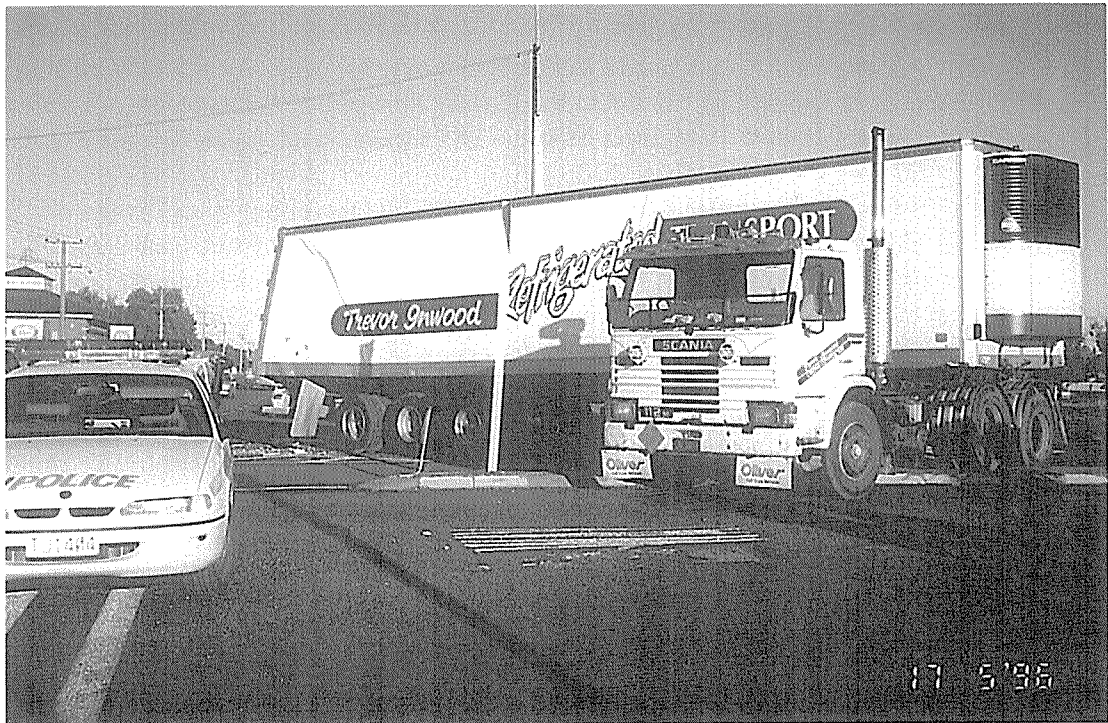
- 1.7 The impact swung the semi-trailer through approximately 150°, leaving it straddling the opposite lane of Kirk Road (Figure 1 and Figure 2). Fortunately there was no vehicle waiting at the barriers in this lane. The driver remained in the cab and although he was buffeted by the impact the only injury he sustained was a cut hand.

**Figure 1**  
View looking south down SH1 (Kirk Road to the right)

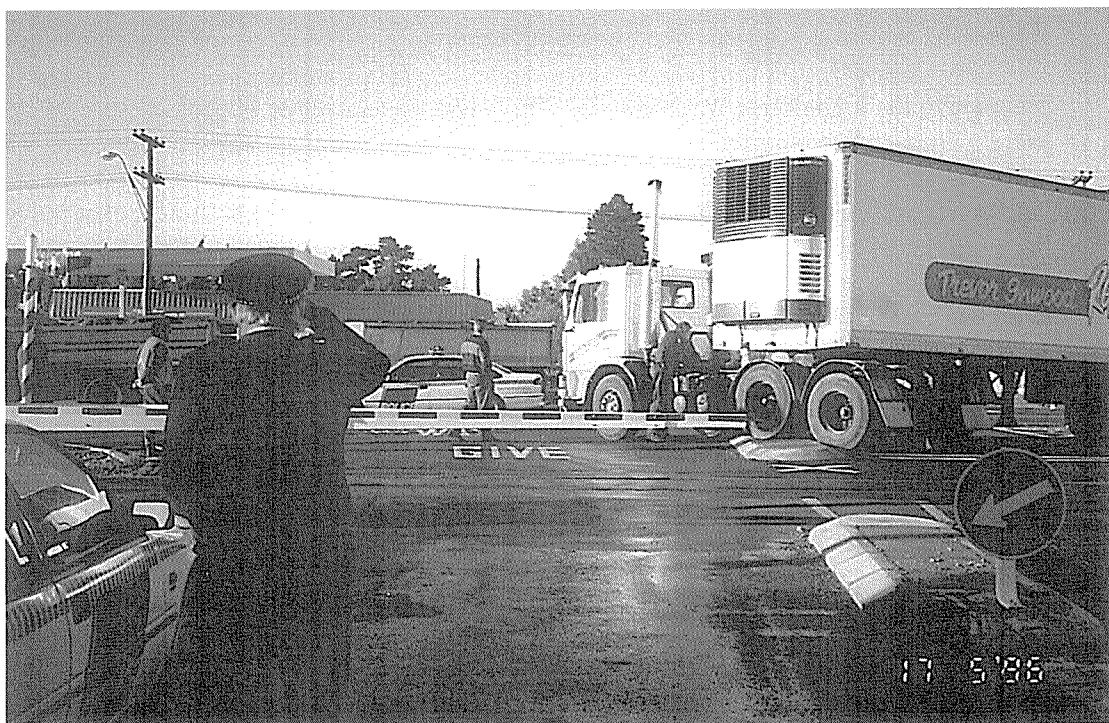
**Figure 2**  
View looking east on Kirk Road, towards SH1

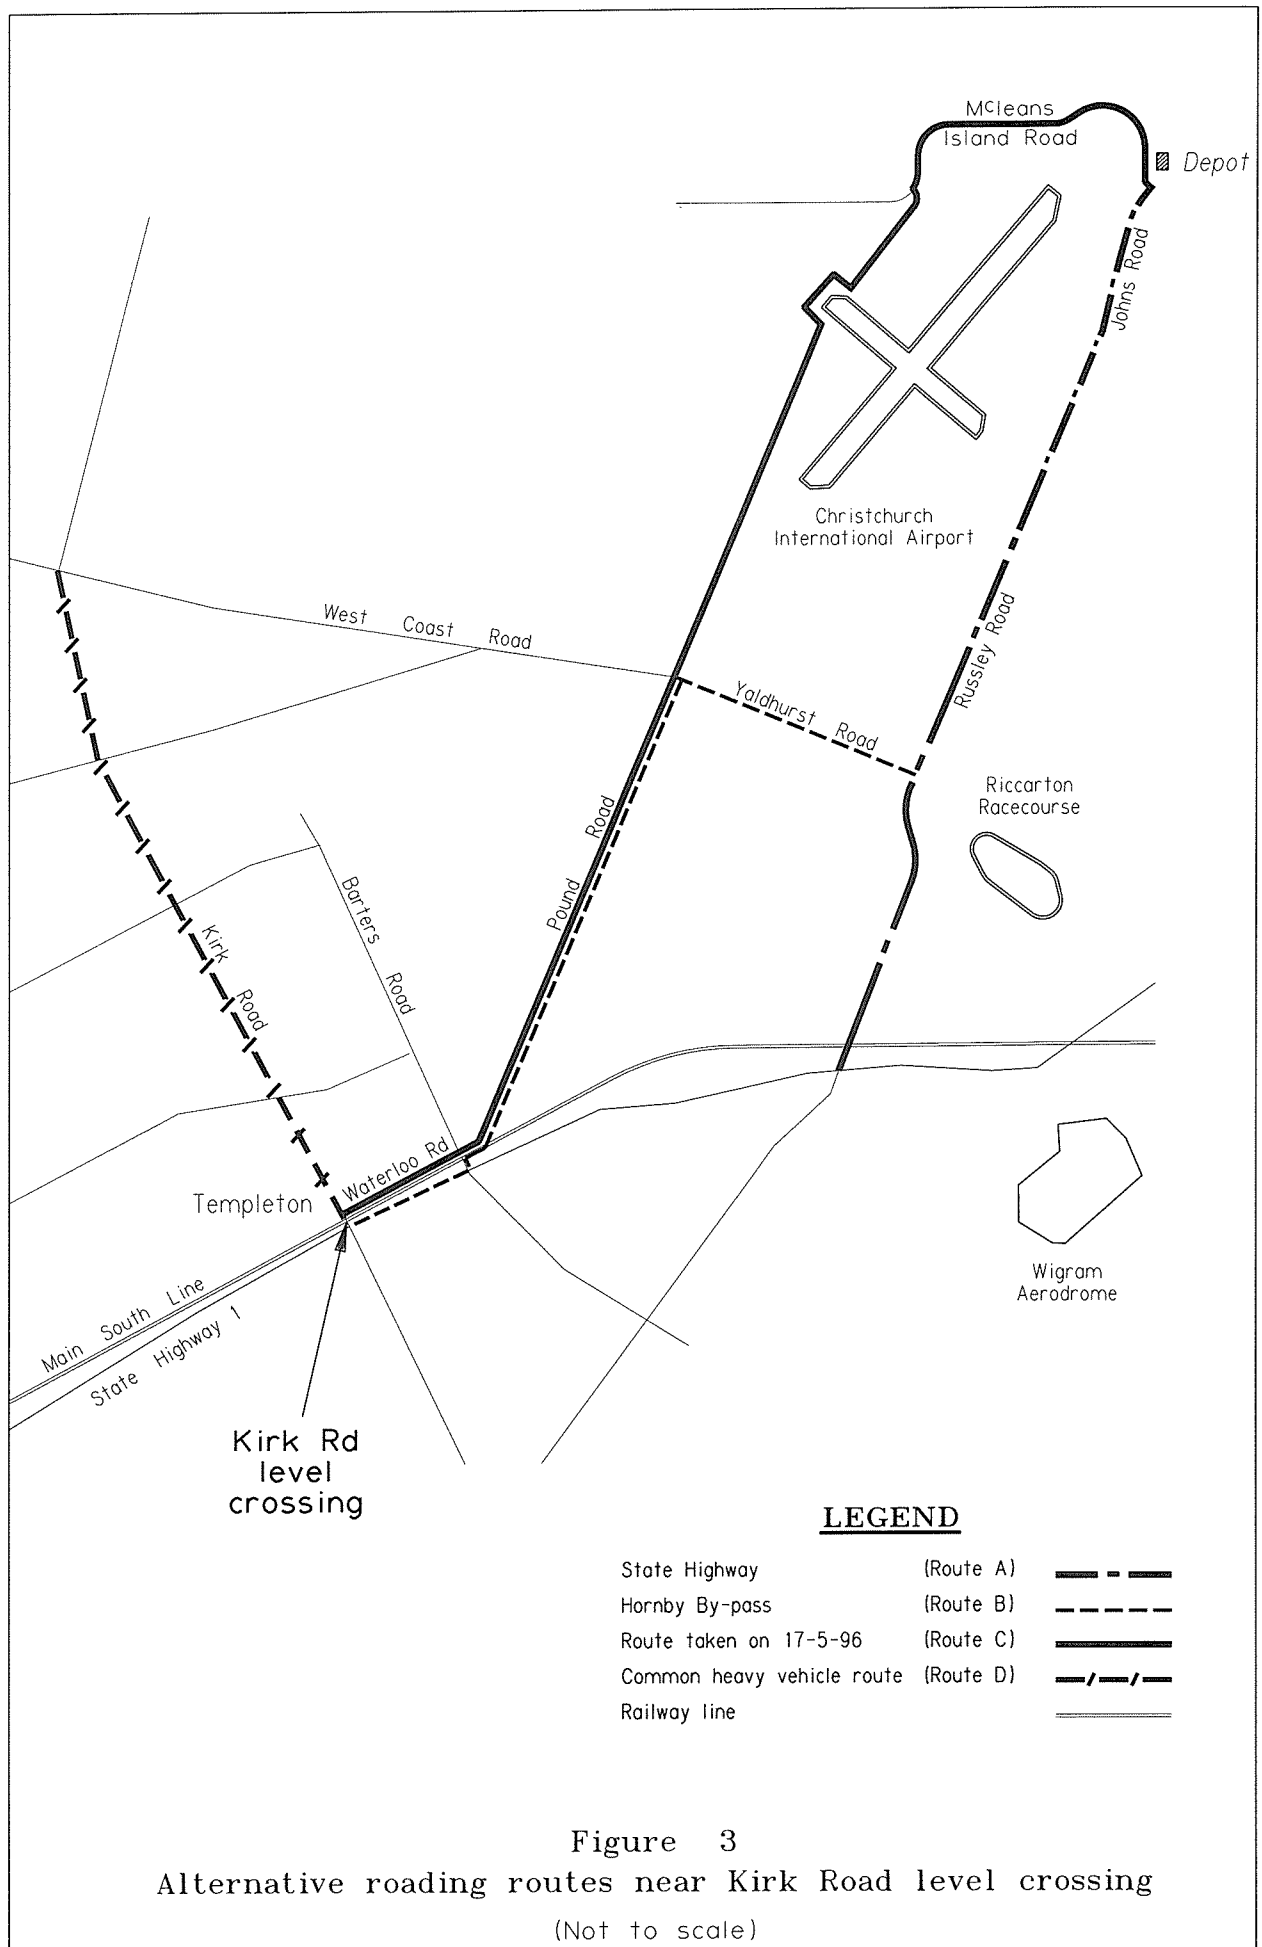
- 1.11 The normal timing of the run meant that the truck departed from the depot at 0400 hours and at that time of day the driver always took the State Highway (SH) (Figure 3, Route A).

- 1.12 On the day of the incident there was no requirement for the truck to be at Fairton until 1045 hours so the driver left the depot at 0800 hours. Due to traffic on Johns Road he elected to go around McLeans Island Road and follow Pound Road south (Figure 3, Route C). In doing this he linked up with the posted Hornby by-pass (Figure 3, Route B). This was the first time the driver had taken Route C during his four months on the Fairton shuttle.

- 1.13 On reaching Barters Road where Route B was signposted to cross the railway to join the SH the driver elected to cross Barters Road and proceed south down Waterloo Road to turn left and cross the railway at Kirk Road. The stated reason for this was his recollection of roadworks on SH1 between Barters and Kirk Road, which may have delayed him (roadworks were in hand on SH1 at the time but south of Kirk Road).

- 2.3 The presence of the central island at the entry to Barters Road from Waterloo Road, and the give-way at Kirk Road to SH1 as compared to the compulsory stop at Barters Road to SH1, had the potential to influence the drivers of vehicles, and particularly long vehicles, to use Kirk Road crossing in preference to Barters Road crossing.

Liaise with the Christchurch City Council to review the integrated use of Barters Road and Kirk Road level crossings and take such steps as are necessary to encourage long vehicles to use Barters Road level crossing and to prohibit any uncontrolled crossing of Kirk Road level crossing by vehicles exceeding 11 m in length. (023/96)

- i) A ban of vehicles exceeding 9 m in length from travelling on Kirk Road between Waterloo Road and the Main South Road.
- ii) Additional sign posting to encourage long vehicles on Pound Road to use Barters Road.
- iii) The marking of a cross-hatched clear zone at the Kirk Road rail crossing.
