Report 96-108

Train 404

Hamilton

31 May 1996

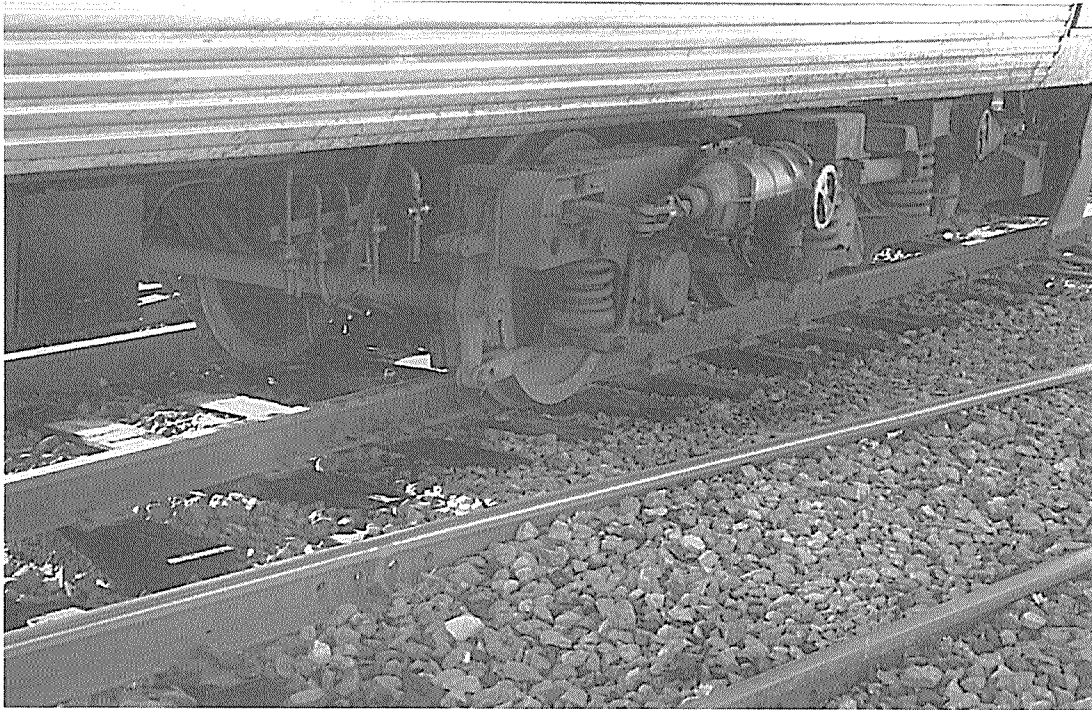
- 1.4 The LE inspected his train and found the trailing bogie of RM 24 was derailed and the number 1 (trailing) axle, A side (right side in direction of travel), was broken on the outside of the wheel (refer Figure 2 and Figure 3).

Figure 2
The derailed trailing bogie of RM 24. View from left side in direction of travel with number 3 axle at left and number 1 axle (obscured) at right.

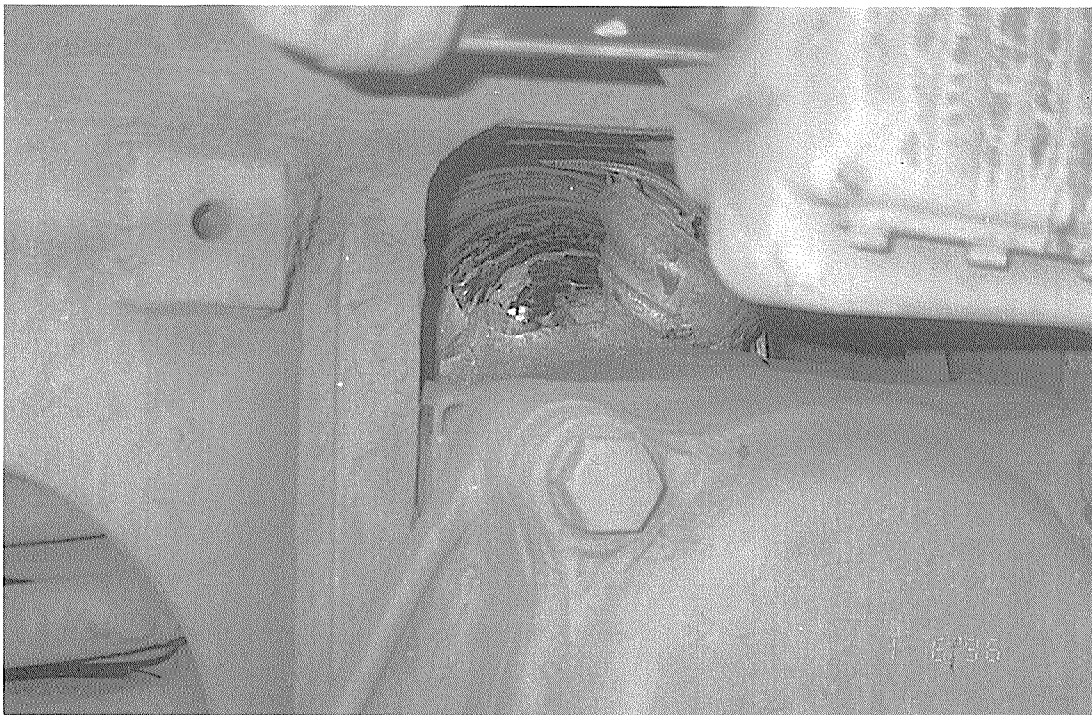
Figure 3
View of the failed number 1 axle taken from the right side through the side of the bogie.

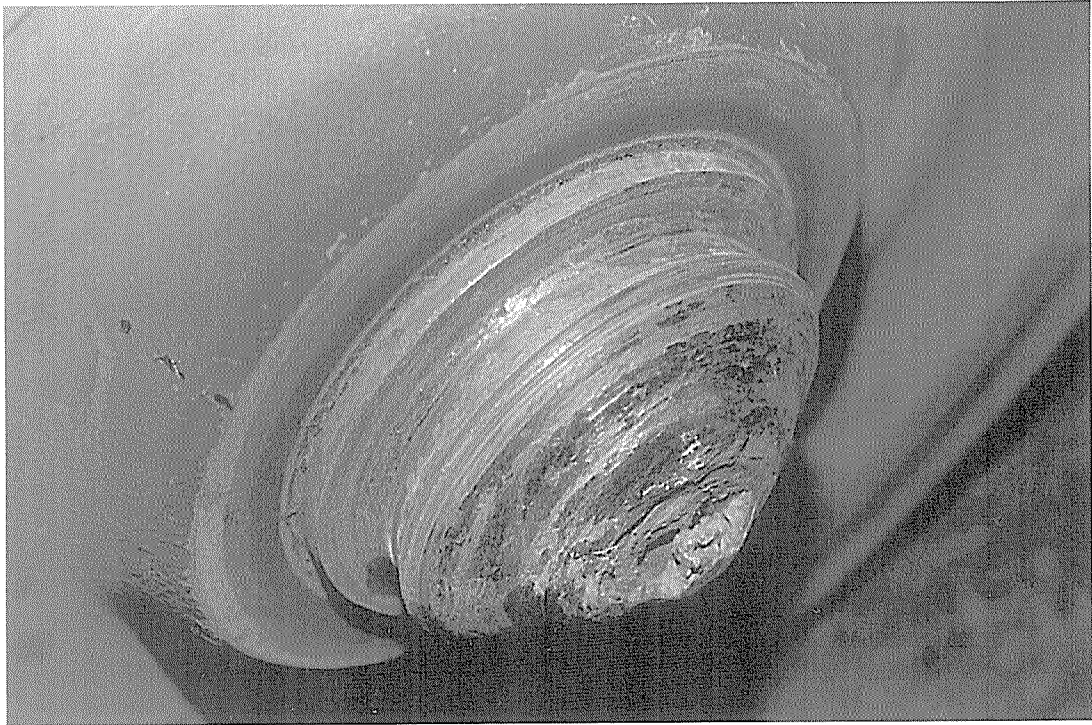
- 1.8 Inspection of the railcar following the derailment revealed that the right side of number 1 axle had sheared off in the journal area outside the right wheel. The remaining stub of the axle was worn heavily and showed signs of high temperature and plastic flow (Figure 4). The axle box showed signs of substantial damage (Figure 5). The number 1 axle was found to be skewed clockwise on the track with wheel A (right side) offset behind wheel B.

Figure 4
Worn stub of number 1 axle

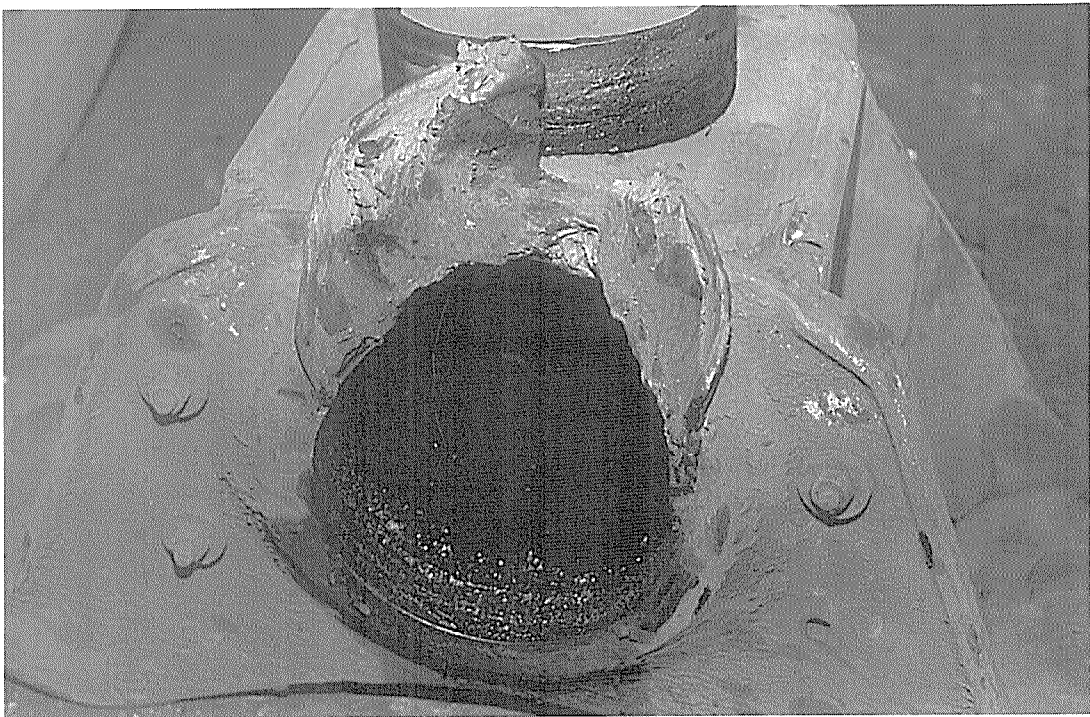
Figure 5
Worn axle box, number 1 axle

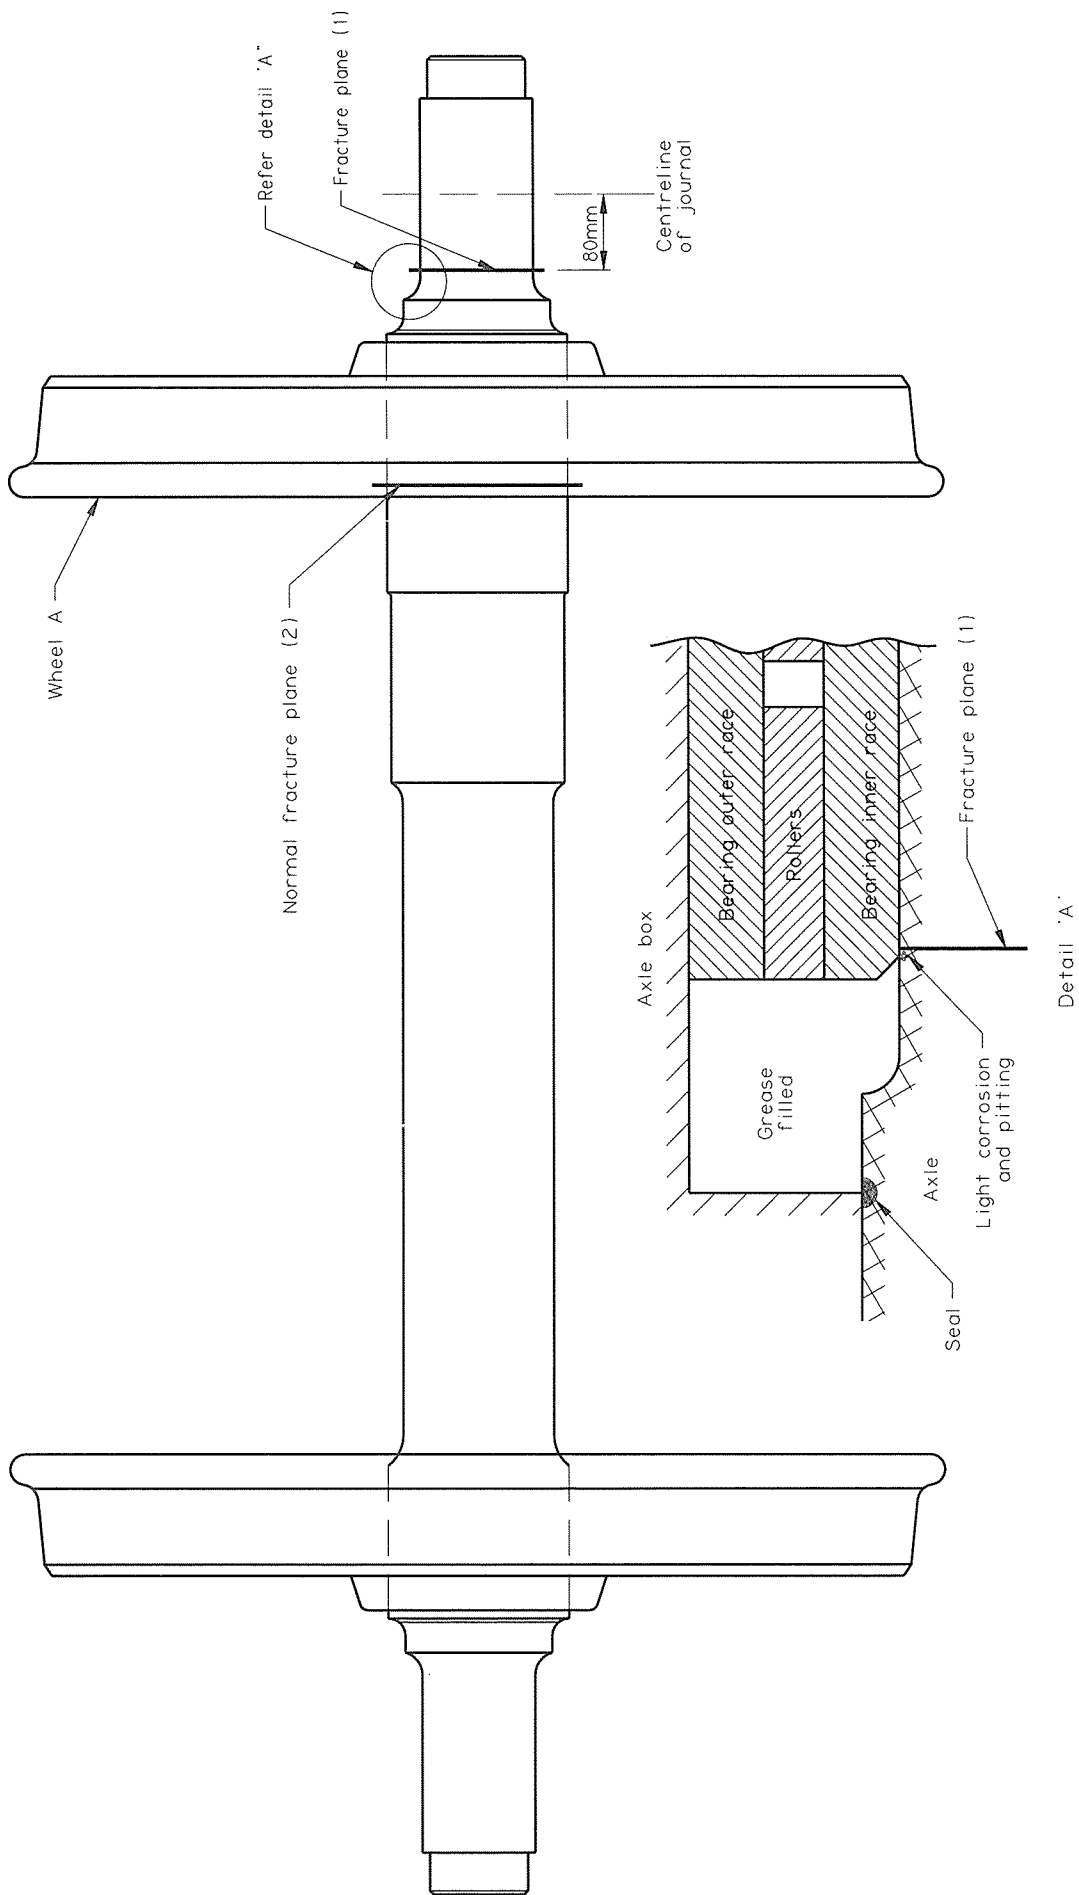
- 1.22 A metallographic section was taken through the surface of the failed axle next to the fracture to evaluate corrosion present. Examination of this section revealed corrosion pits approximately 0.015 mm deep. No cracks were observed. The report concluded that the corrosion present would have reduced the stress at which a fatigue crack would initiate. Figure 6 shows the relative position of the axle failure.

Figure 6
Relative position of the axle failure, (not to scale)

- 2.4 The fracture plane was at the inside of the tapered run out underneath the inner bearing race in the journal area of the axle. This is not recognised internationally as a highly stressed area of rolling stock axles and is generally not prone to fatigue failure. Fracture in the journal area is not uncommon following bearing failure, but in this case there was no evidence of bearing failure prior to fracture. A fracture plane in the wheelseat area is the normal result of in-service fatigue failure (refer Figure 6, fracture zone(2)).

- 5.1 As a result of the investigation of this incident it was recommended to Tranz Rail Limited that it:
 - 5.1.1 Dismantle and inspect for fatigue cracks as a matter of urgency all axles under the three axle bogies currently in service on the Silver Ferns. Reassembly of uncracked axles should include action to prevent corrosion at the tapered gap between the axle and inner bearing. (044/96).
