Report 96-110

Train 401

Huntly

Rail Accident Report 96-110

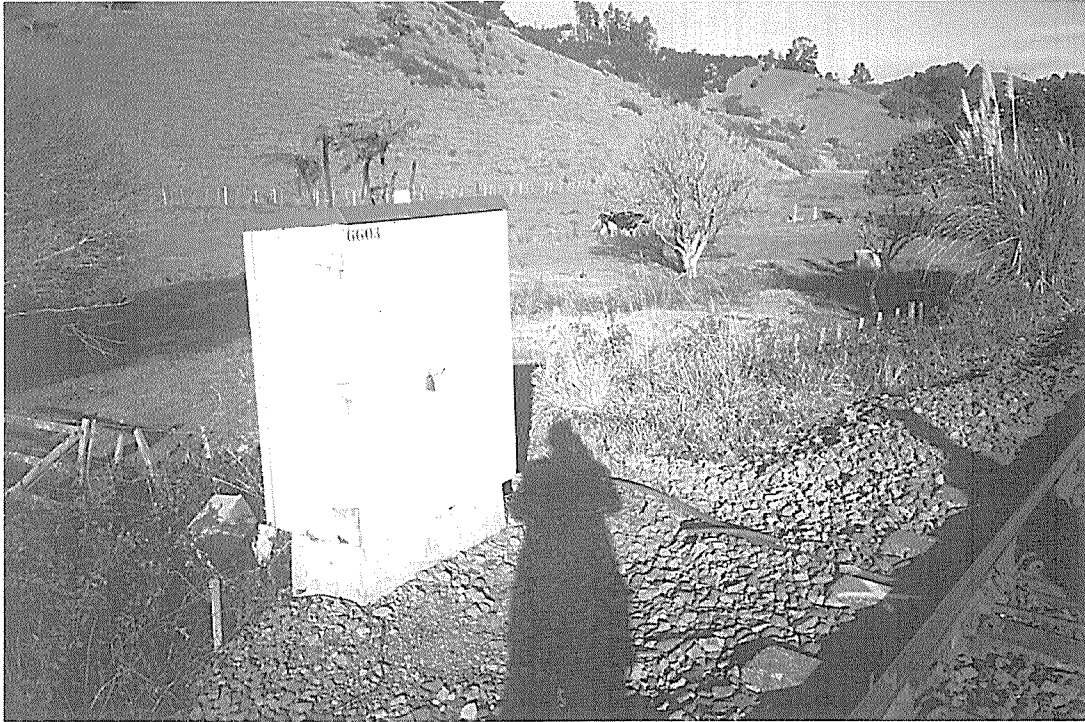
Figure 2
Signal location box 6617 (6603). General view looking south showing relativity to rail.

- 1.22 Signal location box 6617 was a typical Tranz Rail installation measuring 1.08 m wide, 0.56 m deep and the top was 1.4 m above rail level (1.66 m above ground level). The front face was 2.75 m from the centre line of the track and conformed with the clearance requirements for such structures laid down by Tranz Rail. The box had double doors opening towards the track and these were padlocked when not in use. Refer Figures 2 and 3.

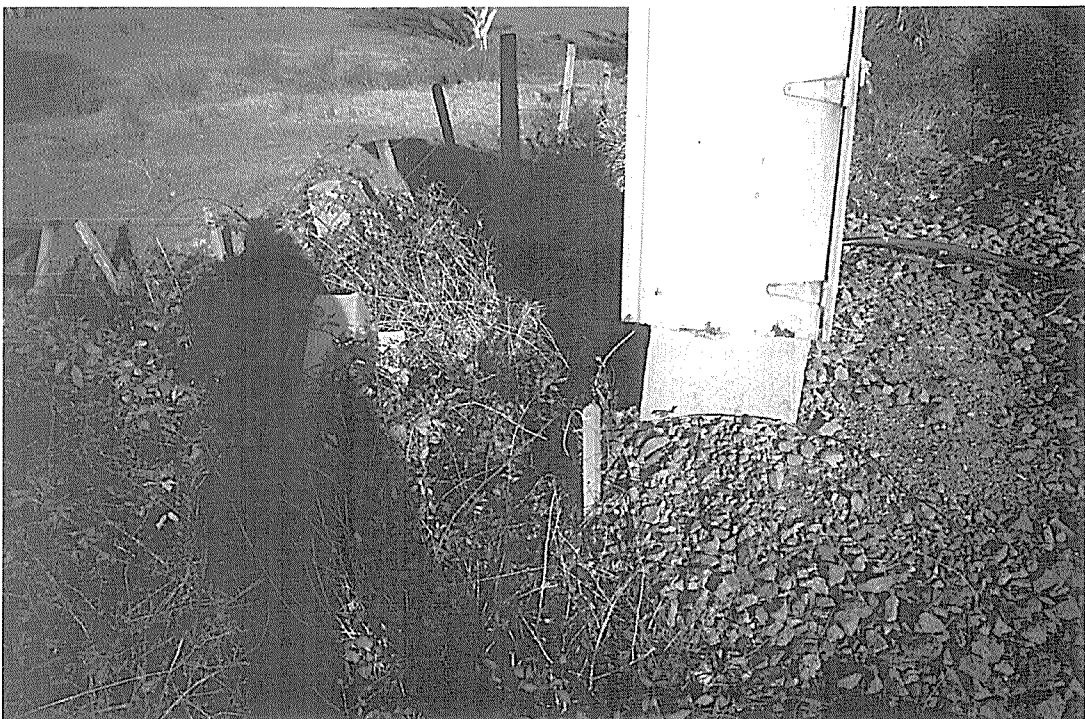
Figure 3
Signal location box 6617 (6003). View looking south showing earth wire at the north end and the rough terrain behind the box.

- 2.6 Evidence indicated the signal maintainer had completed his internal check of signal location box 6617 and had locked the box. The only other possible outstanding work requirement was to check the earth wire. This was at the north end of the box (refer Figure 3) and the rough terrain behind the box made access from the south end difficult compared with the north end. No apparent work related reason could be found for the signal maintainer to be relatively stationary for at least 10 seconds at the south end of the box.
