Report 96-115

P35 Shunting Service

Shunter fell into path of wagon

Rail Accident Report 96-115

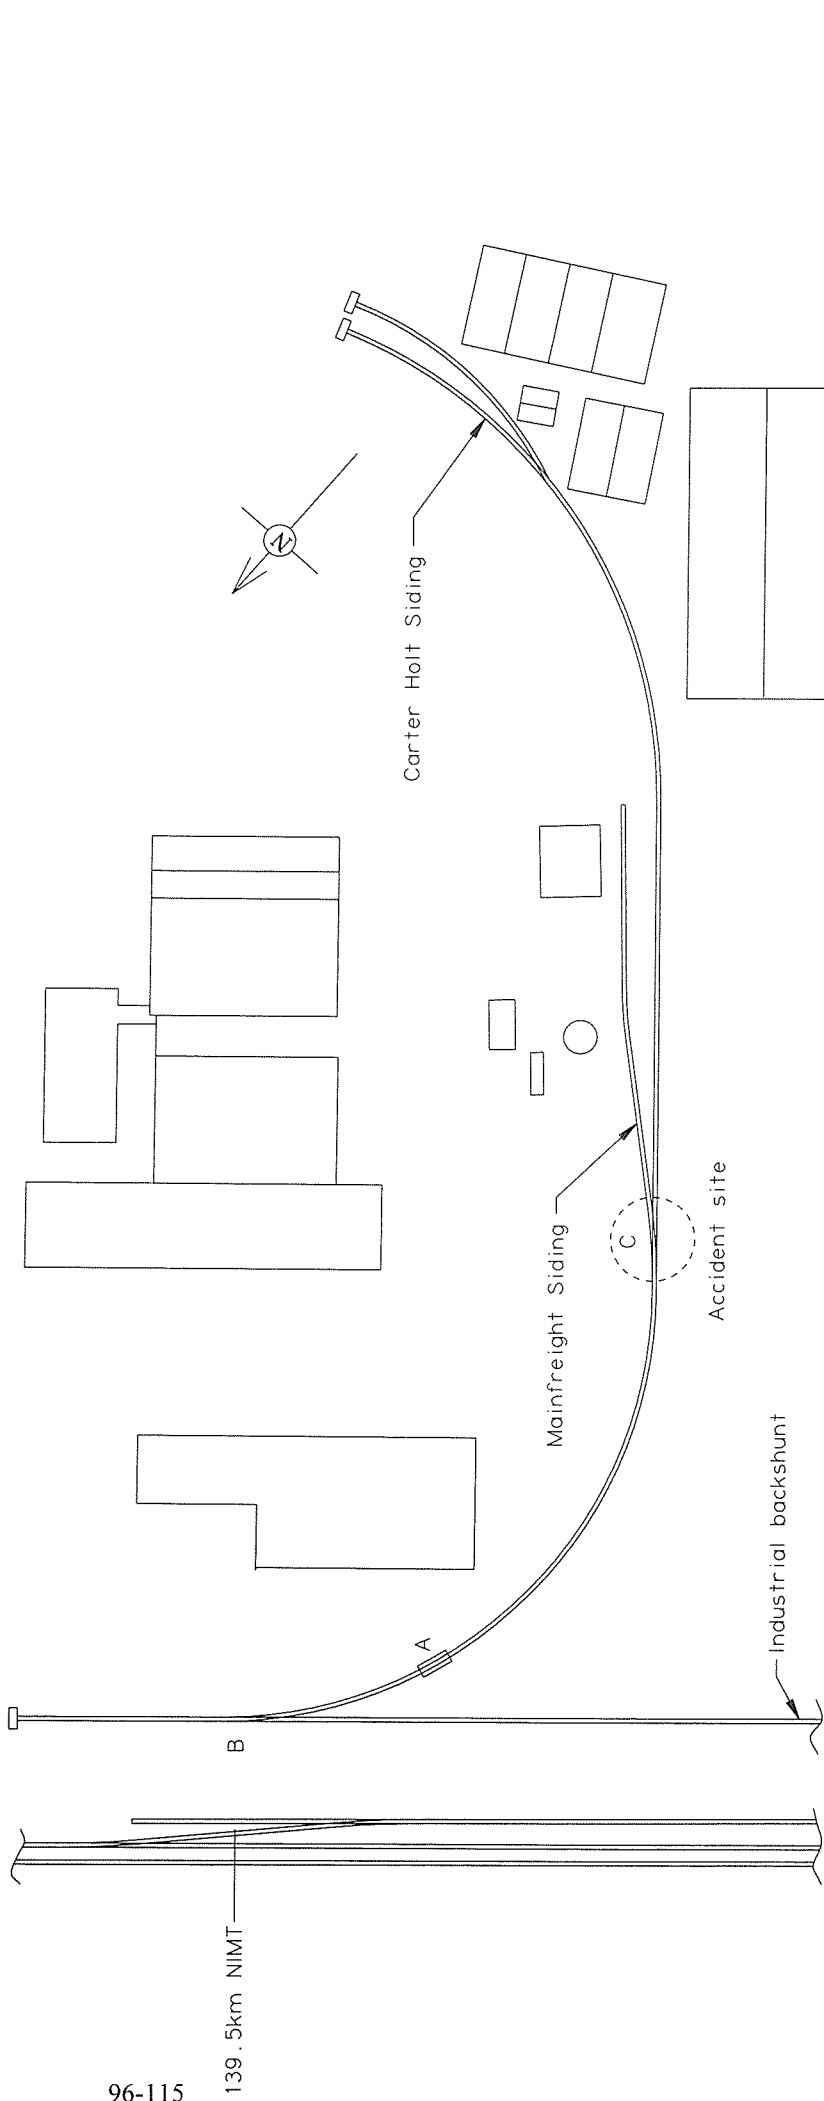
Figure 1 - Locality diagram (not to scale)

- 1.3 The three wagons remaining on the shunt at approximately 0155 hours were for delivery to Carter Holt siding. Entry to the siding was from the end of the industrial backshunt (refer Figure 1) which allowed shunting by hauling wagons to the end and propelling¹ them to their destination.

- 1.5 The RCO had boarded the locomotive at B (refer Figure 1) and stood on the right side of the leading footplate. He remained in this position during the coupling of the shunt to KS18212 and until the shunt came to rest following the accident.

- 1.8 The shunter was controlling the shunt movements by radio, as he called it forward to stop clear of the points of the turnout leading to the Mainfreight siding (C on Figure 1). The turnout was set for the Mainfreight siding and the shunter had to pull the hand lever over to reset the route for the Carter Holt siding. The RCO stated that the shunter called down the wagons in the normal manner, “two, one, a half, steady, stop,” to stop the shunt clear of the points.

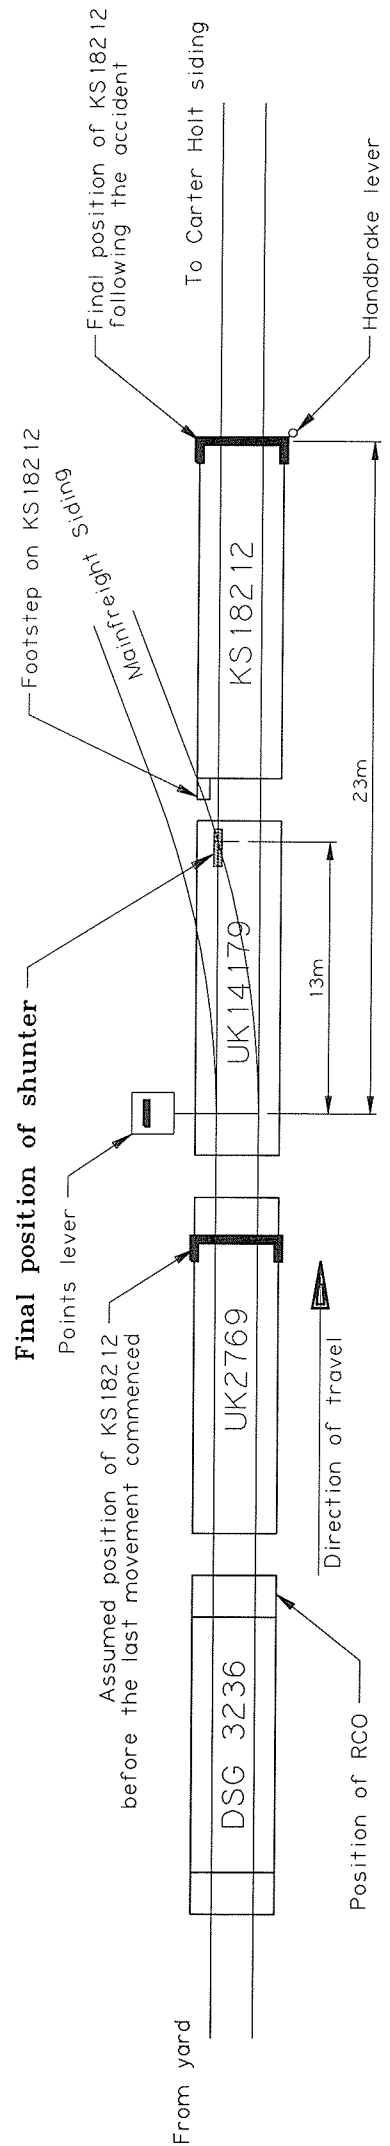
Figure 2 - Site details (not to scale)

1.17 Measurements were taken immediately following the accident to locate the following items and marks found between the rails of the Carter Holt siding:

- shunter's torch 4 m beyond the points
- shunter's pen 5.4 m beyond the points
- shunter's hat 6.1 m beyond the points
- drag marks in the ballast between 4.5 m and 8.4 m beyond the points.

1.18 The shunter's body was found under the leading bogie of UK14179 and approximately 13 m beyond the points of the Mainfreight turnout at the turnout crossing. It was between the rails of the Carter Holt siding, and nearer the left rail.

- 2.4 The location of personal effects in the vicinity indicated that the accident was initiated approximately 4 m beyond the points of the Mainfreight siding.
