**Report 96-201**

**Fishing Trawler *San Manukau***

**off Cape Karikari**

**28 January 1996**

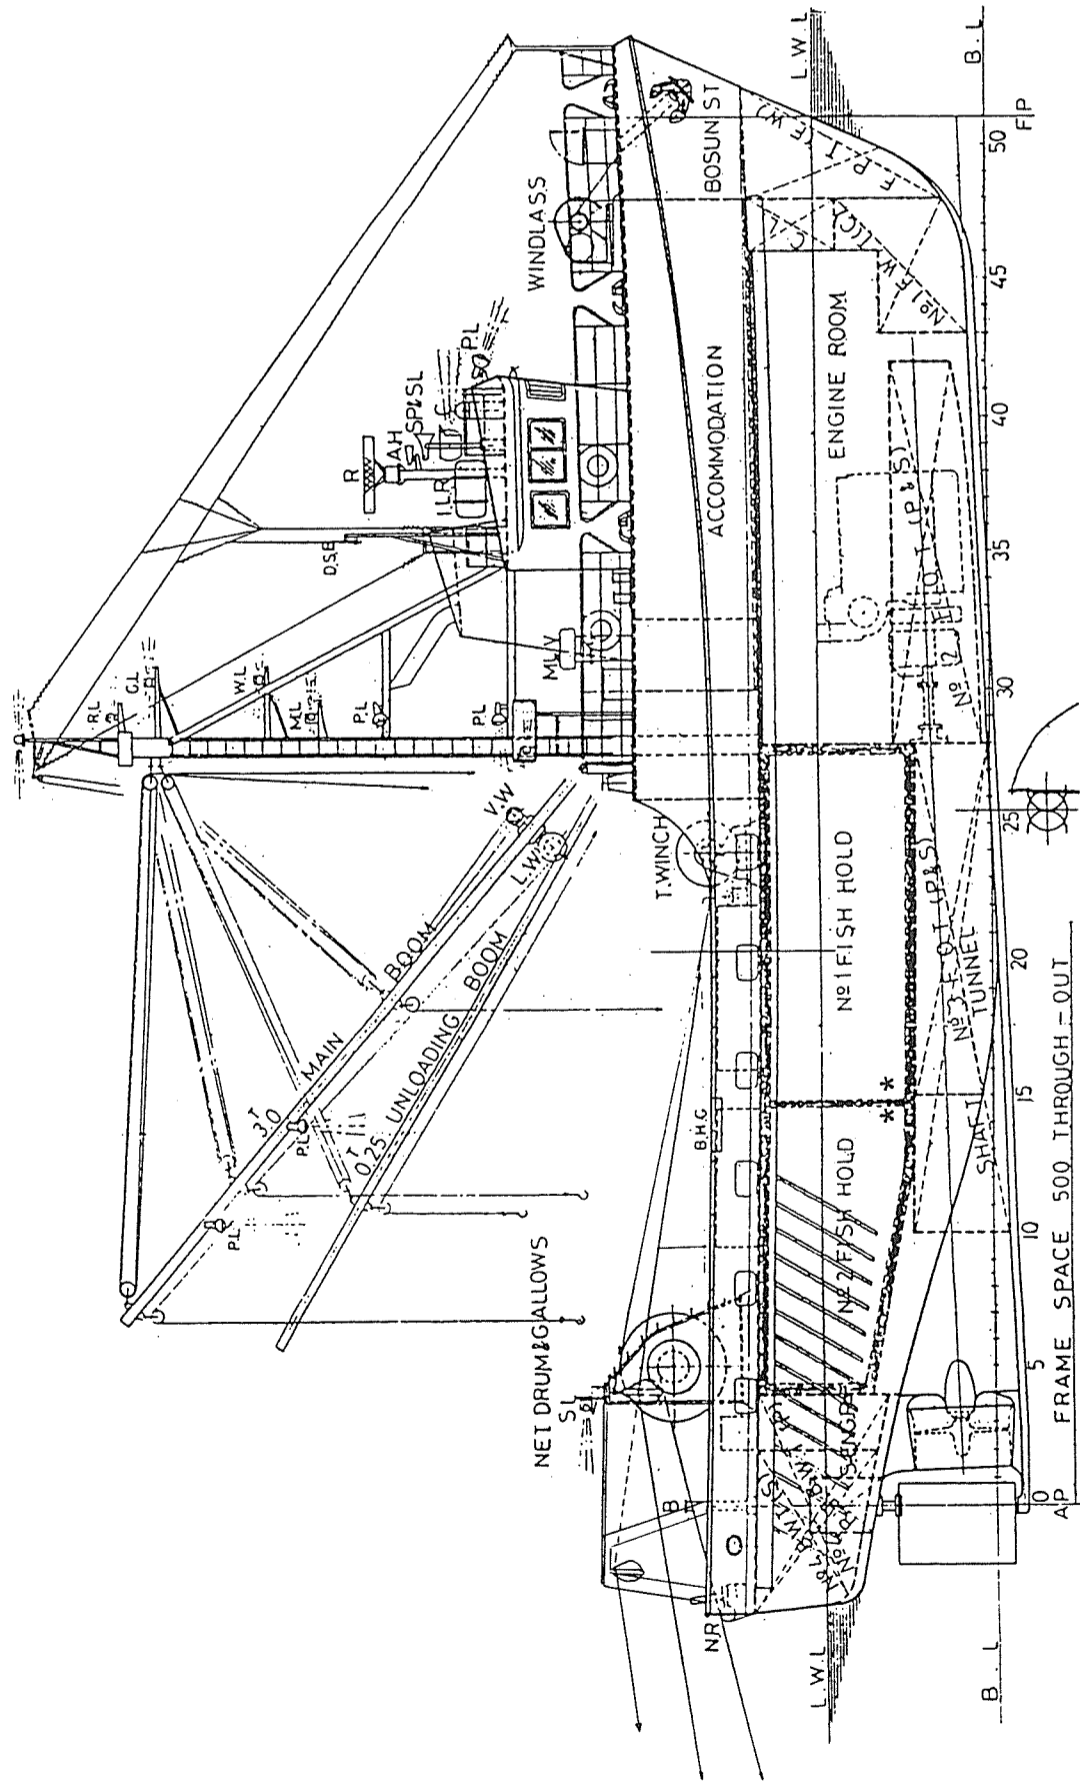
Figure 2  
San Manukau, profile

- 1.2.4 The catch was carried in the two fish holds which were supported on top of the shaft tunnel and the aft fuel tanks. The fish holds were common under deck but could be accessed through separate hatches on the main working deck. Each access was located within a larger working hatch for loading and unloading operations. The aft end of number two fish hold was supported by the solid floors in a void space which followed the line of the hull back from where the shaft tunnel and fuel tanks ended. (See Figure 2.)

- 1.2.5 The fish hold construction consisted of a layer of high density foam insulation sandwiched between layers of marine plywood and covered by a 10 mm layer of glass reinforced plastic (GRP). Timber bearers transferred the weight on the GRP floor of the hold through to the solid steel floors beneath. The wings (under-runs) of the fish holds were compartmentalised by solid GRP bulkheads into nine "bins" each side but the centreline run was common throughout (see Figure 4). Each compartment in the under-runs could be divided vertically by placing loose wooden boards into steel channel supports at two different levels. Using the same system of boards a working platform was usually constructed approximately one metre above the fish hold floor in the centre run. The platform usually extended from the forward end of number one fish hold back to where the floor of number two fish hold angled up to follow the line of the hull and provided a work area for sorting fish during loading. The space under this platform was often used to store lower grade fish in large bins (slurry tanks). Removable corrugated aluminium shifting plates held the fish bins, or ice, in the under-run compartments. There were no fore and aft watertight bulkheads to counter the effects of liquid free surface in the fish holds, although when the wooden boards and aluminium plates were in place, they would reduce any wave action caused by free liquid in the hold. The total volume of the two fish holds was 196.88 cubic metres. (See Figures 2, 3 and 4.)

\* Position of hold bilge wells

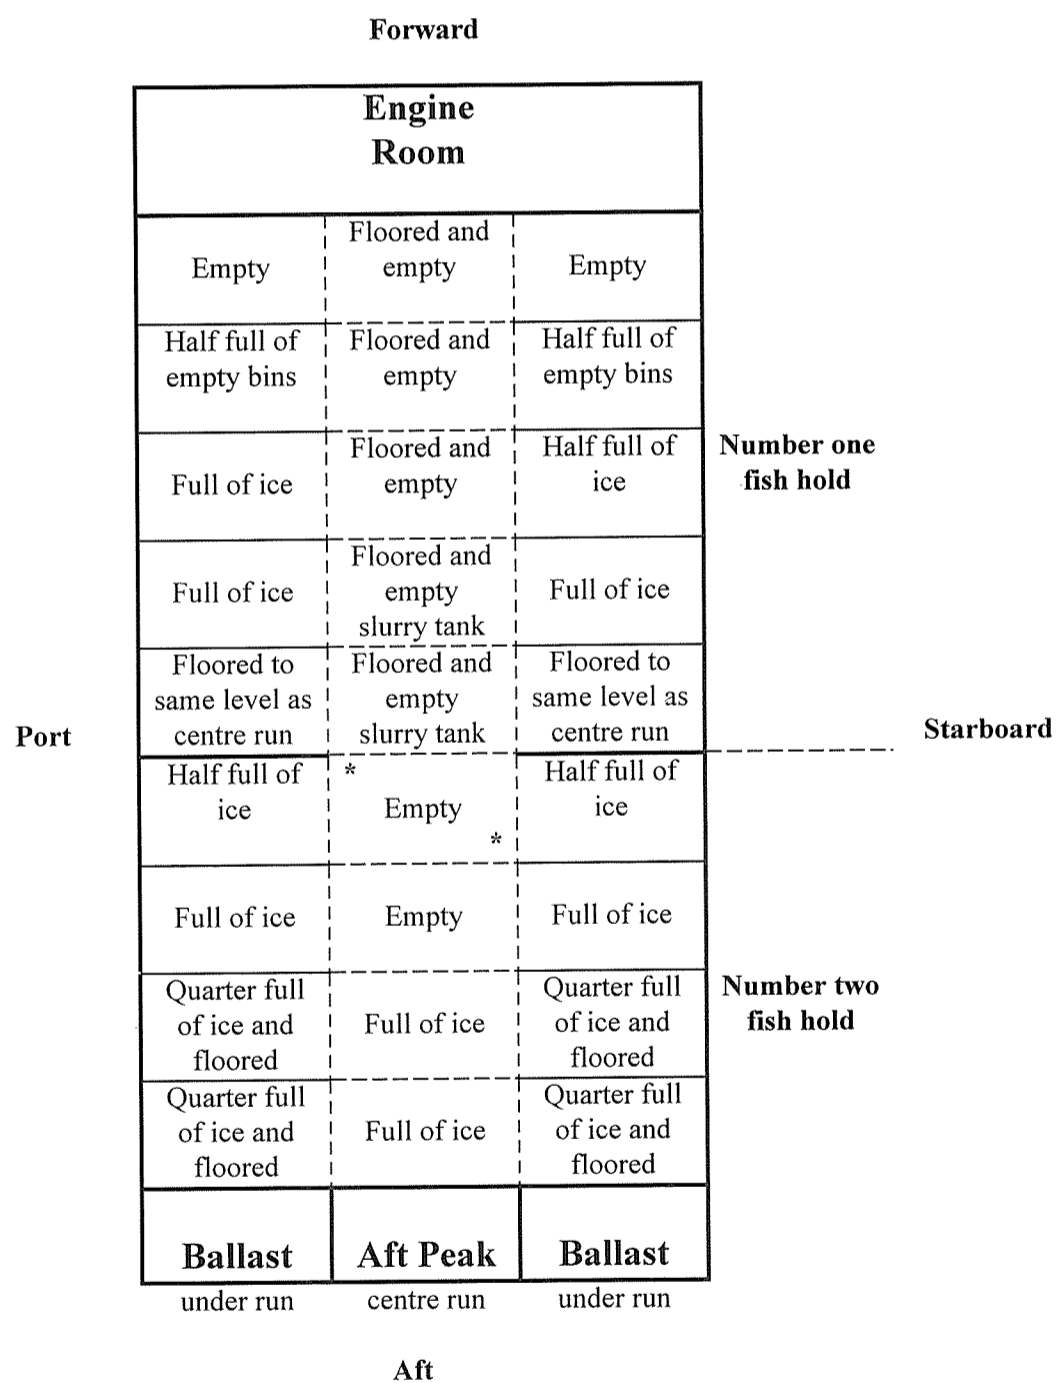
**Figure 4**  
***San Manukau* Fish Hold Plan**

1.2.6 On the accident voyage the *San Manukau*'s fish holds were set up as shown below in Figure 4.

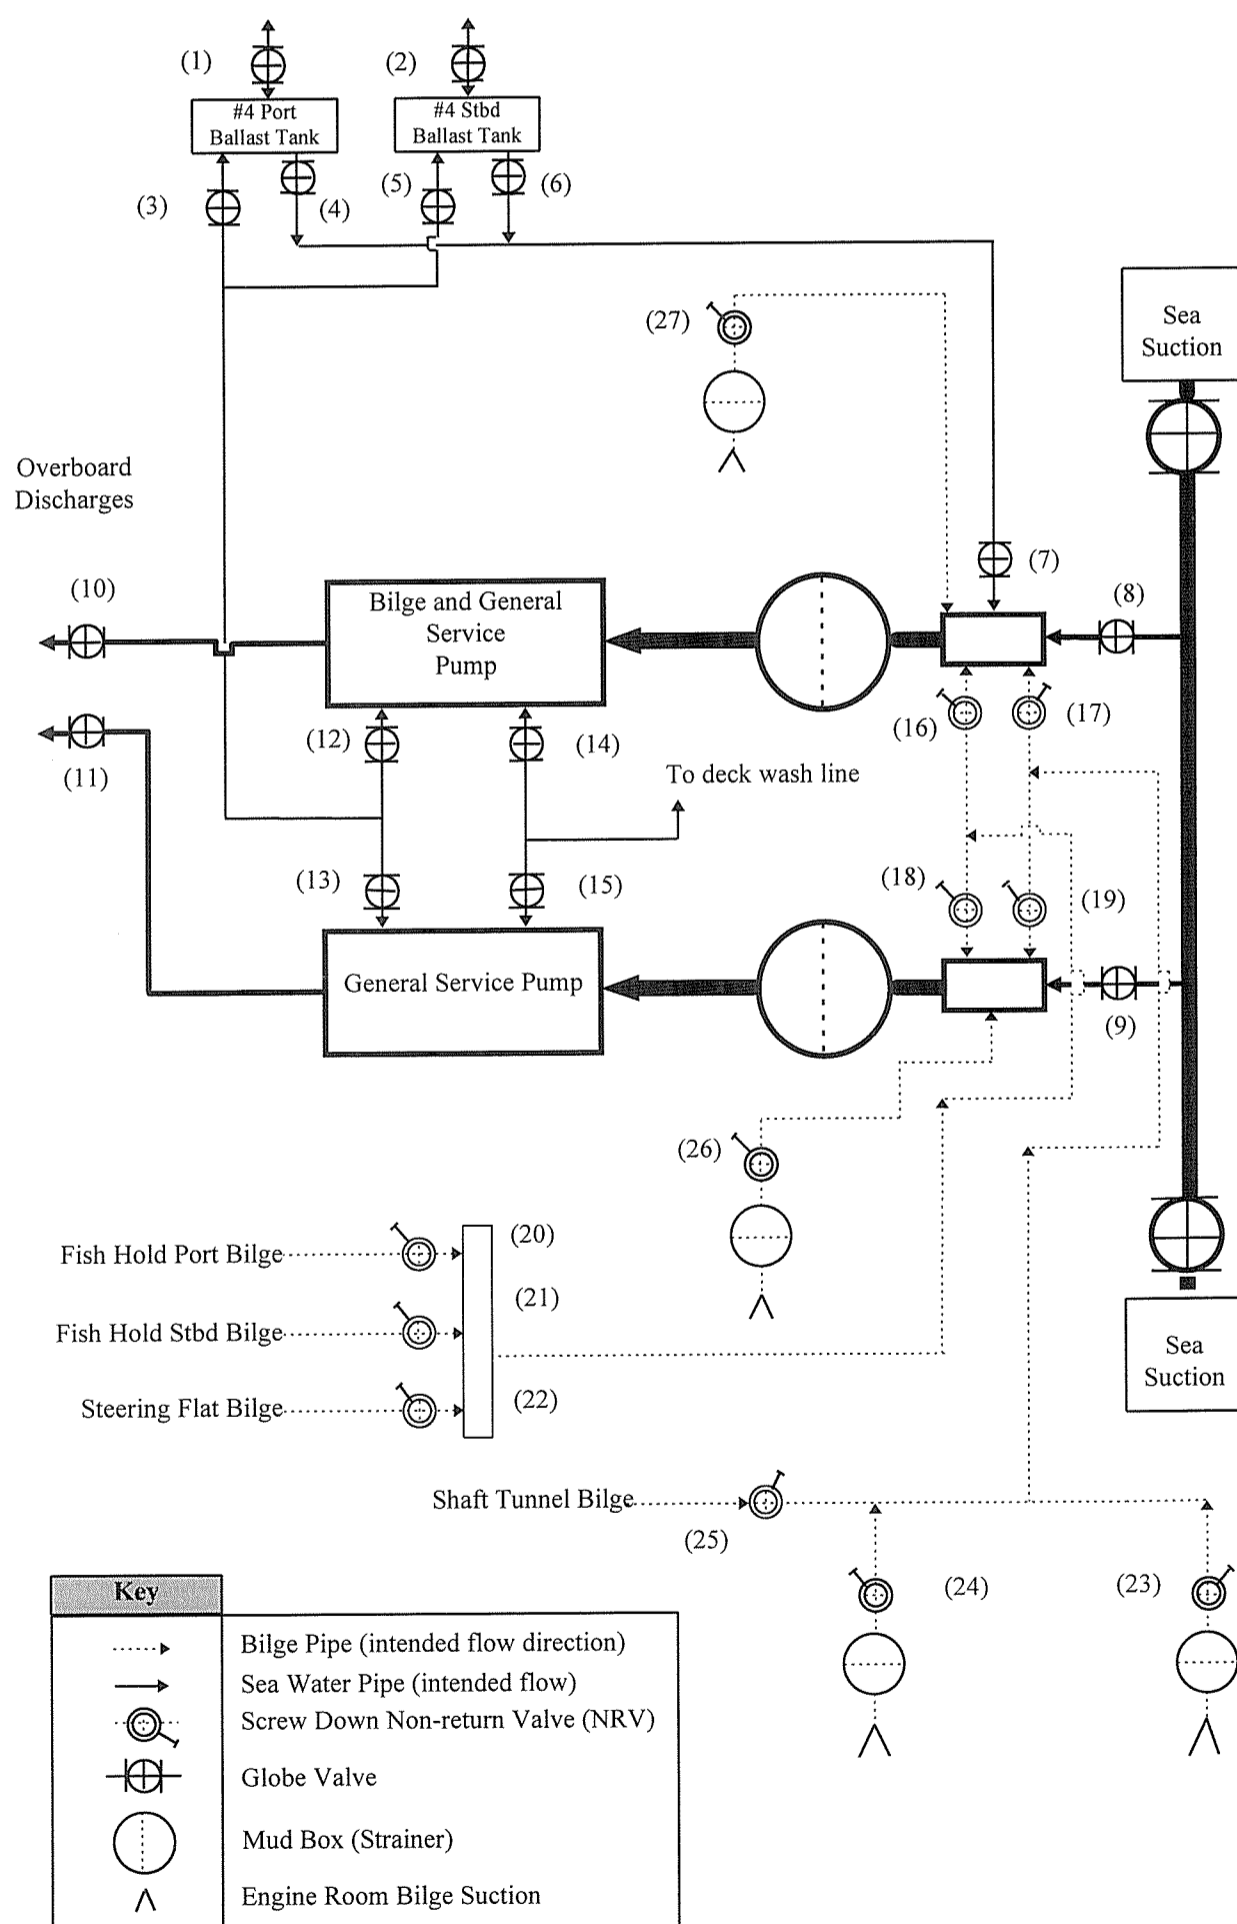
**Figure 5**  
**Schematic Sea Water and Bilge Water Piping Plan in Engine Room, *San Manukau*.**  
 (See 1.5.6 for details of valve functions)

- 1.2.10 The bilge and ballast water pumping arrangement was serviced by two centrifugal pumps located in the engine room; the “general service pump”, which was rated at 35 cubic metres per hour at 33 metres head, and the “bilge and general service pump”, which was rated at 35 cubic metres per hour at 15 metres head. The arrangement was designed so that both pumps could be used to pump from any bilge space, or to fill either of the two ballast tanks; however, only the “bilge and general service pump” could be used to pump from the ballast tanks. Each pump was fitted with a suction gauge which could be used to indicate if the pump was drawing water, air, or if a pipe was blocked, but only if the user was familiar with bilge pumping systems. (See figure 5.)

- 1.5.10 The bilge NRVs associated with the fish hold (numbers 20 and 21) and steering flat (number 22) were dismantled and inspected. All the valves, with exception of the steering flat bilge suction valve, were found with their internal “check” valve seized on to its spindle by scale and fish residue. This meant that the valves were acting as a normal globe valve allowing water to flow in either direction when open i.e. allowing water to flow back into the bilges when they were in the open position. The aft peak bilge suction NRV was operating normally.

- 1.5.11 The setting and condition of the NRVs, as found, meant that sea water had a free path back into the fish hold bilges at the time of the capsizing.

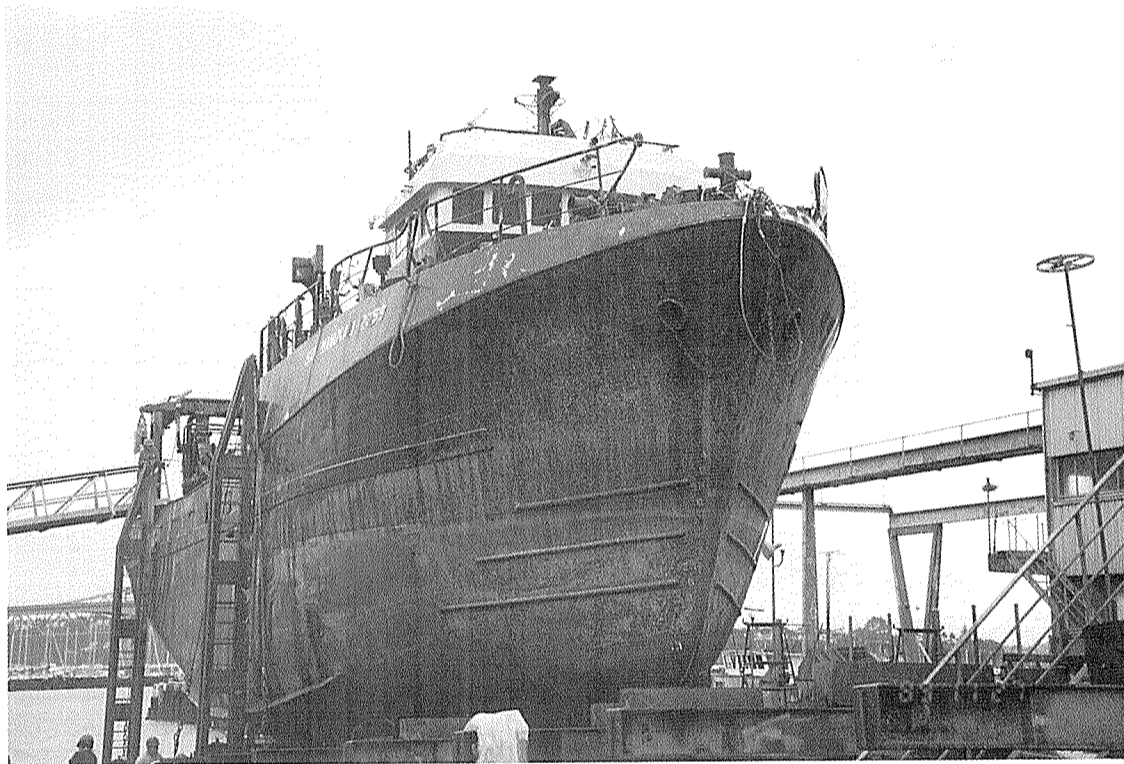
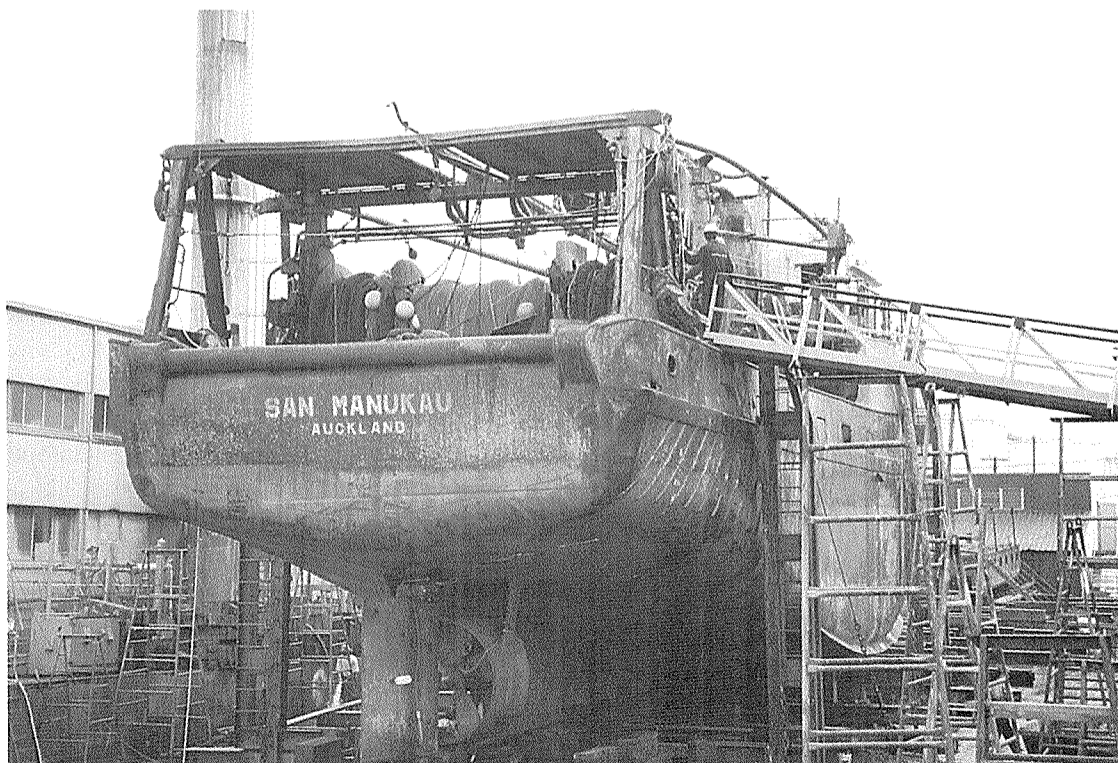
**Figure 6**  
*San Manukau on the slip after salvage*

- 1.5.7 On Sunday, 7 April the *San Manukau* left Manganui under tow bound for Auckland. On Tuesday, 9 April she was slipped in Auckland to undergo examination, assessment and partial repair. (See Figure 6.)

- 1.5.8 The number four port and starboard ballast tanks and their associated pipe work were pressure-tested and closely inspected to determine why the port tank had lost the unknown quantity of water that was initially thought to have caused the increasing starboard list prior to the capsizing. A sister vessel had previously encountered problems with ballast pipes leaking ballast water into the void space and fish hold. The problem on the sister vessel was traced to a leaking pipe, where vibration had caused the pipe to chafe and corrode where it passed through an opening in a solid floor in the void space. Sections of the *San Manukau's* fish hold floor were cut out to allow for inspection of the void space and pipe lines running through it. The void was found to be full of water up to a level just under the number one fish hold floor. The *San Manukau's* ballast tanks and pipe work were found intact and in very good condition.

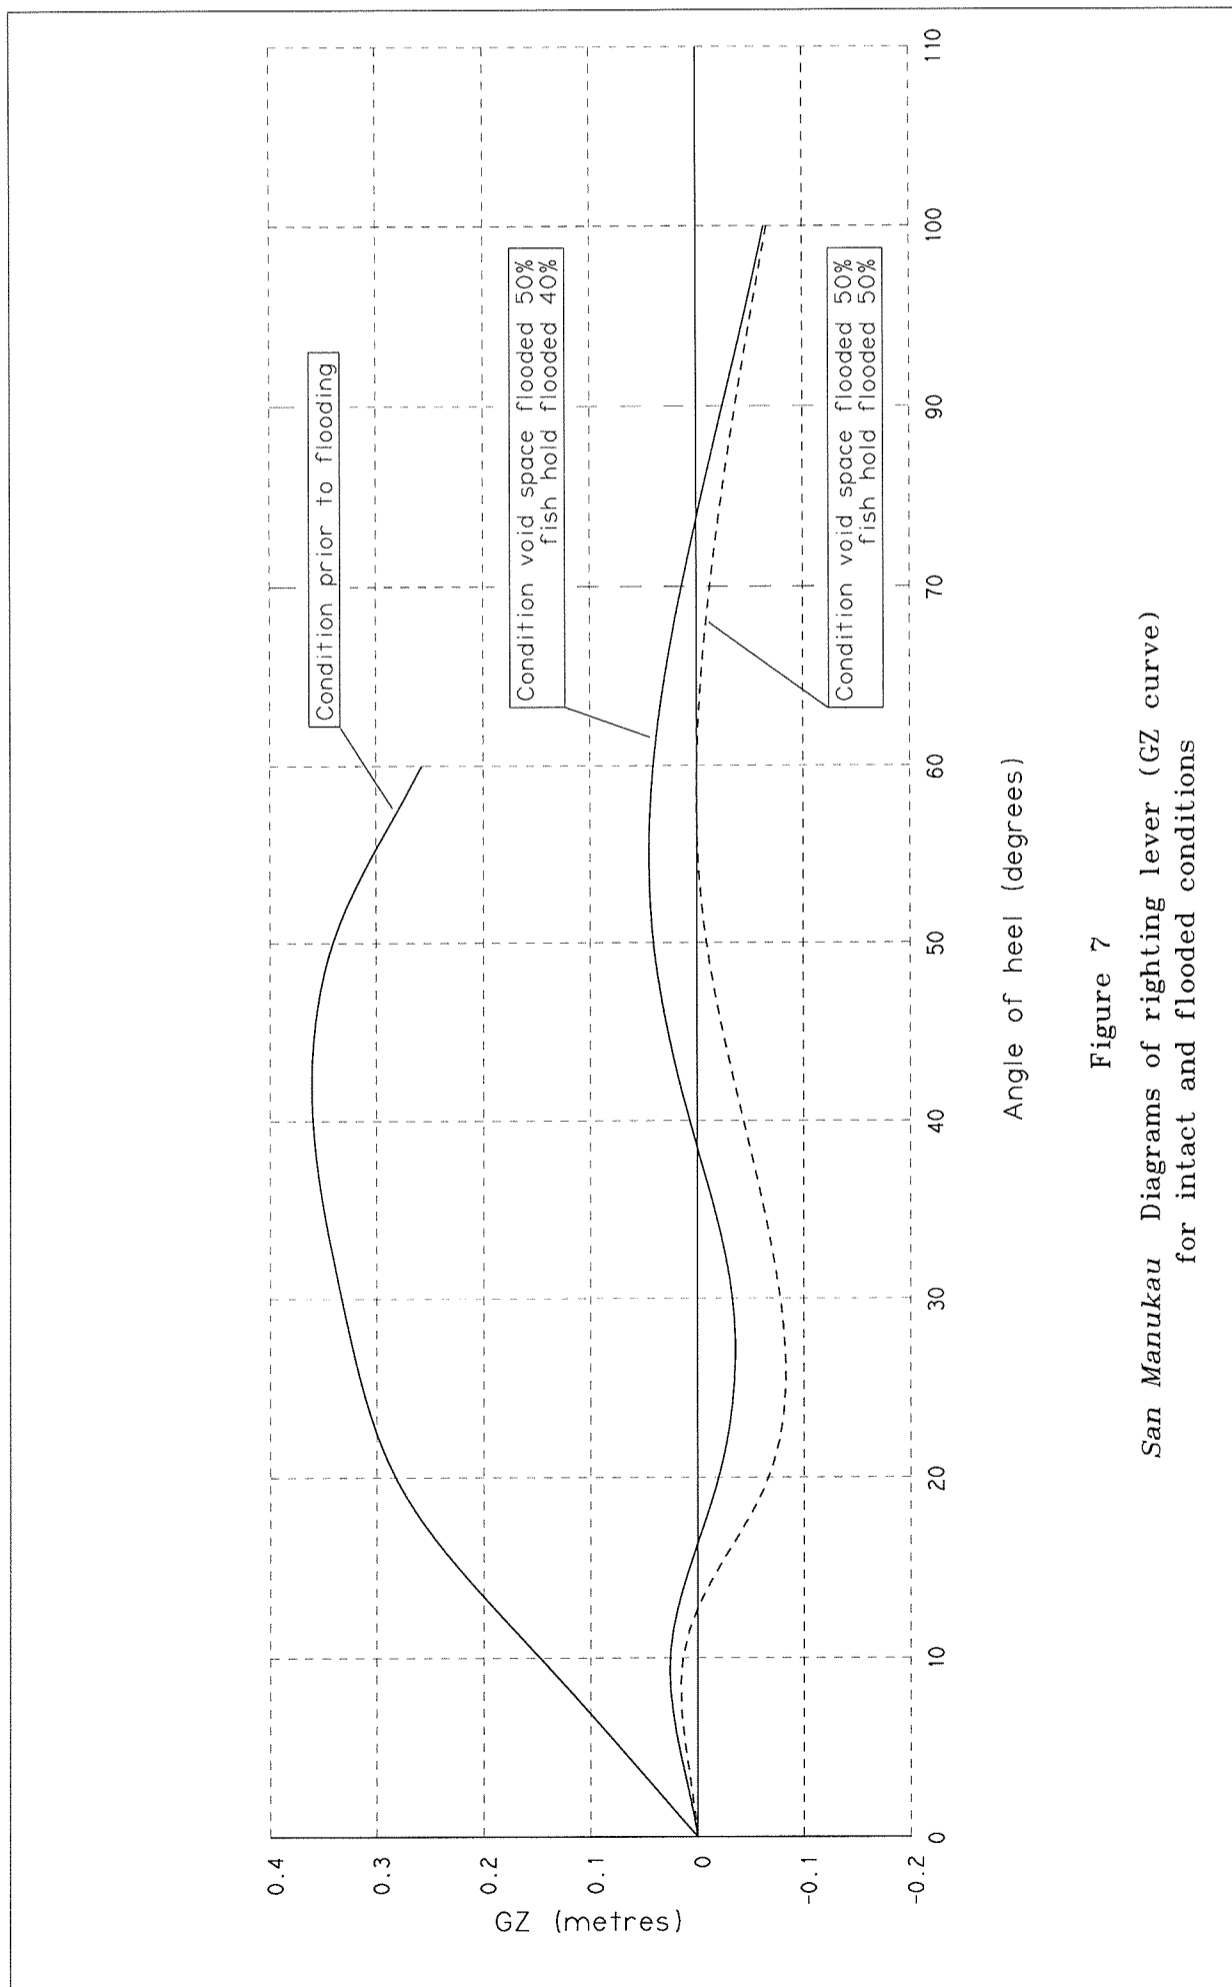
Figure 7  
 San Manukau Diagrams of righting lever (GZ curve)  
 for intact and flooded conditions

- 1.7.9 A computer model was made of the *San Manukau* and her response to loaded conditions analysed. The analysis was extended to consider the progressive flooding of the fish hold and void space by the mass transfer method to deduce the quantity of water in these spaces required to produce instability, and the manner in which the instability occurred.

- 1.7.11 Fifty percent of the combined volume of number one and two fish holds equates to 98 tonnes of water. Calculations indicate that it would take approximately 8.7 hours for this amount of water to flood back through the bilge system with the valve setting and condition as found. This figure may vary depending on the attitude of the vessel in the water and resultant driving force of the water through the bilge system. At the time of the vessel's capsize she had been at sea for 17.8 hours.
