Report 96-202

Whale Watch Passenger Craft *Uruao*

off Kaikoura

Marine Accident Report 96-202

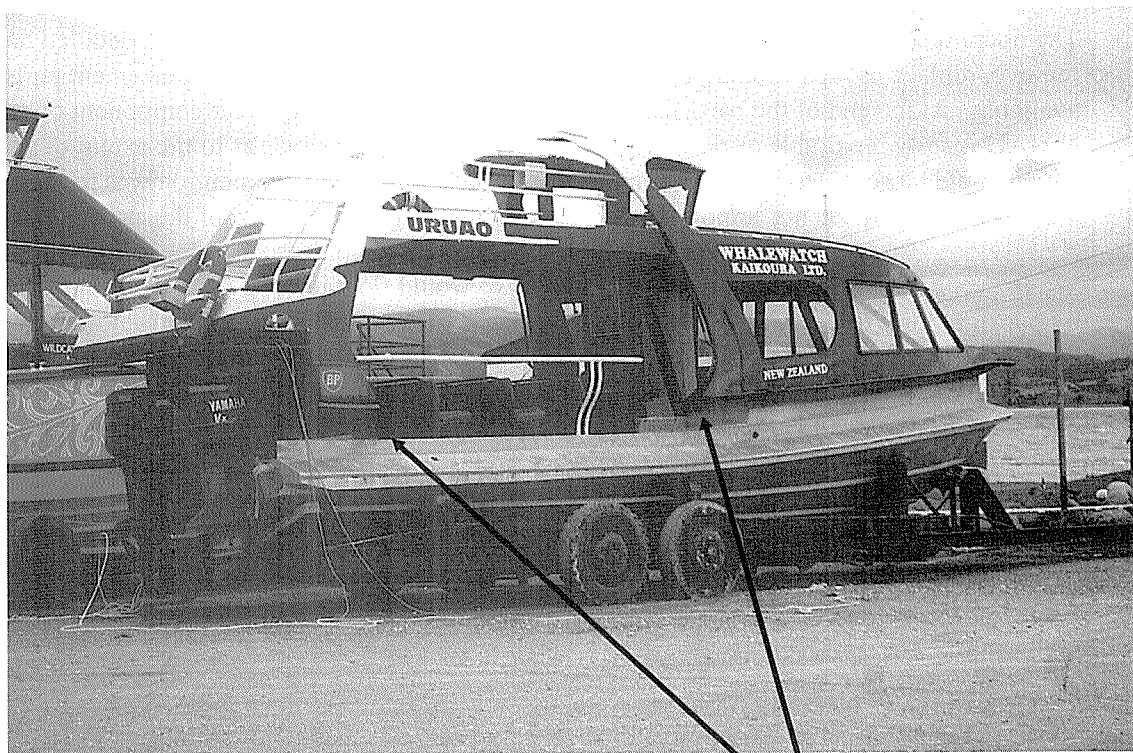
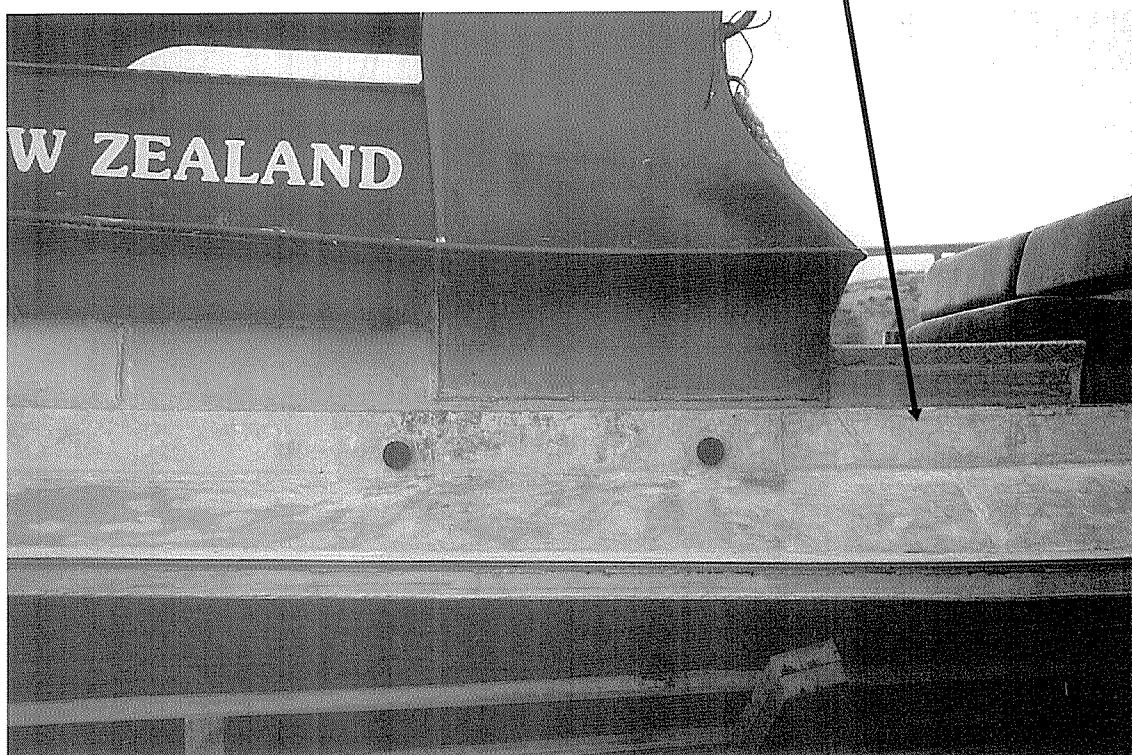
Figure 5
Photographs of *Uruao* without pontoons fitted

Quarter-round, low freeboard in this area

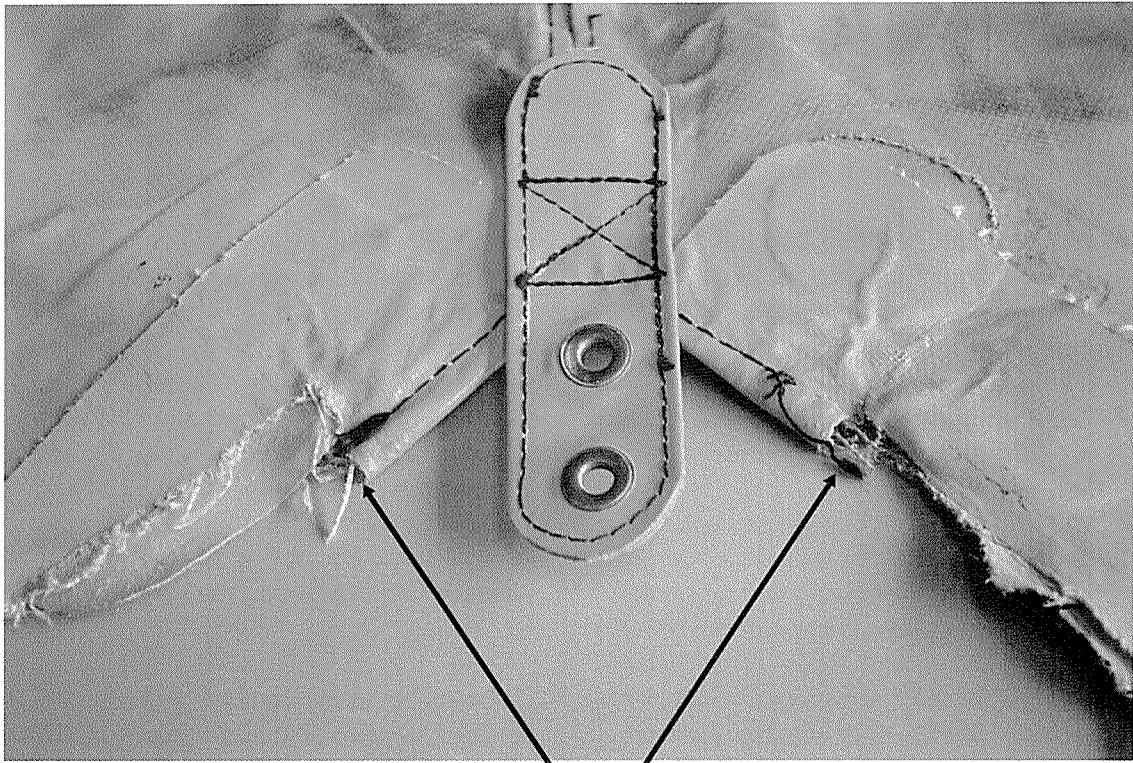
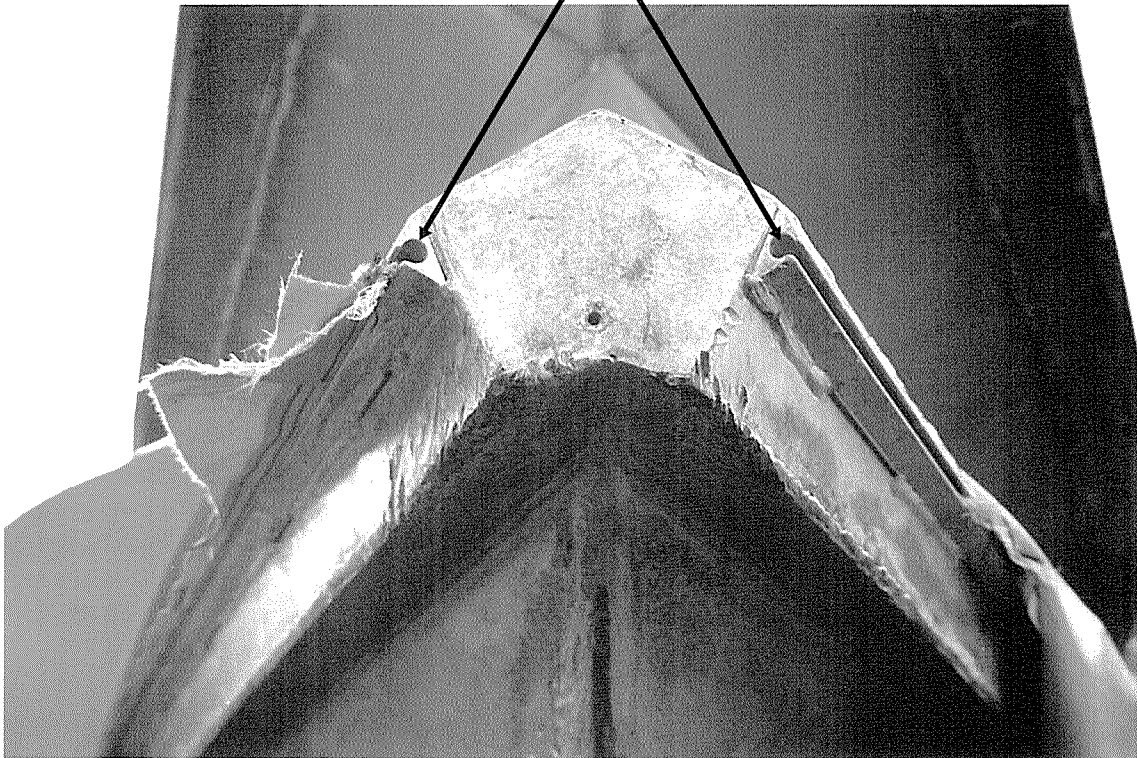
Figure 6
Photographs showing *Urualo's* bowsprit and points of initial failure of the bags

- 1.8.2 The repair to the bow section of the bags consisted of two, or three, layers of PVC glued and stitched over the worn and frayed original fabric. After the repair had been performed the rope ends did not continue under the securing tongue, but stopped on both sides at the point where the bag edge entered the aluminium extrusion. Removal of the outer PVC layer showed that the rope had originally extended almost to the seam under the securing tongue. The tongue was not secured at the time of the failure. The fabric and rope ends at the beginning of each tear were frayed and weathered. (See Figures 6 and 7.)

Boltrope termination

2.3 That the July 1994 repair fabric on the bow section was of a suitable strength was evidenced by the post-accident test results. However, during the course of the repair the securing rope appeared to have been cut, probably due to the tapered part being damaged, and stopped on both sides at the point where the boltrope channel entered the aluminium extrusion. The lack of the securing tongue, the end of the extrusion, and the change in the hull geometry combined to create a weak point. The rope was designed to add extra stiffening and strength across the weak point. Its absence caused the fabric to be “worked” more heavily at the weak point until the fabric split at this point on both sides of the bowsprit. This was exacerbated by the fact that the tongue was not secure, enabling the bag to creep forward allowing still more play in the fabric.

- 2.4 Once split, further working of the fabric in this area caused a tear to progress back through the reinforced repair for approximately 11 centimetres. The progress of the tear would have accelerated as the failing fabric allowed itself more play and opened a bigger gap for wave action to invade the space inside the bags. It could not be determined conclusively for how long the tears on both sides of the bowsprit had been present; however, the frayed and weathered end of the rope and fabric at the origin of the tear indicated that the bow region of the bags had been torn for some time, awaiting only a moderate force to initiate total failure of the craft's inflated buoyancy system.

3.5 The shortened boltrope and failure to attach the tongue to the hull resulted in a weakening of the bags to a point where they could not sustain normal working loads.

- 4.3.1 Review the NAIAD Instruction Manual and expand it to include full fitting instructions for the bags, and guidelines for the user regarding repair or replacement of wearable parts. (054/96)
- 4.3.2 Consider extending the half-round recess for the full length of the craft to ensure adequate freeboard in the event of deflation or loss of a pontoon on similar craft built in the future. (055/96)
- 4.3.3 Introduce a system where each set of bags has an identification mark that can be used to trace their movement and repair. (056/96)

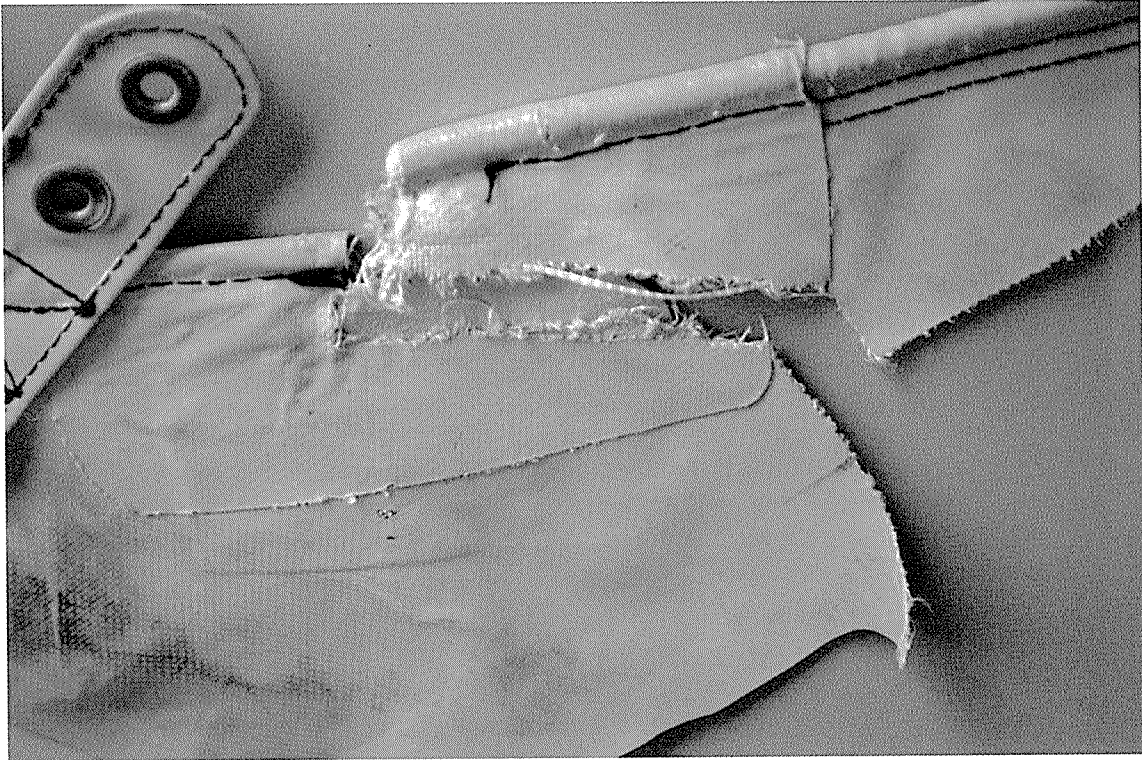
Figure 7
In situ photograph of boltrope on one side of the securing tongue
