Report 96-210

Longline Fishing Vessel *Amigo*

17 nautical miles south-west of Hokitika, West Coast

Marine Accident Report 96-210

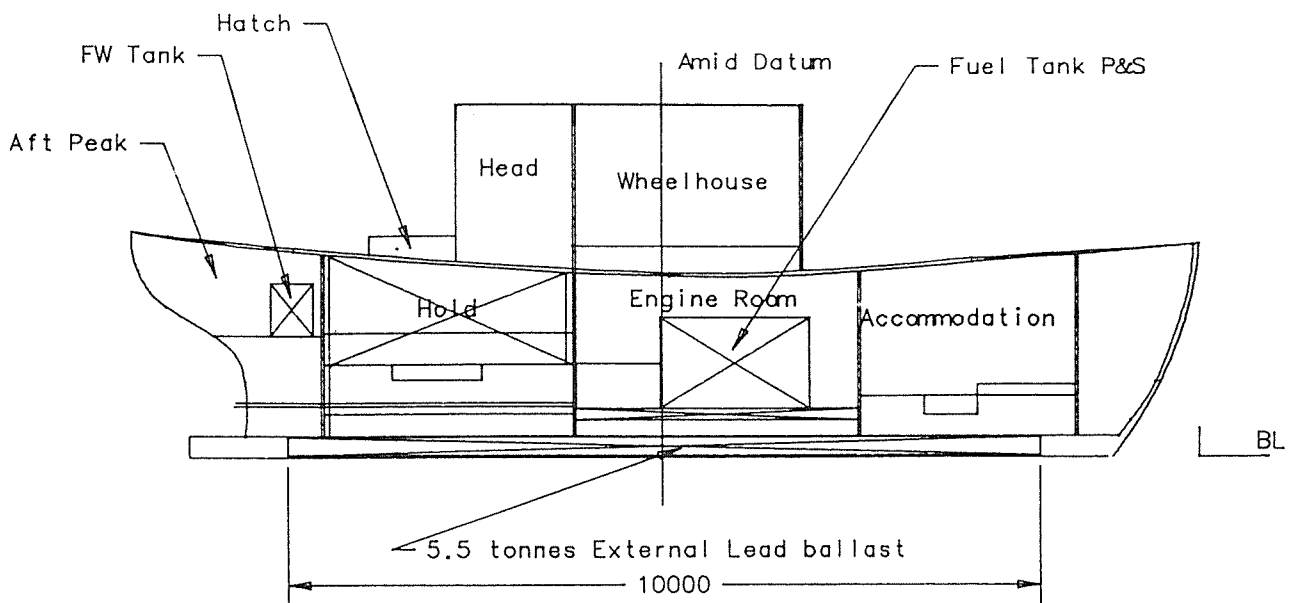
Figure 2
Profile of *Amigo*
(Diagram not to scale)

1.2.2 The *Amigo*'s engine-room was located amidships with the fish-hold aft and the accommodation forward of the engine-room. The wheel-house, which was located on top of the engine-room, had two sliding doors, one rear facing, which opened onto the aft deck, and the other opening to the starboard side of the vessel. Access to the accommodation and engine-room was from inside the wheel-house. (See Figure 2.)
