## **Report 96-214**

### **Collision between the container vessel *Sydney Express* and the fishing trawler *Maria Luisa***

**Wellington Heads**

**29 December 1996**

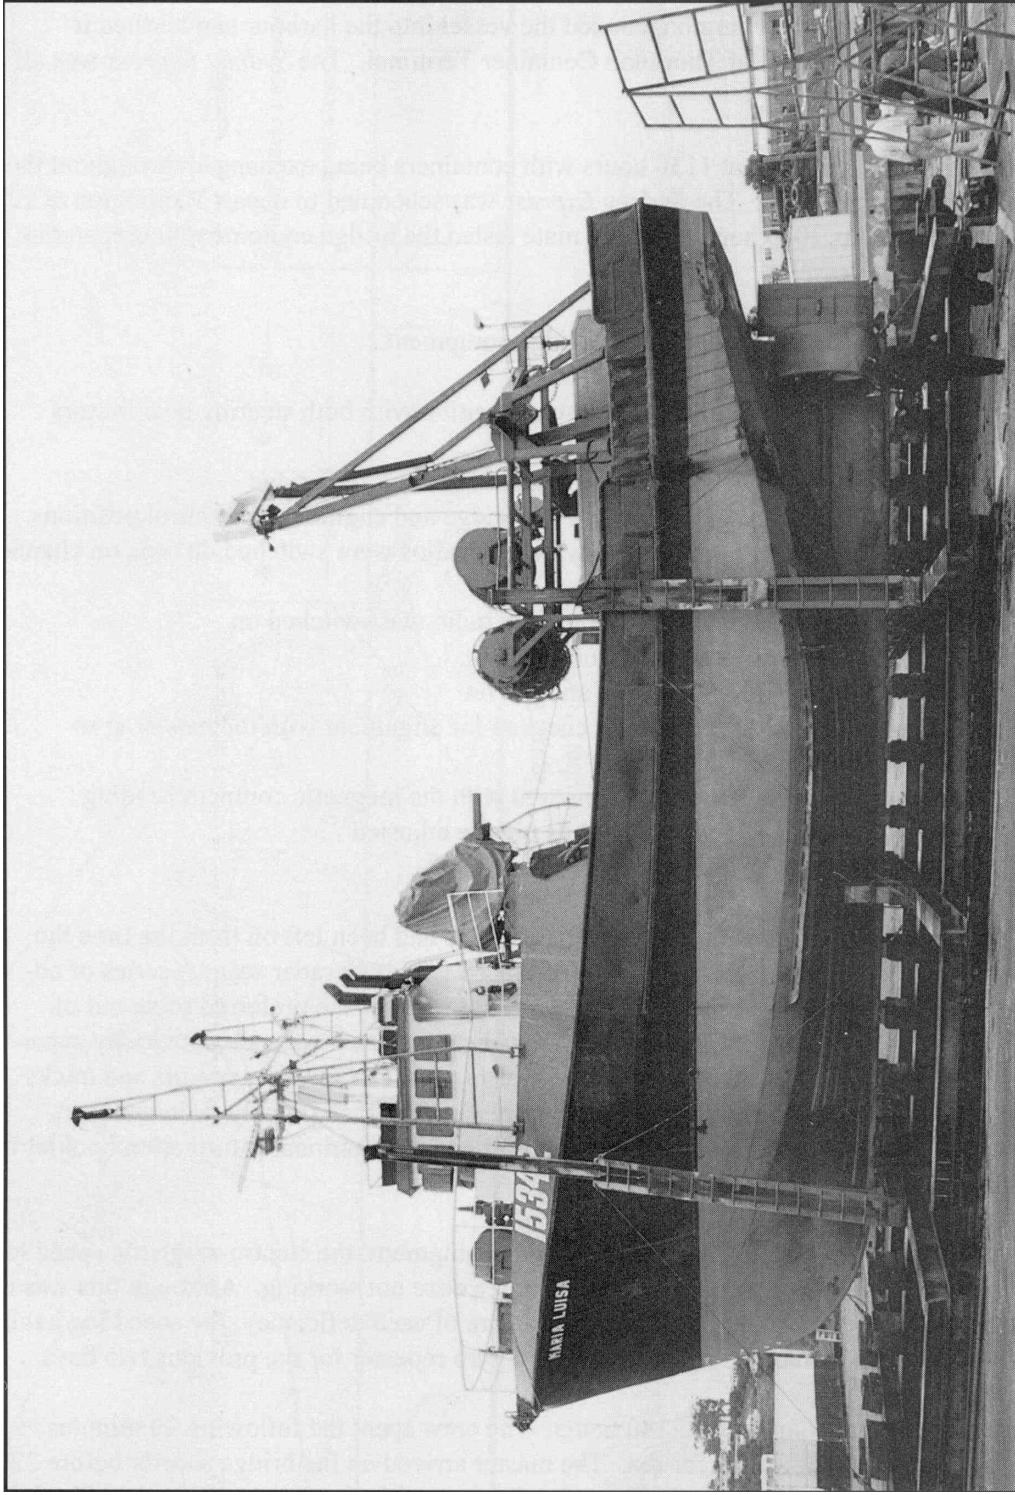
*Maria Luisa* on the slip after salvage

- 1.8.2 The *Maria Luisa* suffered moderate indenting, firstly at the point of initial impact, then down the port side in a direction forward and towards the keel. At the keel the direction of steel distortion changed to run back up the port side. The damage was consistent with the vessel having been turned over to starboard and forced under by the port shoulder of the *Sydney Express* until buoyancy forced it to the surface. Sea water damage to equipment was substantial.

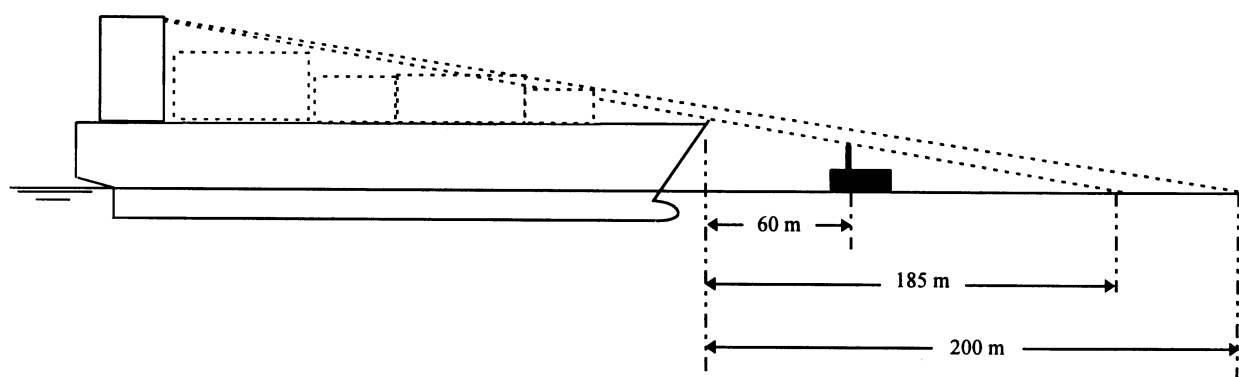
**Figure 3**  
**Visibility diagram showing approximate distances**  
**(Diagram not to scale)**

- 1.5.12 When the *Sydney Express* has no deck-cargo, and is in normal working condition of trim, there is a blind sector from the bridge that extends 185 m forward of the bow at sea level. When the vessel is carrying a full deck-load of containers the blind sector extends out to 200 m forward of the bow.

- 1.5.13 At the time of the accident the deck was only partly loaded. The visibility would have been restricted up to 185 m forward of the bow over the centre-line row of containers and to about 190m on either side out to the extremities of the vessel. The two cranes do not create any blind sector on the starboard side of the vessel.

- 1.5.14 The sidelights of the *Maria Luisa* would have been visible on the bridge of the *Sydney Express* until the fishing vessel came closer than 110m ahead. The masthead light, if operating, would have been visible until the fishing vessel came closer than about 60 m ahead. The sidelights on the *Soundsgood*, on top of the mast, would have remained visible regardless of how close the yacht was except when it passed behind the cranes as it went down the port side of the *Sydney Express*. (See Figure 3)

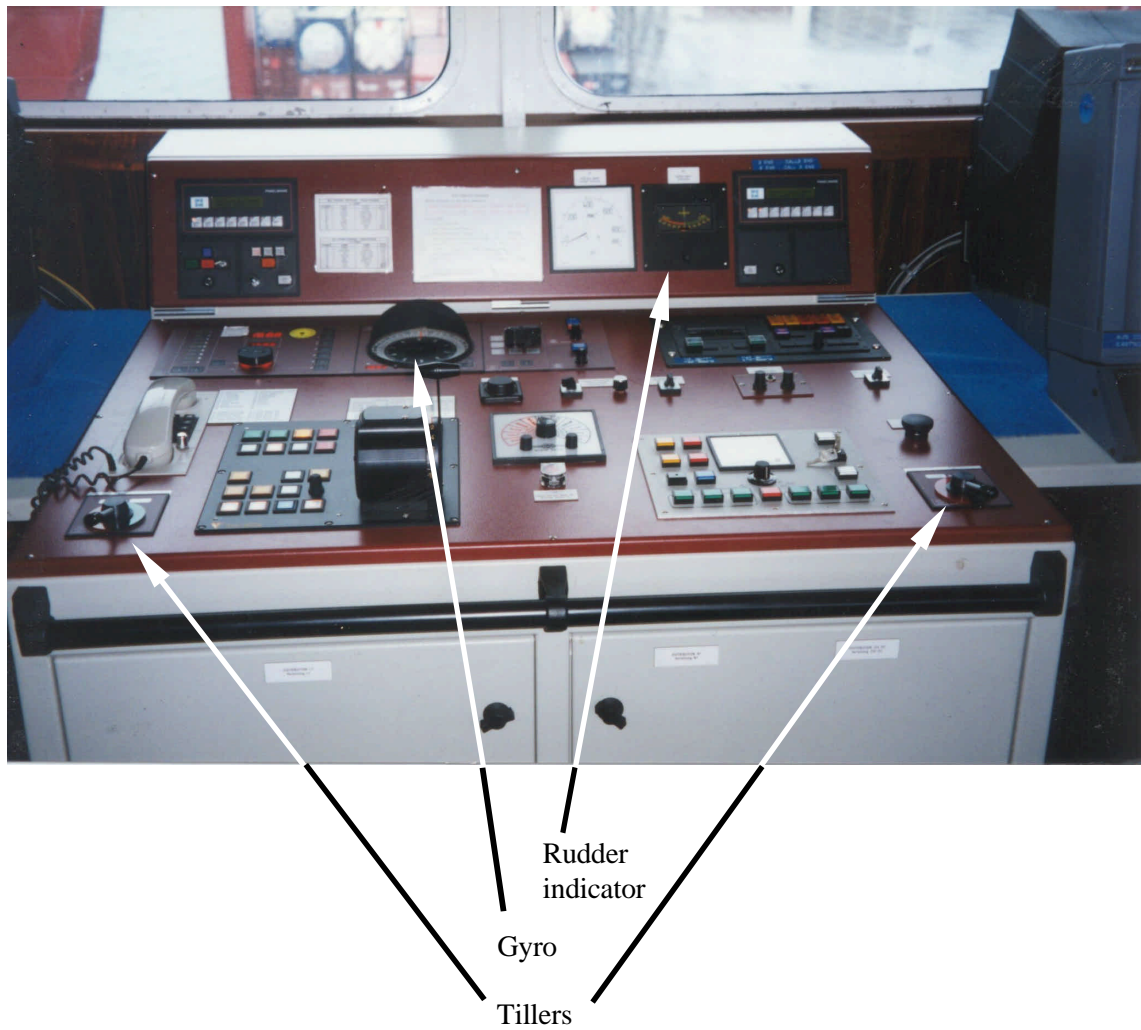
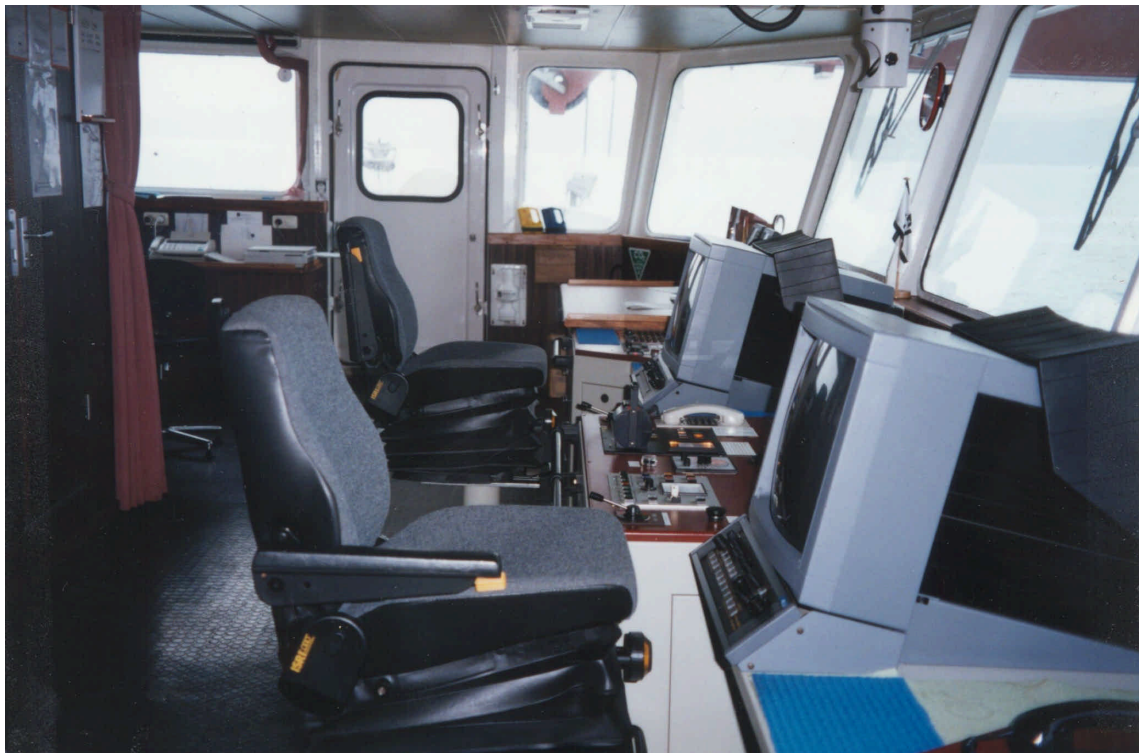
**Figure 4**  
*Sydney Express*, bridge and console layout

1.5.18 There is no steering wheel and each tiller operates in the non-follow-up mode. The tiller is held over in one direction until the desired rudder angle is observed on the rudder-angle indicator. The tiller, which is spring loaded, is then released and the rudder will stay in that position until either further or opposite rudder is applied using the tiller.

- 3.22 In putting the helm the wrong way the helmsman added to the master's workload, but did not cause the collision.
- 3.23 The master's unclear helm instructions under pressure, the poor ergonomics of the helm, and the helmsman's inexperience with it, were factors which contributed to the wrong helm application.
