Report 97-012

Beechcraft BE58 Baron

ZK-KVL

in-flight loss of control

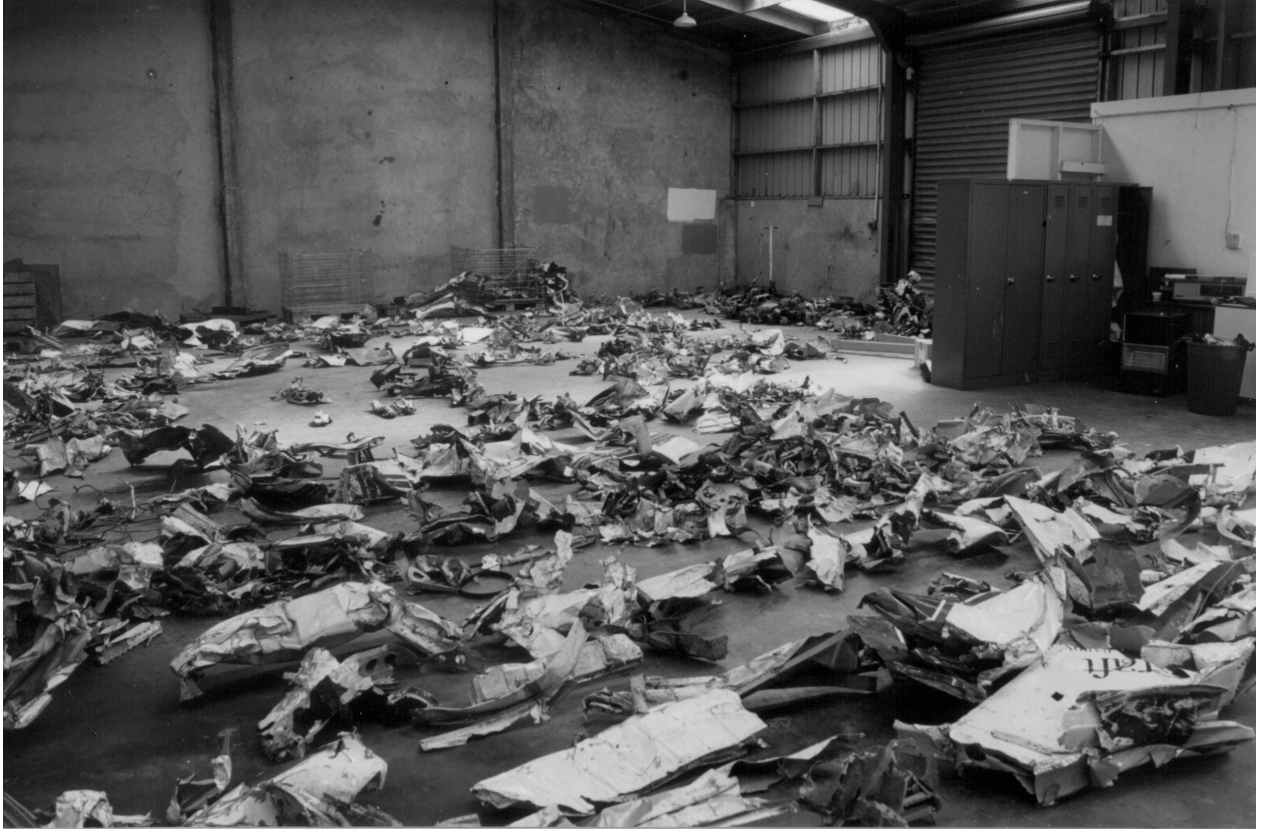
Wreckage of ZK-KVL
