Report 97-018

Various Boeing 767 and 747 aircraft

unrestrained cargo

Aircraft Incident Report 97-018

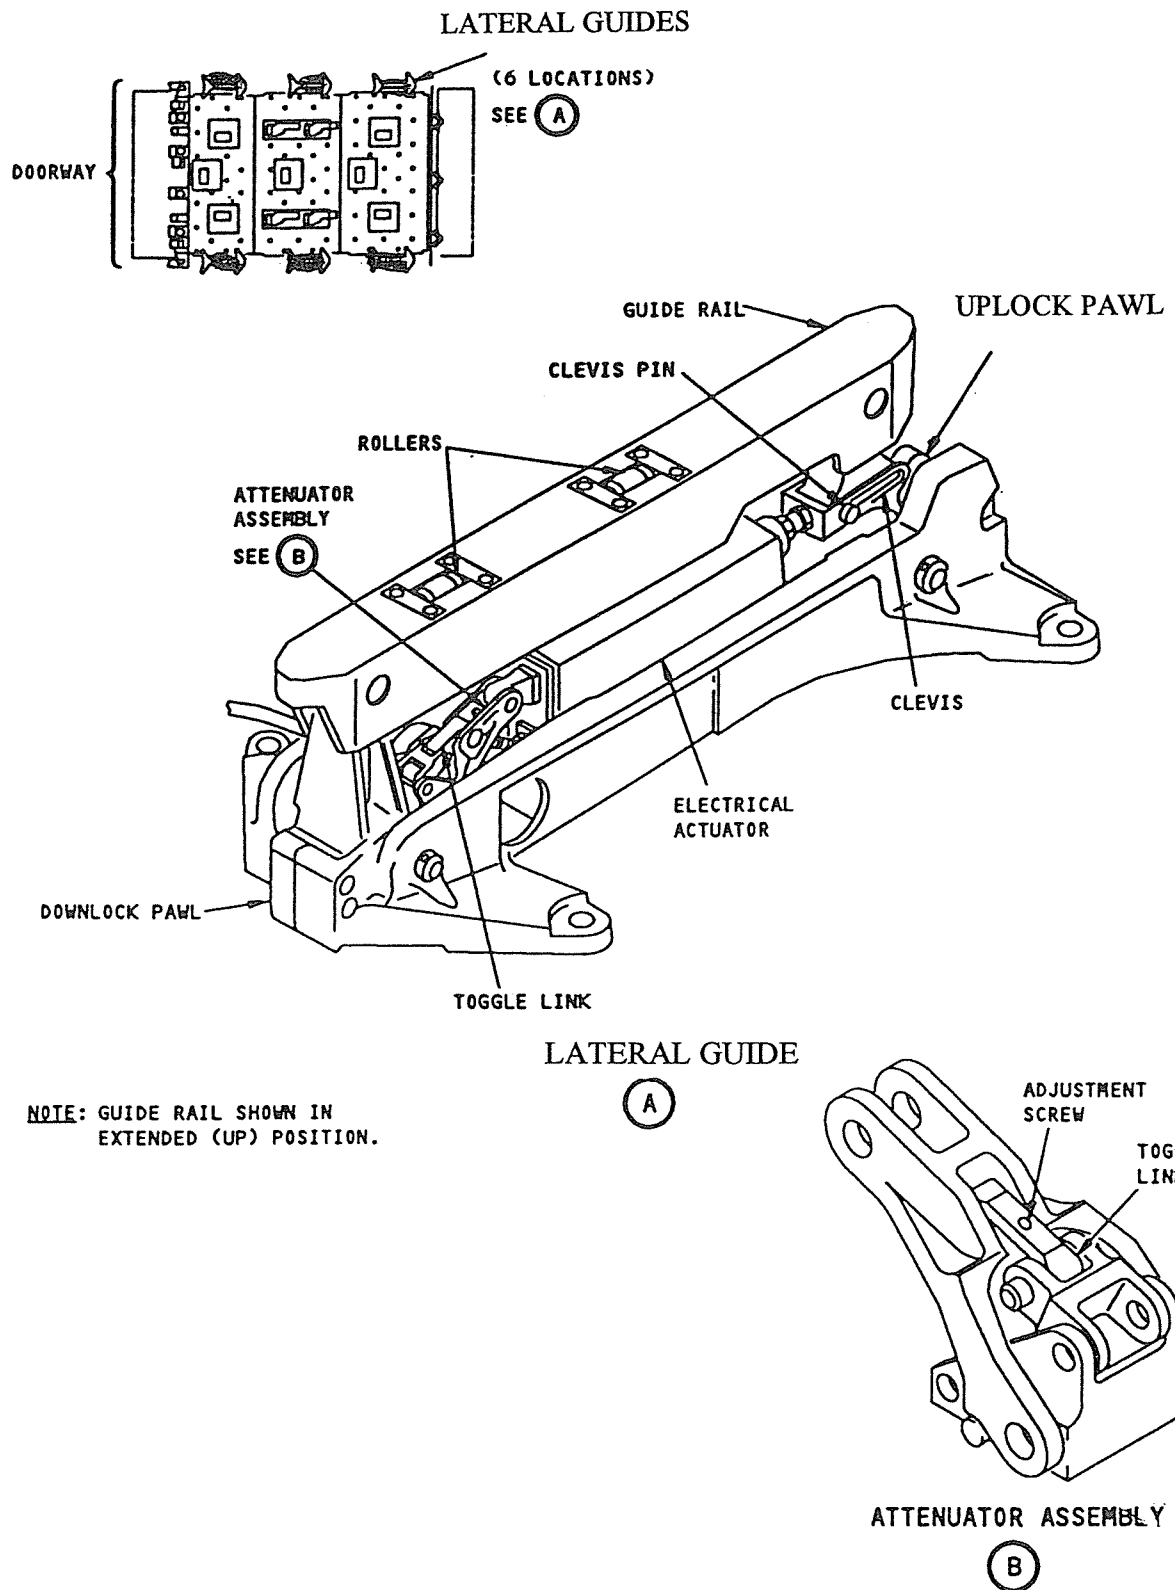
Figure 2
Lateral guides

- 2.23 The lateral guides (see figure 2) were devices designed to keep the ULDs aligned as they moved into the hold and to re-erect automatically after the load had passed over them. The re-erection was particularly important when, as in this case, there was a “no-fit” in the aircraft compartment(s) immediately inside the door.

- 2.24 The guides in each hold were in two rows of three, one forward and one in the centre of the forward hold doorway compartments and one row on either side of the rear hold doorway compartment. When electrically operated the guides automatically raised when a load was being transferred into the aircraft from the JCPL. When the loader selected the direction in which he wanted to drive the cargo from the doorway the lateral guides, which would otherwise obstruct the movement, were automatically retracted. At the completion of the loading the lateral guides returned to the raised position.

- 2.25 Most Boeing 767 aircraft, including two QANTAS aircraft which these loaders had dispatched earlier in the shift, had electrically operated lateral guides. As the Air New Zealand Boeing 767 aircraft did not have electrically operated lateral guides the guides had to be operated manually. As they could not be reached once a load was inside the doorway, they could not be raised to guide the load in on occasions when they would subsequently obstruct the progress of the pallet or ULD in the required direction. The lateral guides were required to be raised and locked by hand after the pallet or ULD had passed over them.

- 2.30 Experience showed that some of Air New Zealand’s Boeing 767 aircraft were arriving for routine maintenance with all of the manually operated lateral guides unserviceable due to a distortion of the latch which was intended to keep them in the raised position. Examination of the damage to the latches indicated it was unlikely to have occurred in normal usage. The bending of the component to disable the lateral guides was effected in a position which was not vulnerable to damage by cargo passing over the guides.

- 3.28 There was some evidence that the removal of the actuators from the lateral guides led to interference with the manual latches to prevent the guides being used. Some aircraft were found during routine maintenance to have all of the lateral guides deactivated in a similar manner. The acceptance of aircraft for loading with all of their lateral guides inoperative removed the defence against insecure loads provided by one series of locks. The acceptance of the aircraft for loading with all of its guides inoperative, as must have occurred before the aircraft was taken in for maintenance, indicated an uncritical approach to the serviceability of in-hold equipment by loading gangs and engineers alike.

- 6.1.8 Consider introducing more frequent inspections of the lateral load guides on the B767 in-hold loading equipment, or other appropriate measures, to ensure that any damage caused to these devices in the course of loading operations is detected and rectified promptly. (113/97)
