Report 97-103

Train 3656

collision with motor vehicle

Transport Accident Investigation Commission

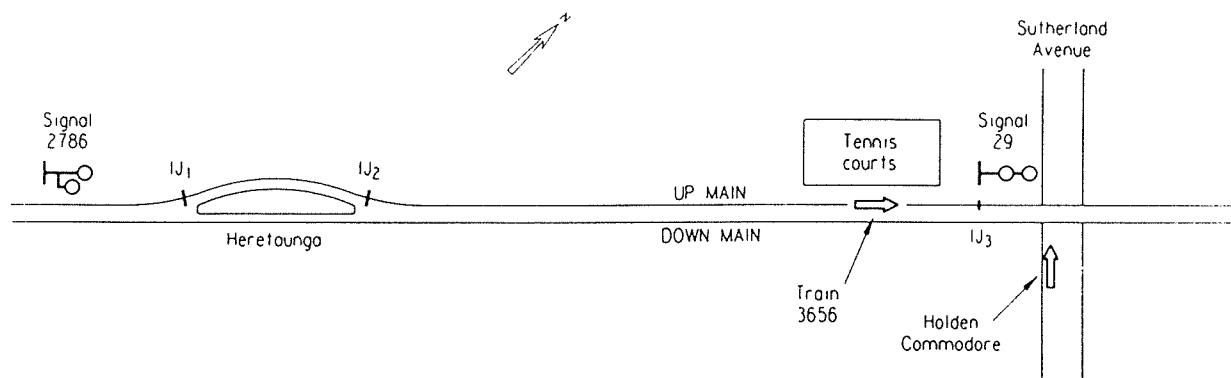
Figure 1
Locality diagram (not to scale)

- 1.1.4 Heretaunga has an island platform. North of Signal 2786 the two tracks diverged and the LE could not see Signal 29 ahead as the Up Main curved left to the platform. Figure 1 shows a diagram of the layout.
