Report 97-109

Train 138

derailment

Te Kauwhata

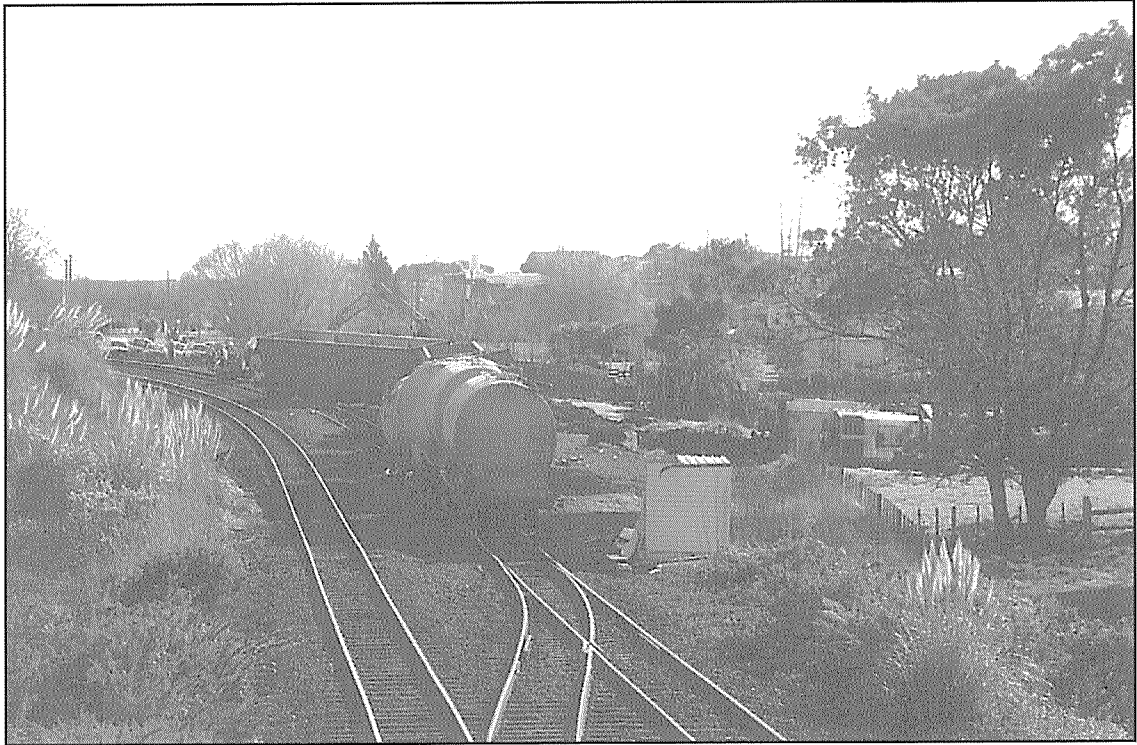
- 1.1.25 The locomotive overturned to the right, as it negotiated the crossover, derailing the following wagons. The locomotive separated from the wagons and travelled on its right side, tangential to the track coming to rest approximately 100 m beyond the point of derailment (POD) and 25 m away from the up main. (See Figure 1 and Figure 2)

- 1.1.26 The seven derailed wagons continued to follow the general line of the down main and came to rest over the up main and loop alignment with the leading wagon at approximately 591.293 km, some 40 m north of the locomotive.

Figure 1
General view of the derailment site looking north

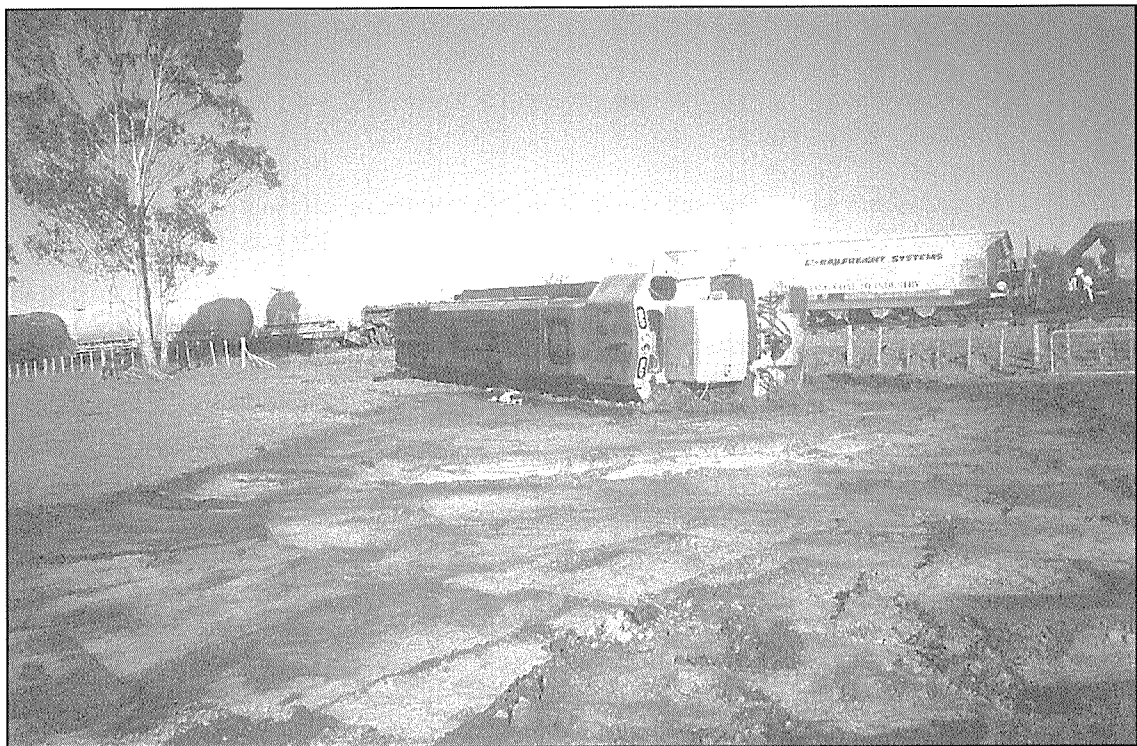
- 1.1.27 The locomotive, wagons and track were damaged substantially.
- 1.1.28 The LE stated that his first memory after the derailment was hearing someone tapping on the locomotive side window and he assumed that he had been unconscious for a short period of time. He received cuts and abrasions. Although these were assessed as minor at the time, later complications required the LE to be off work for several months.

Figure 2
DC 4755 viewed from the east side

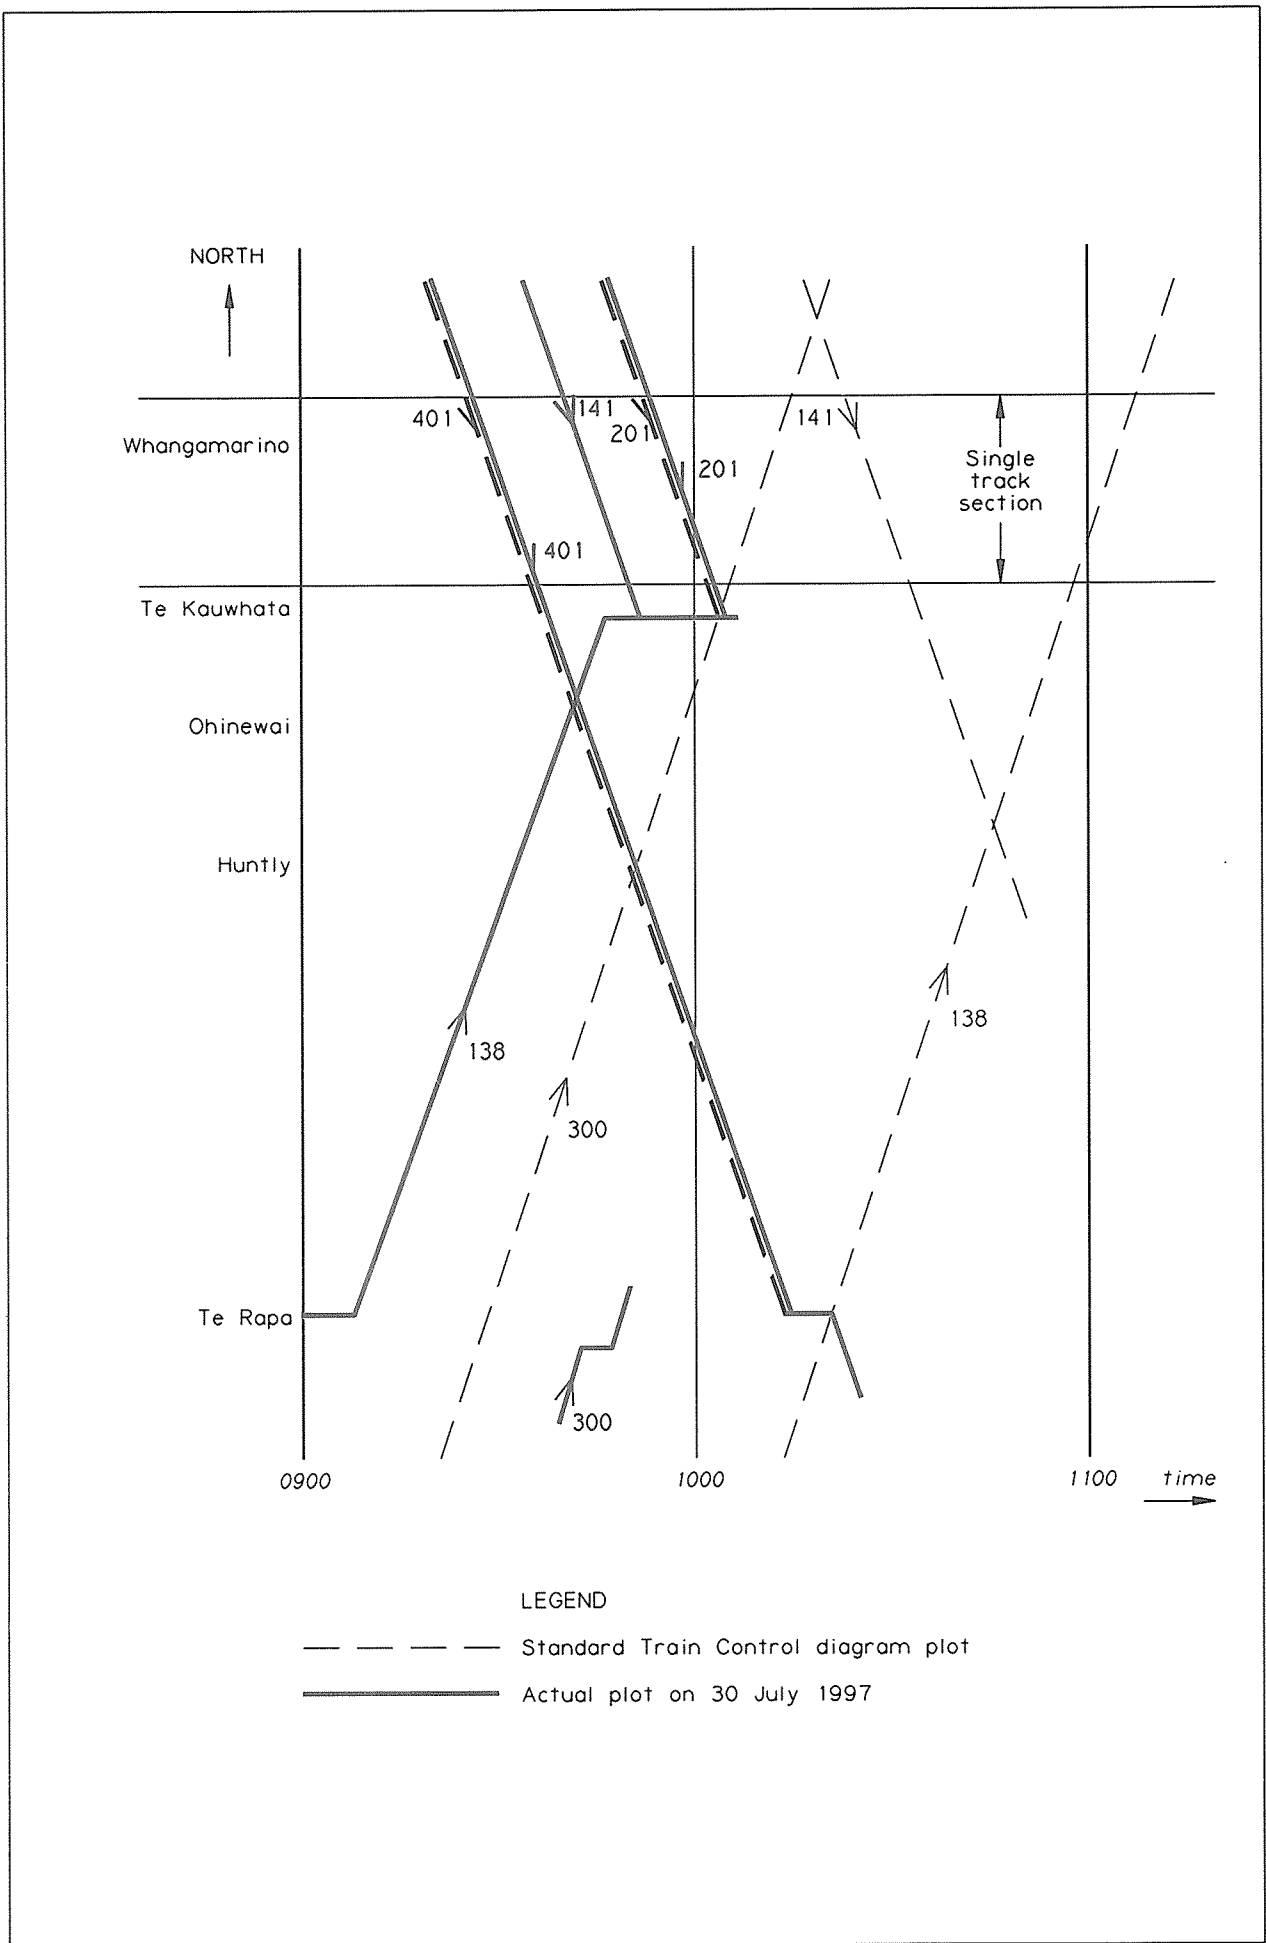
1.5.7 The Train Control Officer's (TCO's) report indicated that the routing of Train 138 to the loop was primarily to suit the particular train movements at the time, although it also achieved the de-rusting requirement. Figure 3 is a plot of part of the Train Control diagram for 30 July 1997.

- southbound passenger Train 201 running to time
- southbound freight Train 141 running approximately an hour ahead of its standard plot and ahead of Train 201
- northbound passenger Train 300 running close to time (Train 300 was not pulled out at Te Rapa until after the TCO had set the loop for Train 138 at Te Kauwhata)
- northbound Train 138 running over an hour ahead of the standard plot.

Figure 3
Train movements
