Report 97-110

Shunt M28

level crossing collision

near Morrinsville

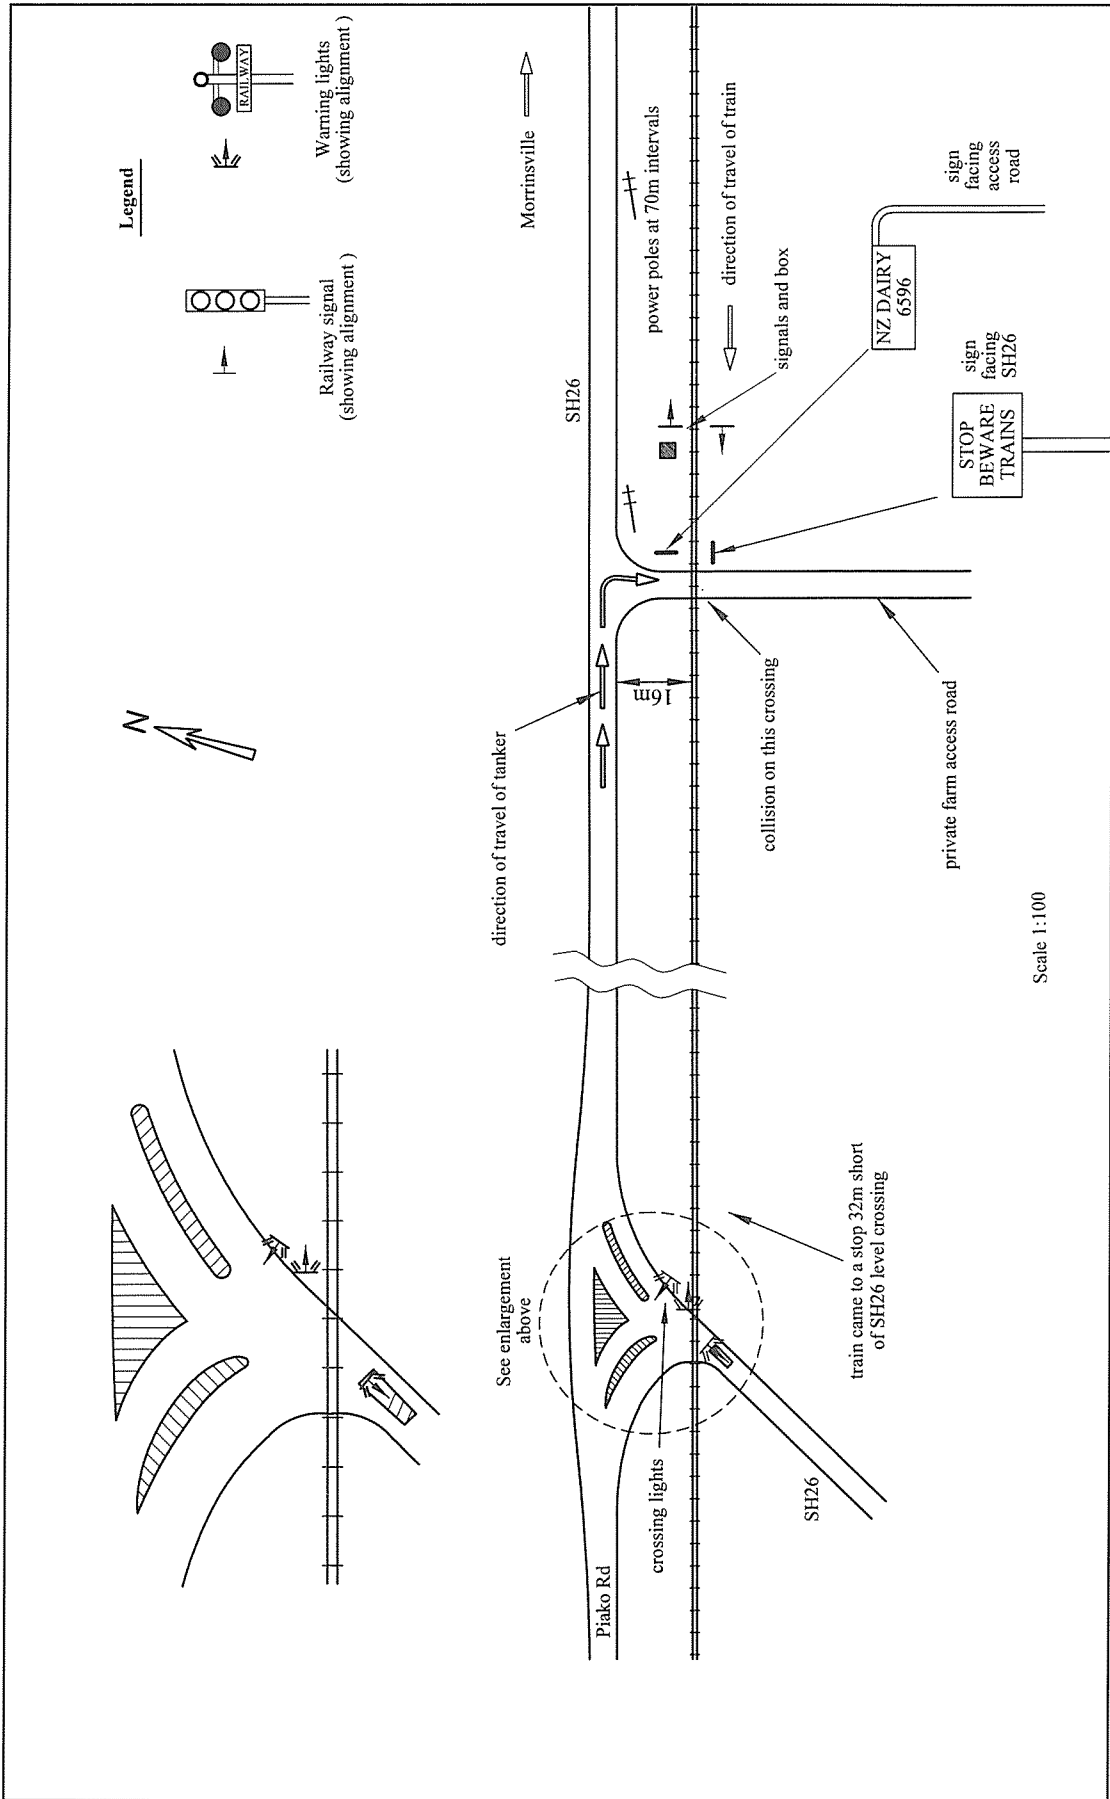
Figure 1
Collision of Shunt M25 with milk tanker near Morrinsville

- 1.6 The shunt was travelling west and the tanker eastward in an area where state highway (SH) 26 and Piako Road run parallel and close to the railway line for about 4.6 km. The level crossing was about 1 km from the Morrinsville end of the area in which the road and rail ran alongside each other (see Figure 1).

- 1.11 Some 50 m to the right (south) of this intersection is the level crossing where SH 26 crosses the railway. For motorists travelling towards Morrinsville on Piako Road the lights on this crossing are designed to attract the attention of any who turn right off Piako Road into a slip lane before crossing the highway and entering the level crossing. A “seagull” patterned intersection guides the Piako Road traffic in an arc to the left then to merge straight ahead onto the state highway which joins from the right (see Figure 1).

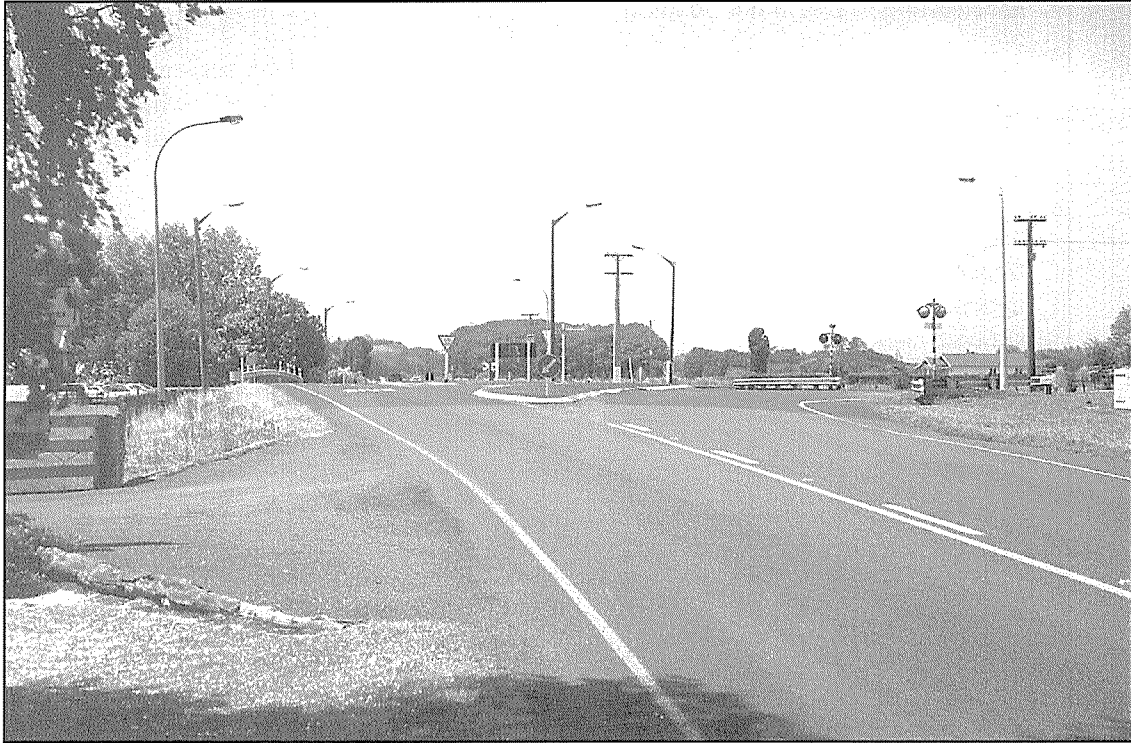
Figure 3
View from tanker cab of rail and road facing Morrinsville from turn point

- 1.14 At the point on SH 26 from which the tanker driver had to make a right turn to enter the property the headlights of a westbound train would first come into view some 1030 m before it reached the private level crossing. Although the tanker driver’s view of an approaching westbound train was generally clear (see Figure 3) the driver’s line of sight, from his turn-in point on the road centreline was interrupted by 15 concrete poles supporting the conductors of a power line which paralleled the railway.

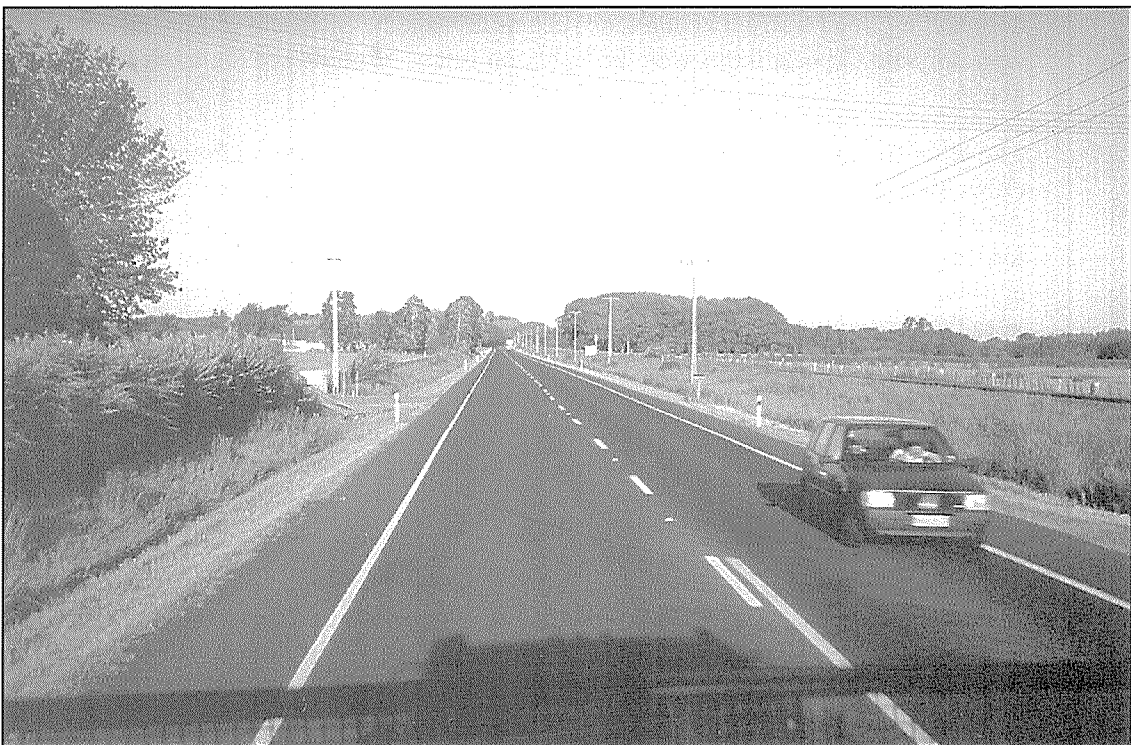
Figure 4
View of SH 26/Piako Road intersection facing Morrinsville

- 1.15 Prior to reaching the intersection between SH 26 and Piako Road the driver’s view of the railway ahead was blocked by the signage on the traffic islands associated with the intersection (see Figure 4).
