Report 97-111

Train C25

log fall from wagon

Rail Incident Report 97-111

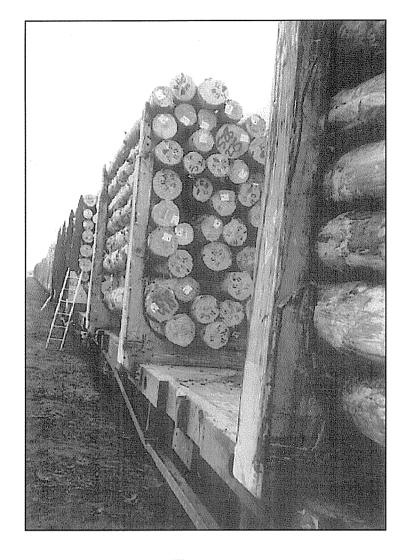
Figure 1
End view of Wagon ULE 213 at Mount Maunganui prior to unloading

- 2.3.1 The photographs taken of the loaded wagons on Train C25 at Waharoa and Mount Maunganui showed that in a number of cases the logs were loaded higher than allowed by the code. From the photographs it was determined that at least eight of the wagons were loaded more than 200 mm above the top of the cradles. Seven of the wagons showed logs which had significant non-compliance with code requirements for longitudinal projection beyond the outside of the cradle. Figures 1 and 2 show typical height and projection non-conformity.

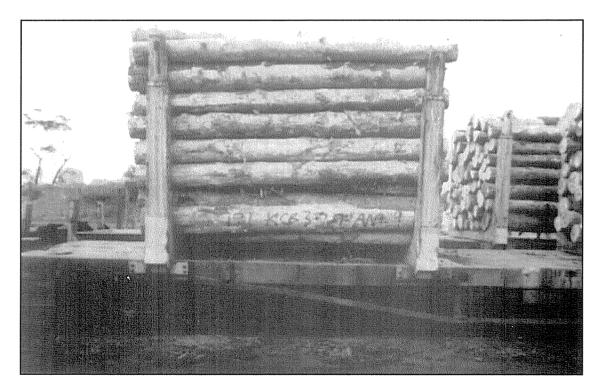
Figure 2
Side view of wagon ULE 213 at Mount Maunganui prior to unloading
