Report 97-114

Train 801

tunnel door closed on train

Otira Tunnel

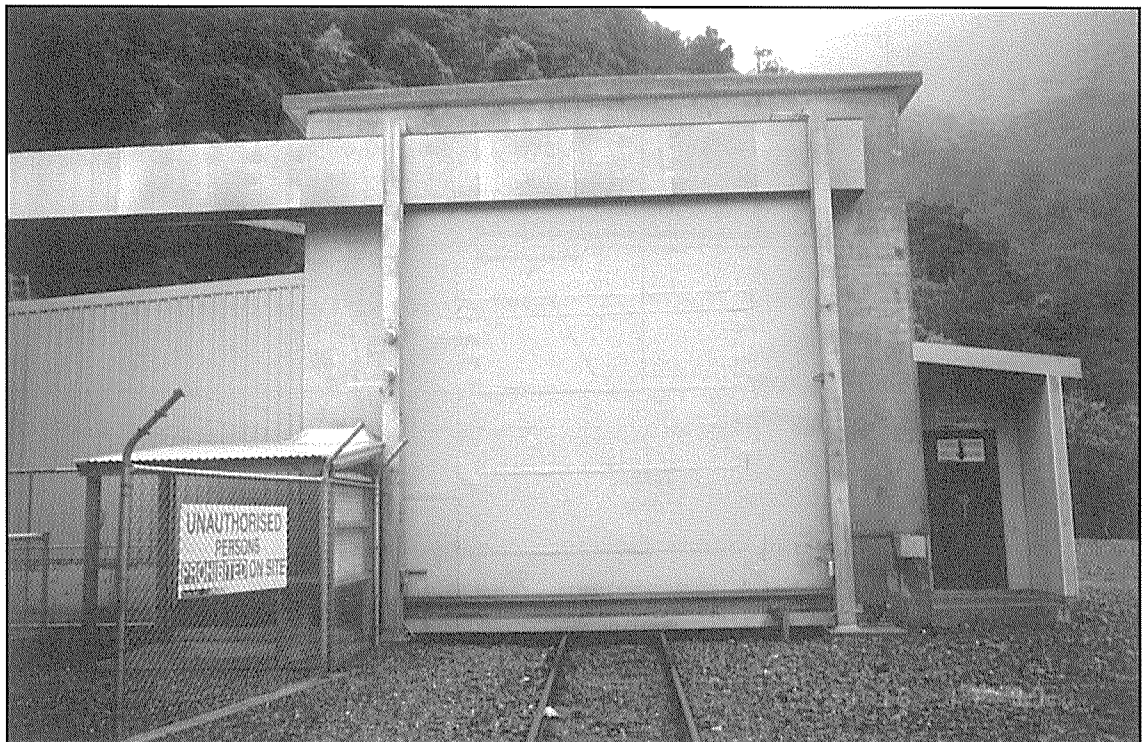
- 1.1.19 On arrival at the west portal shortly after 1200 hours he found the tunnel door open, with visible damage to the vertical south end of the sliding door and realised that the tunnel door had closed on Train 801.

Figure 1
Looking east at the door in the closed position
(the door opens by sliding from south to north)

2.3.1 Although the “knock through” design permitted a train to pass through the light central door structure, this safety feature did not provide protection for the combination of factors which caused the incident on 12 November 1997.

2.3.2 It was fortuitous that the door closed on a carriage rather than on a gap between carriages. If the door closing had coincided with the 0.9 m gap between carriages the relative speed of the train and the door could have resulted in a maximum 55 mm protrusion of the structural door frame impacting on the following carriage with the likelihood of more serious consequences. There was no obvious indication that the door had moved in the gap between the rear carriage and the van after impacting on the carriage, and it is likely that the 0.13 seconds which elapsed as this gap passed the door was too short to allow any significant movement of the door from rest.

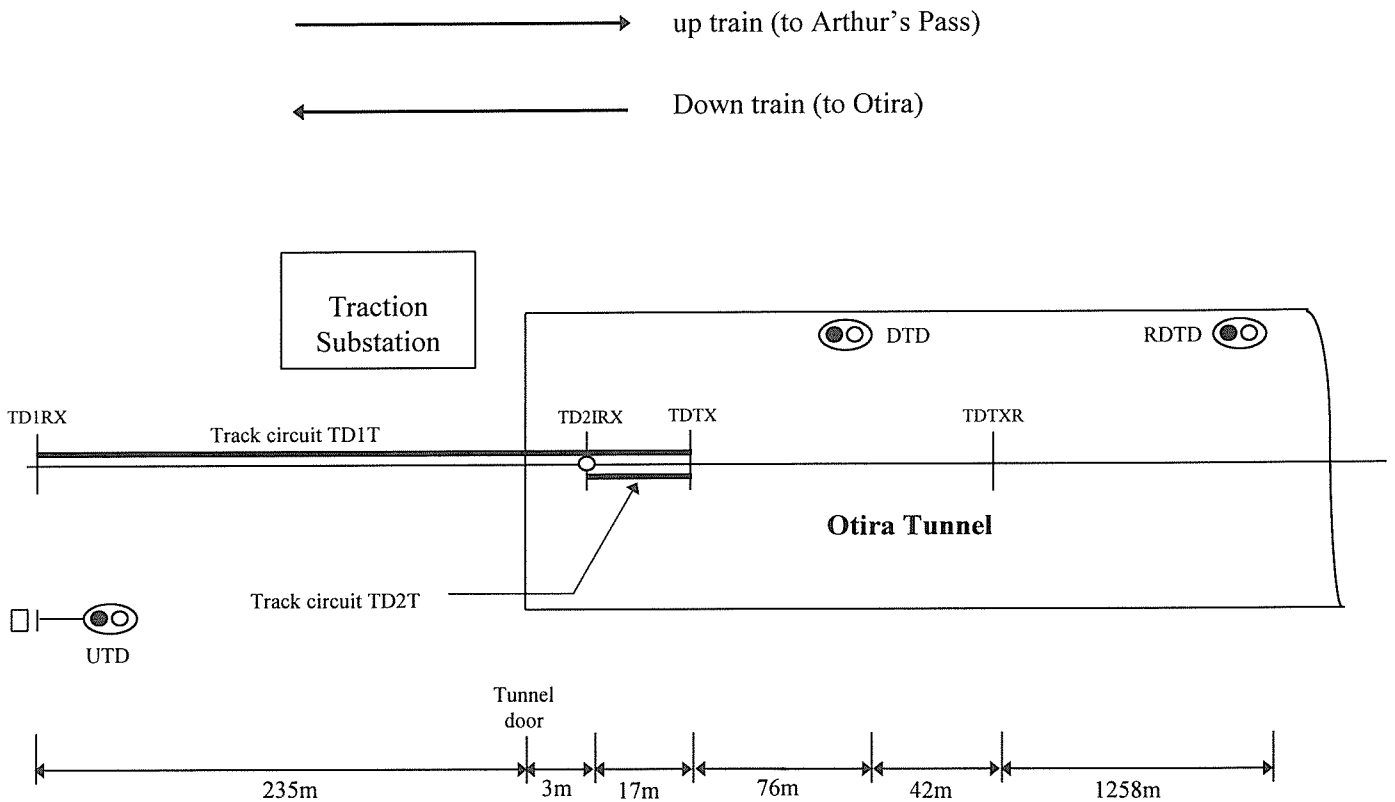
Figure 2
Schematic plan view of the west portal

1.4.1 The signalling system installed to control the door movement is shown schematically in Figure 2.

2.1.1 The door closure was initiated by a combination of trains which had not been anticipated when the program was designed for the logic controller which received input from the signalling system to automatically operate the door and fans for up trains.

- 3.3 The signals indicating the status of the tunnel door operated as intended.
- 3.4 The logic of the integrated signalling and door control system did not allow for the situation of a train entering and leaving the vicinity of the west portal without entering the tunnel.

- 4.1.1 Immediately following the incident Tranz Rail track-locked the door actuator control which meant the door could not close when track circuit TD1T was occupied. This interim modification overcame the design deficiency, although it had the operating disadvantage of not permitting manual overriding of the system.
- 4.1.2 Since DC traction was removed from the area Tranz Rail have redesigned the signalling on conventional insulated joint track circuitry involving two adjacent track circuits. The new system allows for automatic ventilation for both up and down trains, and will be able to detect and allow for the direction of each train. The new system is programmed for installation by July 1998.

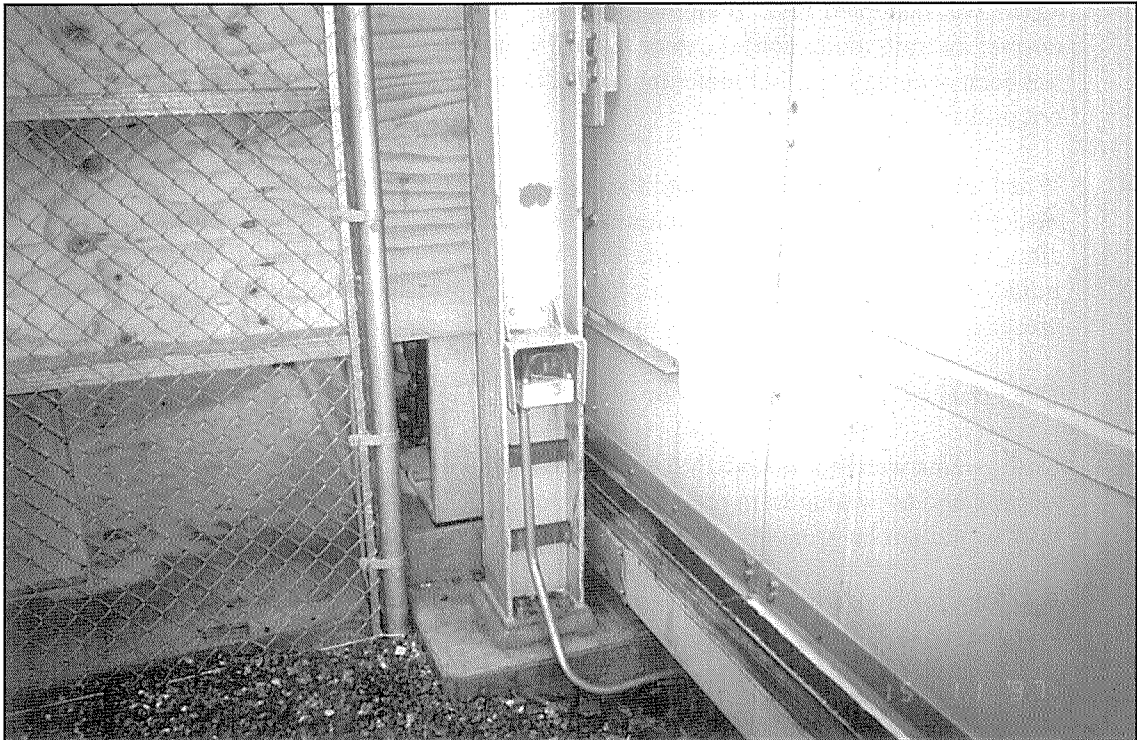
Figure 3
The optical sensor on the north side just outside the tunnel exit

A similar sensor is fitted just inside the tunnel. Two reflectors on the south side return the beams when the open doorway is unobstructed.

- 1.8.3 Two optical sensors were employed, one on the inside of the door and one on the outside (see Figure 3). Each sensor transmitted a beam across the door opening to a reflector mounted on the other side. The reflector then reflected the beam back to the sensor. If the door opening was obstructed the beam was broken and not received back at the sensor.

- 1.8.4 The type of sensor used was defined as “dark on” which meant that the output relay controlled by the sensor was energised if the beam was broken and de-energised if the beam was received back at the sensor. This meant that if power was lost to the sensor (which put the output relay into its de-energised state) the system thought that the beam was unbroken and the door unobstructed.

- 1.8.5 The power to the safety circuit was supplied from the door actuator control box situated just outside the west portal. A detailed check of the door actuator wiring by Tranz Rail electrical staff following the incident revealed a loose terminal block connection supplying power to the safety system which prevented the safety relay from energising.

- 1.8.6 The terminal block connections were a screw down type which if tight provided a secure connection. Tranz Rail advised it had been standard practice to remove the wire from that particular terminal in order to bypass the safety circuit for testing purposes and that it appeared that after the last such occasion the wire was not terminated correctly.

2.2.2 The likely cause of the loose connection which rendered the optical sensor safety system inoperative was the failure to terminate it correctly following testing.

2.2.3 Had the sensor system been operational the incident under investigation would have been avoided. The continual breaking of the beam by the passage of Train 801 would not have permitted the door to close.

- 4.2.1 Tranz Rail have redesigned the safety circuit system to a fail-safe "light-on" operation and the modification will be made when the new signalling system is installed.
