Report 97-202/203

Restricted-Limit Passenger Ferry *Te Waka o Kapanga*

groundings

Waiheke Island and Coromandel Harbour, Hauraki Gulf

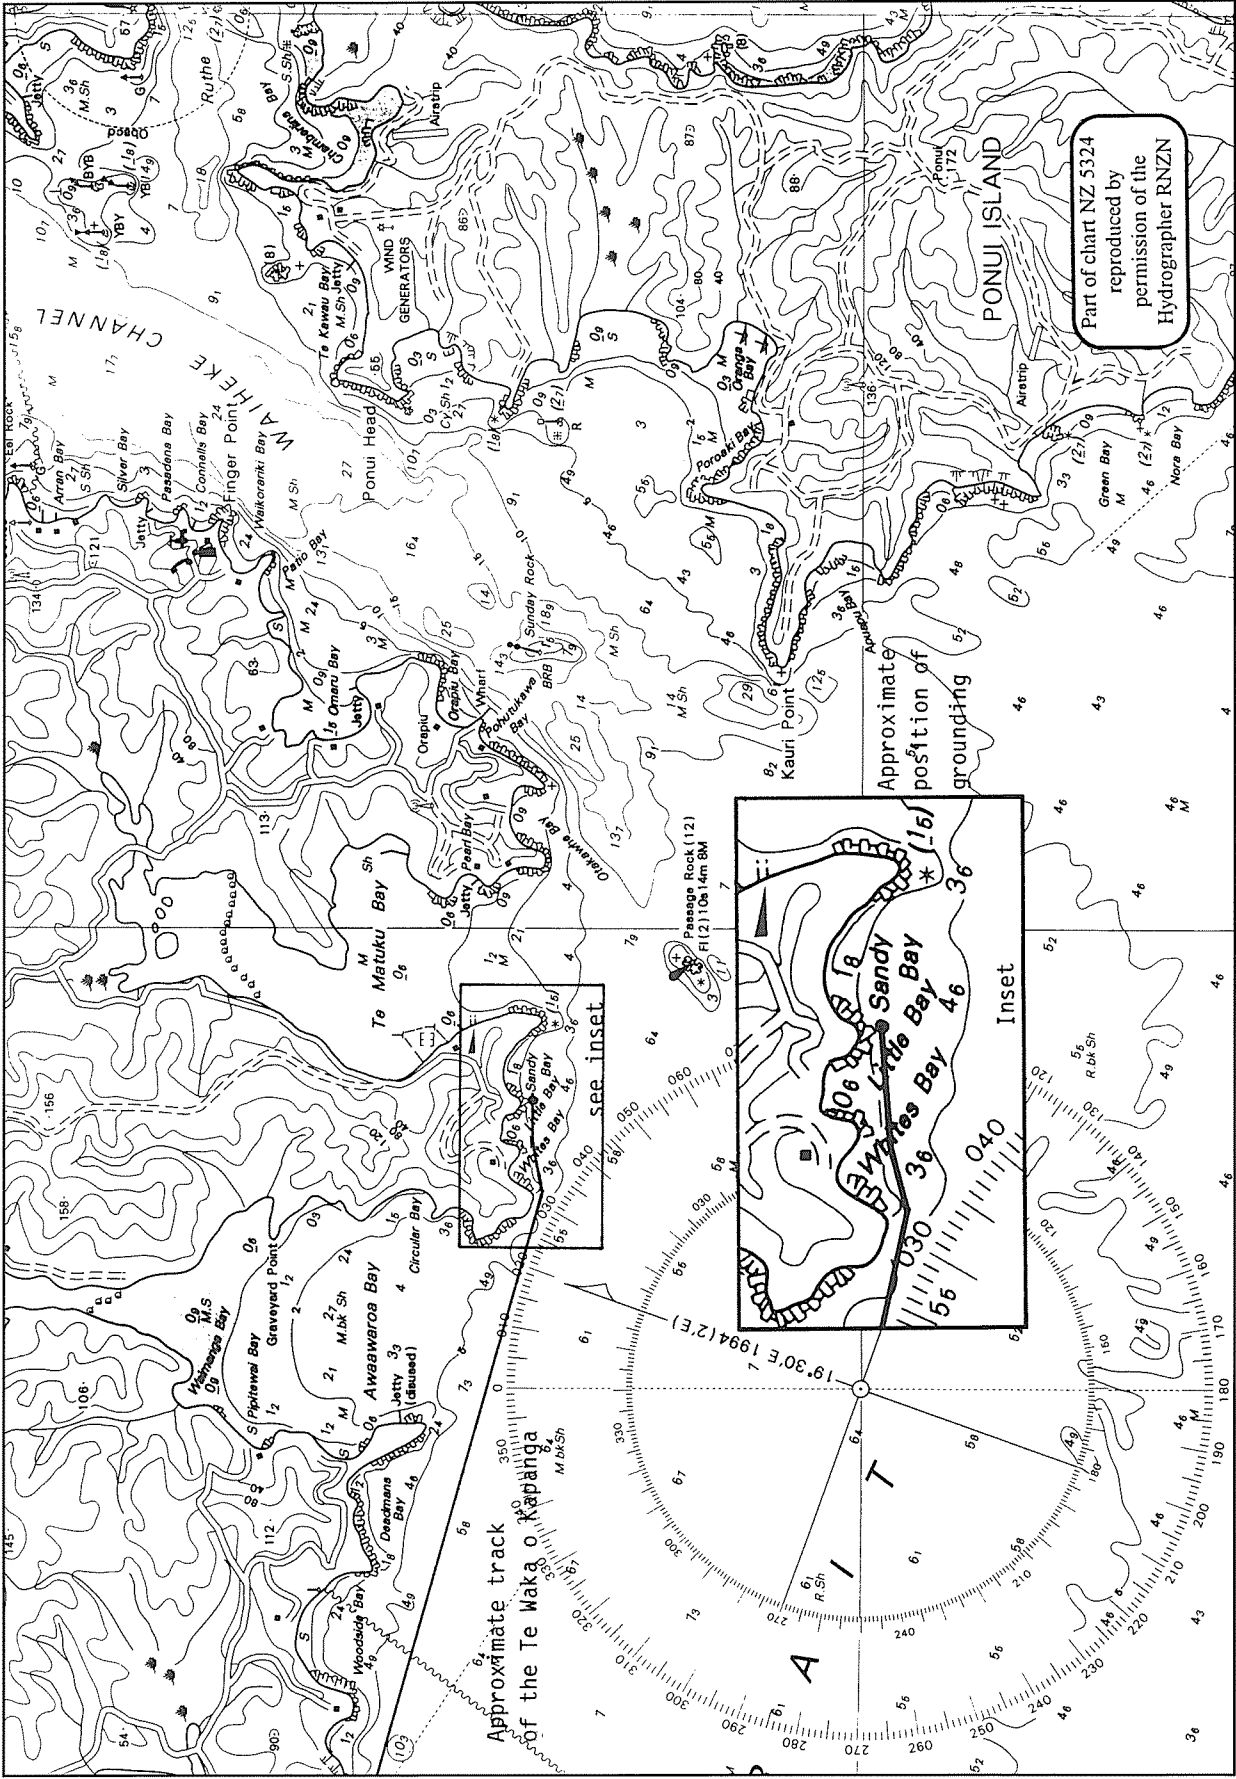
Figure 1
Part of chart NZ 5324 showing approximate track of the Te Waka o Kapanga (97-202)

- 1.1.7 As the *Te Waka o Kapanga* crossed the end of the Peninsula where Whites, Little and Sandy Bays are located the skipper steered closer to the shoreline than he would normally. Some of the passengers had asked the skipper to go close in to White Bay where they knew a property was for sale. (See Figure 1)

- 1.1.8 The *Te Waka o Kapanga* passed within 100 to 200 m of the shoreline in Whites and Little Bays and approached the point at the western extremity of Little Bay inside the line which would have taken the vessel clear of the submerged rocks off the point.

- 1.1.9 According to the skipper he was about to adjust the course of the *Te Waka o Kapanga* to pass outside the rocks when the cellular telephone near his console rang. He reached across, picked up the telephone and had just started speaking when the *Te Waka o Kapanga* struck the rocks. The vessel yawed to starboard and its momentum carried it over the rocks into deeper water.

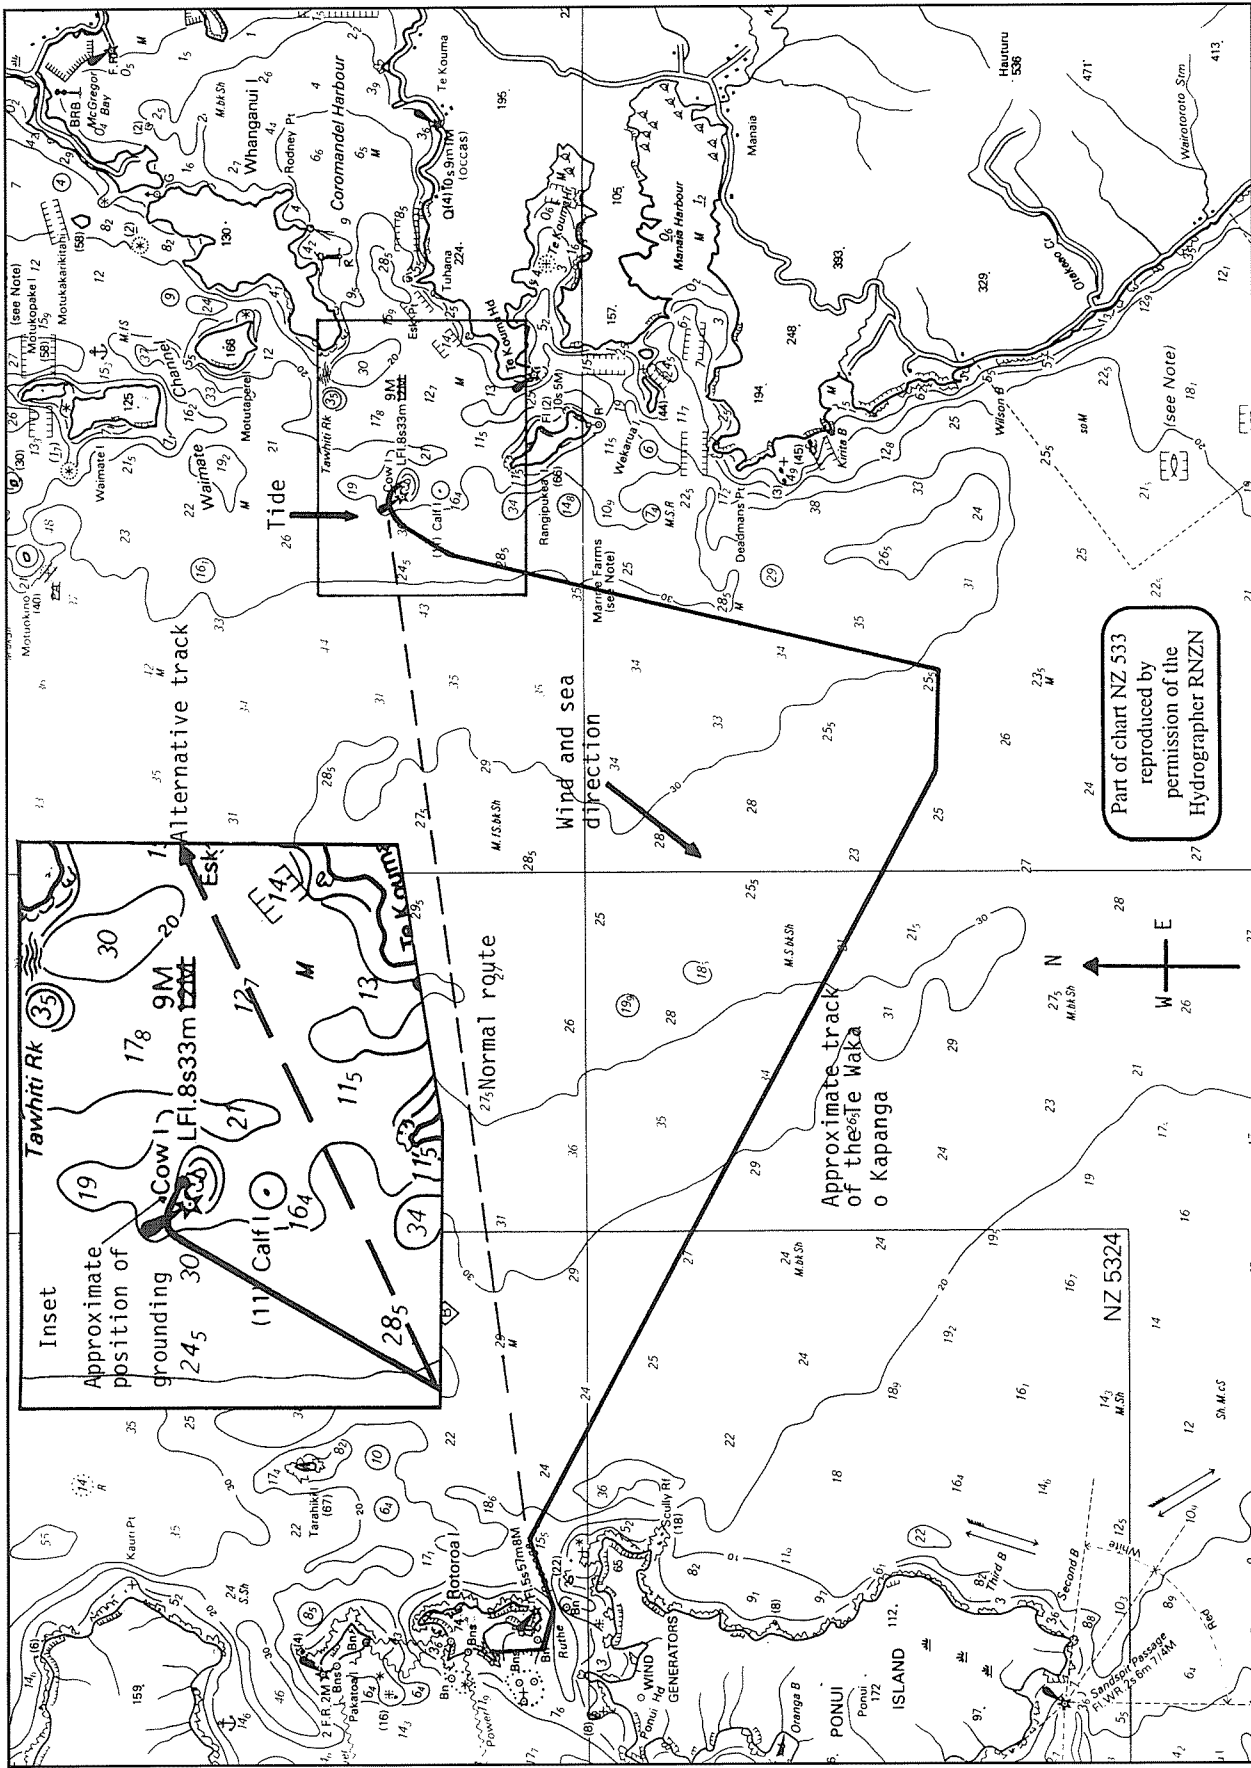
Figure 2
Part of chart NZ 533 showing approximate track of the Te Waka o Kapanga (97-203)

- 1.4.5 The *Te Waka o Kapanga* left Rotoroa with five passengers on board. The skipper headed south and then east, entering the Firth of Thames via Ruthe Passage between Rotoroa and Ponui Islands. From past experience in strong north-east weather conditions the skipper was expecting the seas to be rough in Ruthe Passage. (See Figure 2)

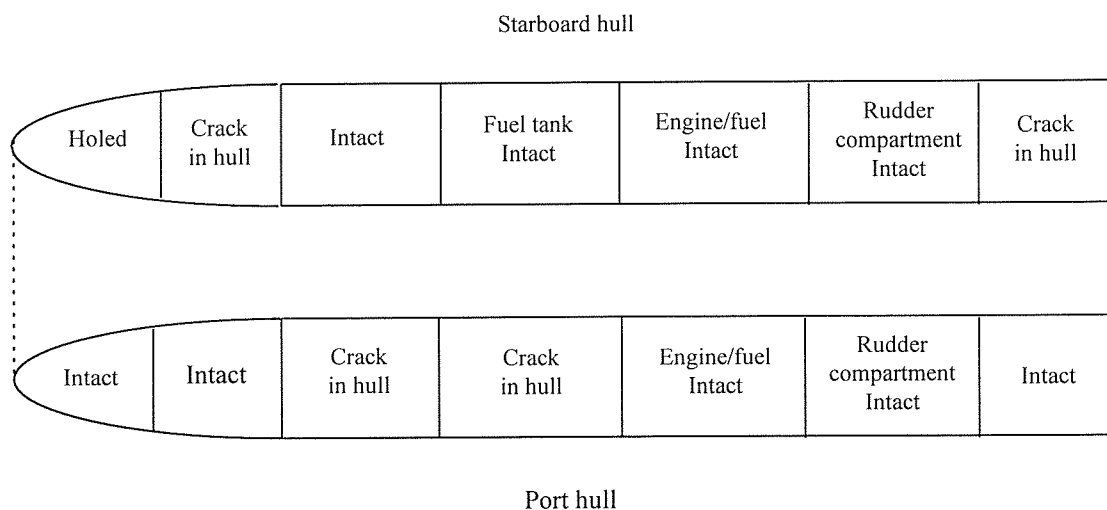
Figure 3
Schematic diagram showing damage to hulls of the *Te Waka o Kapanga*
Diagram not to scale

- 1.5 Damage to the vessel (97-203)**
- 1.5.1 Each of the hulls of the *Te Waka o Kapanga* is divided into seven water-tight compartments. Three compartments of those in the starboard hull, and two in the port hull were breached. (See Figure 3 below)

- 1.5.2 Both propellers, their shafts and the rudders needed replacement. The starboard propeller had been pulled back displacing the starboard engine by about 20 mm.

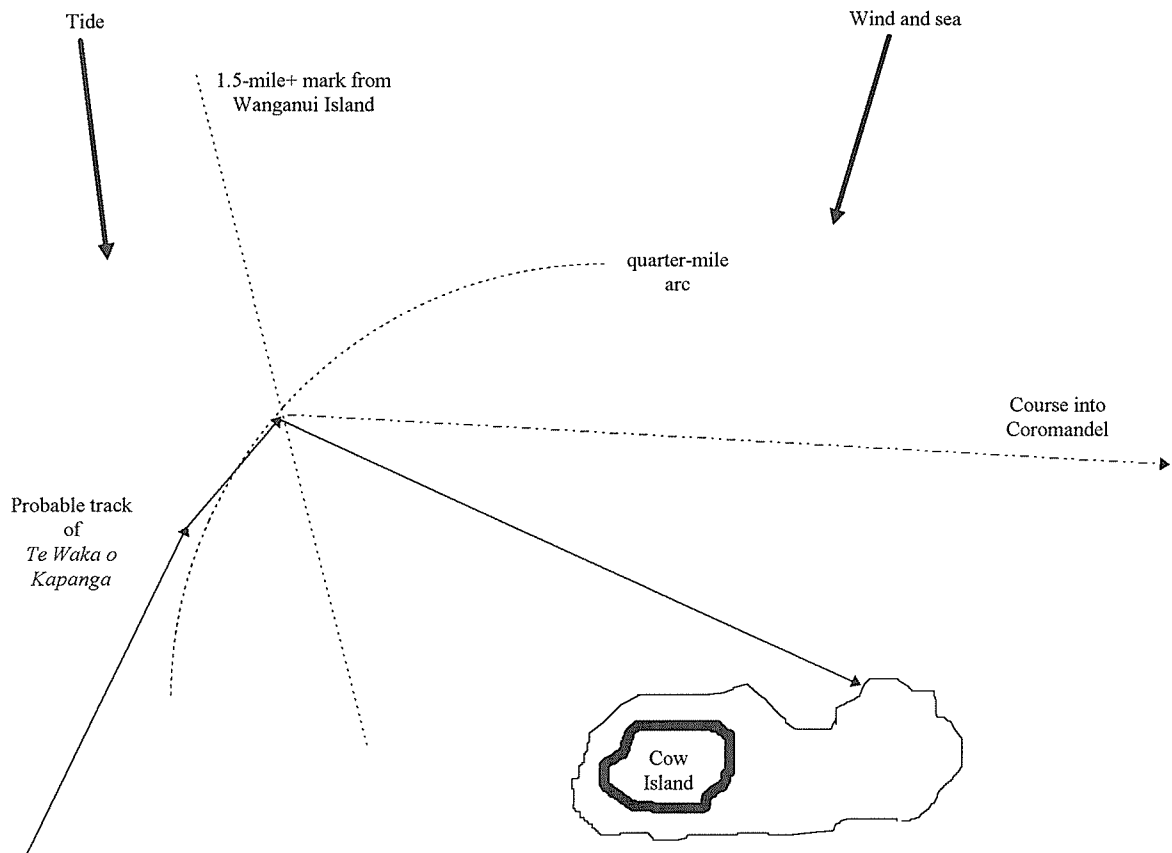
Figure 4
North-up diagram showing probable track of the *Te Waka o Kapanga*
(Diagram not to scale)

- 2.2.13 The skipper recalled being a quarter of a mile off the island just before he switched the radar to the 1.5-mile range. He stated that the south-west tip of Wanganui Island was “just on the edge of the screen, outside the 1.5-mile range ring”. This would have placed the *Te Waka o Kapanga* in a position somewhere north-west of Cow Island. If the senior skipper then made his final adjustment of course to enter the harbour based on the relative position of the tip of Wanganui Island on his radar screen, his vessel would have passed inside the quarter-mile mark on the radar. This may not have been readily apparent to him with the radar on the 1.5-mile range scale. (See Figure 4)

- 2.2.14 The *Te Waka o Kapanga*, with its high superstructure and relatively shallow draft was highly susceptible to leeway. The severe rain squall that was passing as the *Te Waka o Kapanga* rounded Cow Island would have caused a considerable amount of leeway down towards the island. This combined with the effect of the tide that would have been running broadly with the wind and sea, and the reduced speed of the *Te Waka o Kapanga* as it rounded the island, produced a resultant drift angle large enough to carry the *Te Waka o Kapanga* onto the reef that extended eastward of Cow Island.
