**Report 97-207**

**dinghy *Solo***

**swamping**

## Marine Incident Report 97-207

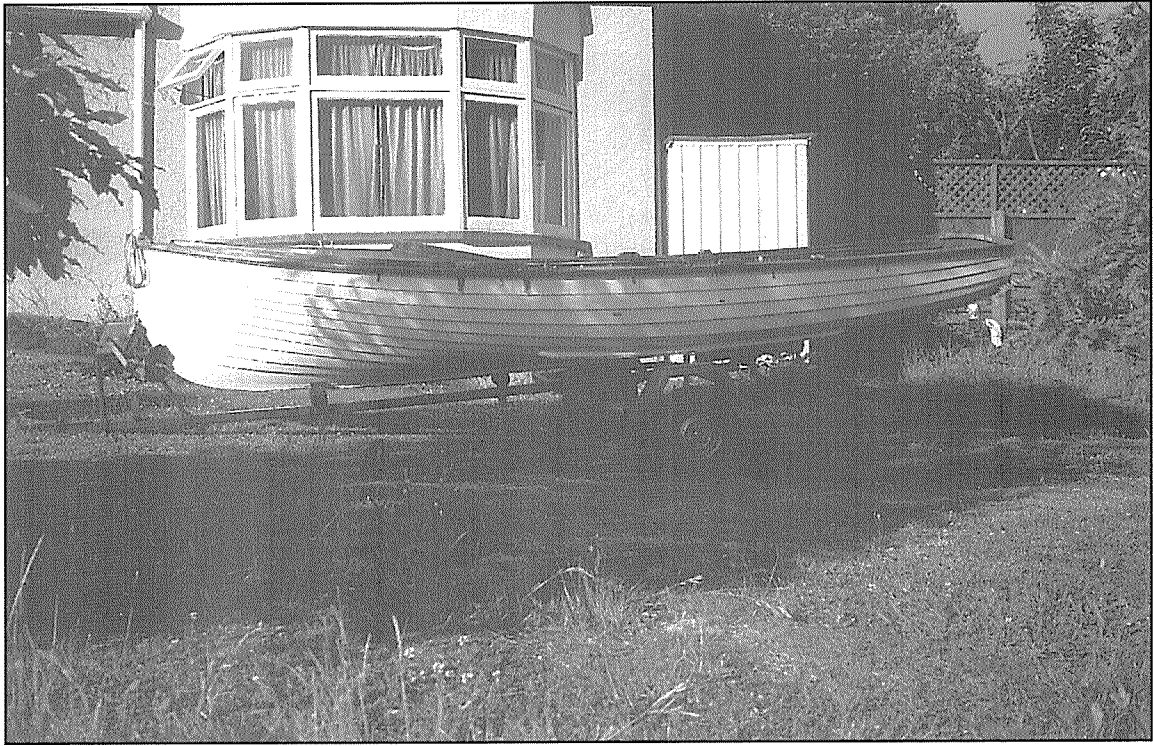
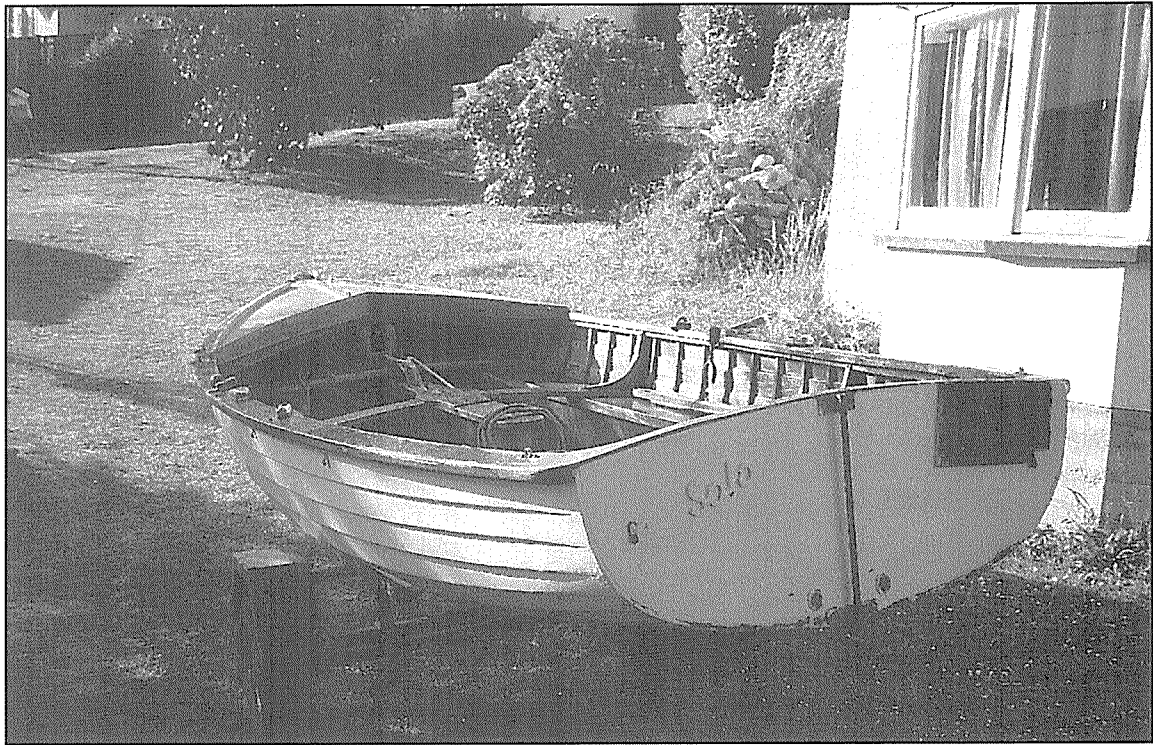
*Solo* at owner's residence

- 2.9 The freeboard of 300 to 350 mm, as estimated by the owner, was not sufficient to stop water ingress over the side of the boat when confronted with waves estimated to be 500 mm high. The loading of the boat to this extent was the main contributory factor in the swamping.
